S E R V I C E N O T E

Agilent 3070/79000 Board Test System

Notification of Potential Operator Safety Hazard

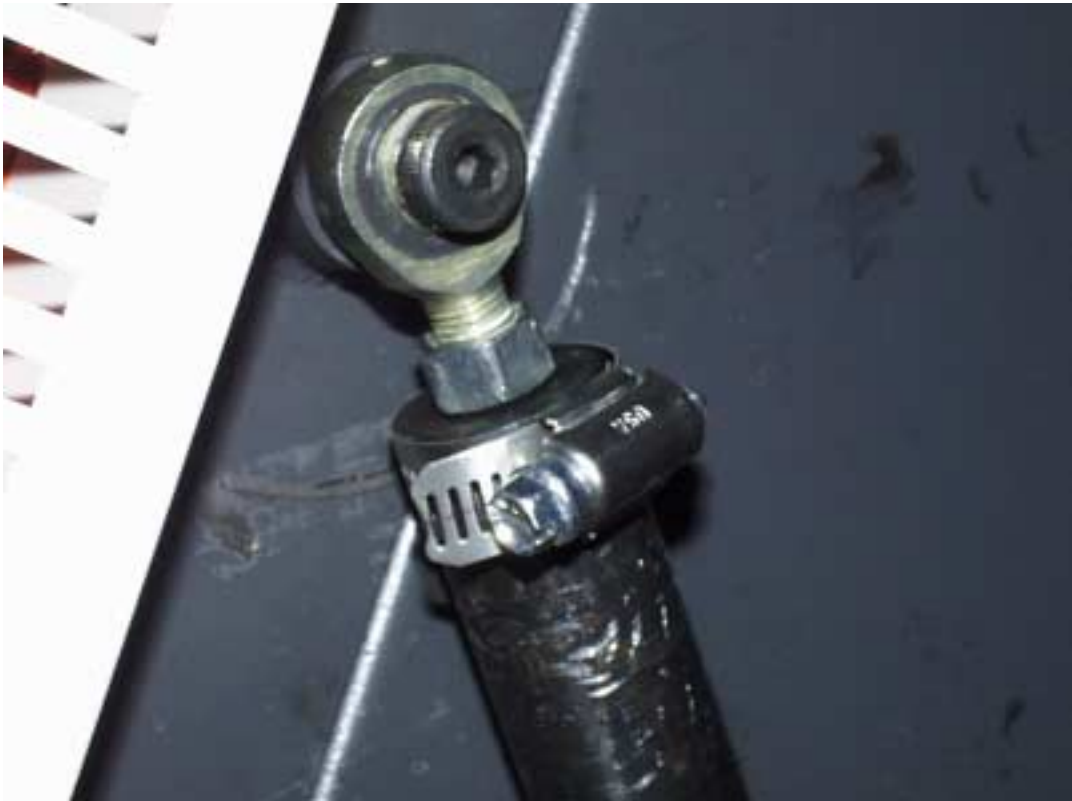
Figure 2. Nut on Linear Actuator

The black telescoping tube of the testhead rotation system can slip off the threaded portion of the length adjusting shaft, if the nut located above it is not tightened properly. The normal operation of the black telescoping tube during rotation is to slide up and out of the chrome outer tube portion of the rotation system. If the nut above the black telescoping tube is not properly tightened, the telescoping tube will instead turn with the nut until it reaches the last thread on the eye bolt and disconnect. This can cause the testhead to fall either backwards or forewards and/or the gas spring on the opposite side of the testhead to release and eject.

Ensure the nut on the linear actuator is tight using a 14mm wrench or an adjustable wrench. If needed, hold the black telescoping tube on the linear actuator with a pliers to prevent it from turning. Tighten the nut firmly, to approximately 120 inch-lb/13.5 Newton-meter.
