33510B-02

Modification Recommended Service Note

33510B Function Generator

Serial Numbers: MY000000000 to MY57200600 and SG000000000 to SG57200600

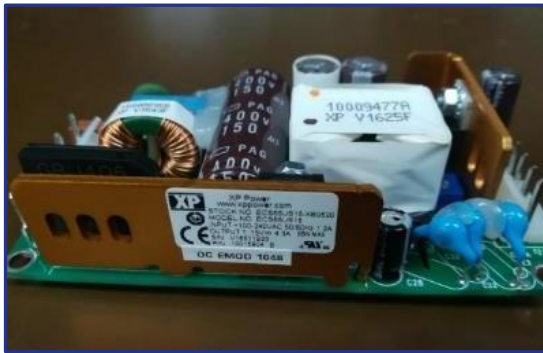
Old Noisy XP Power Supply (PN xxxx-xxxx)

The Problem – Some customers have reported that, when line power is applied to the instrument but the instrument is NOT turned on (“Standby Mode”), some instruments will emit an audible high-pitched whistle or whine. To fix this, the existing power supply must be replaced with a newly designed power supply, as detailed in the solution below.

The solution is to replace the old power supply with a new one. The old power supply was manufactured by XP Power. The new power supply is manufactured by MeanWell, and has Part Number 0950-6082.

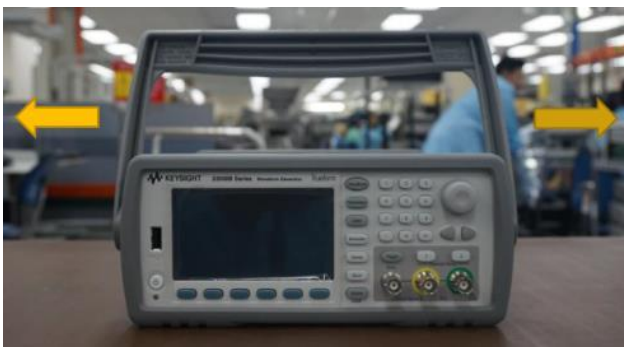
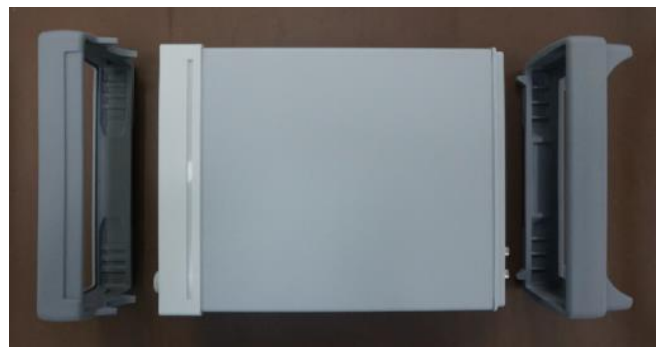
- 1) Rotate the handle upright and pull off the handle. Then pull off the instruments bumpers.

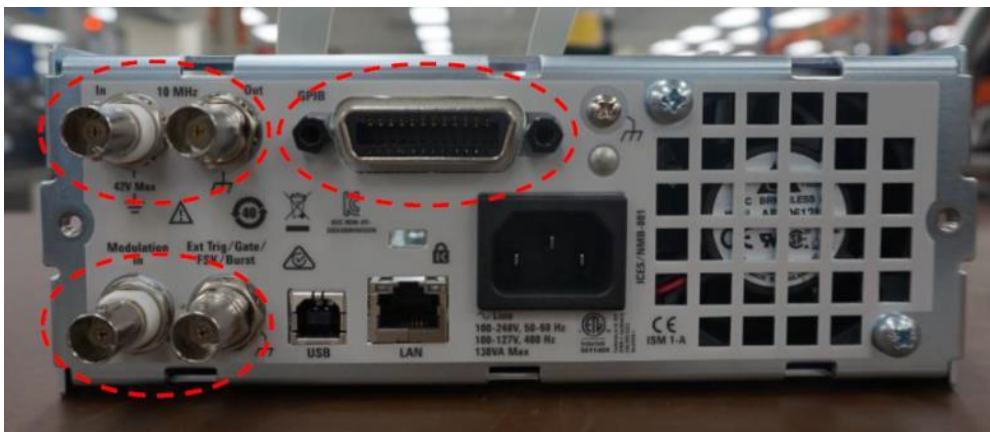
- 2) Loosen and remove the nuts securing the **10 MHz In**, **10 MHz Out**, **Modulation In** and **Ext Trig** BNC connectors to the rear panel. Remove the hex screws and washers securing the **GPIB PCA**.

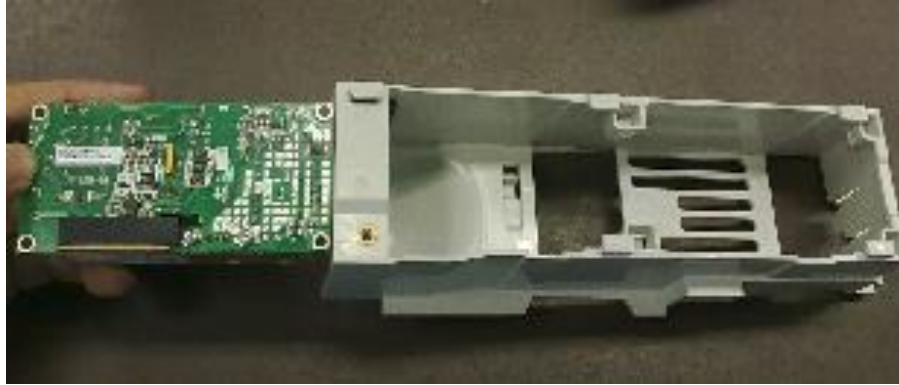
Figure 1

Take the New Power Supply (0950-6082) and slide it into the Power Supply Cover. Make sure the orientation of the power supply is correct as shown on Figure 1.

NOTE: The illustrations below show the **OLD** XP power supply assembly. Be sure you are installing the **NEW** MeanWell power supply. Reference the photos at the beginning of this Service Note to be sure you have the correct supply.

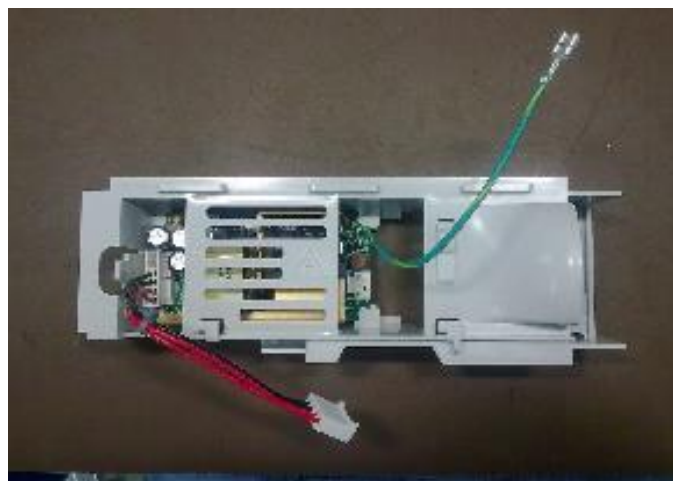
Figure 4

Install the Power Supply cable (53200-61619) and the Chassis Ground Cable (53200-61610) into the power supply connectors as shown in Figure 4.
