33512B-02

# Modification Recommended Service Note

## 33512B Function Generator

Serial Numbers: MY000000000 to MY57400600 and SG000000000 to SG57400600

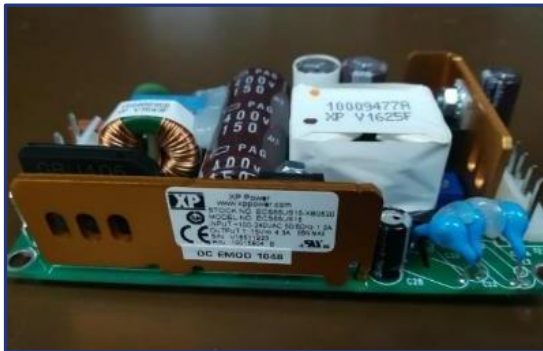
**Old Noisy XP Power Supply (PN xxxx-xxxx)**

**The Problem** – Some customers have reported that, when line power is applied to the instrument but the instrument is NOT turned on (“Standby Mode”), some instruments will emit an audible high-pitched whistle or whine. To fix this, the existing power supply must be replaced with a newly designed power supply, as detailed in the solution below.

The solution is to replace the old power supply with a new one. The old power supply was manufactured by XP Power. The new power supply is manufactured by MeanWell, and has Part Number 0950-6082.

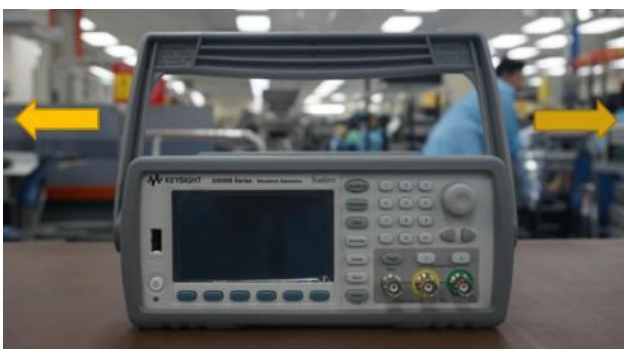
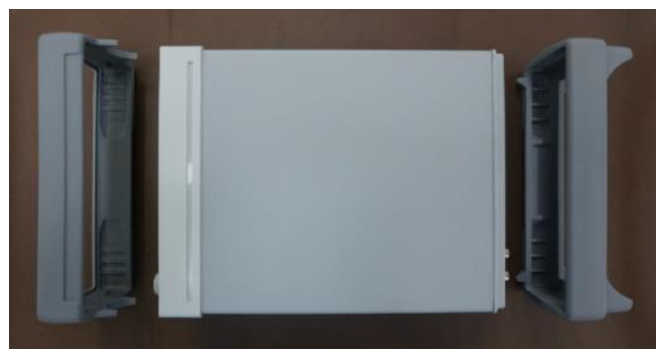
- 1) Rotate the handle upright and pull off the handle. Then pull off the instruments bumpers.

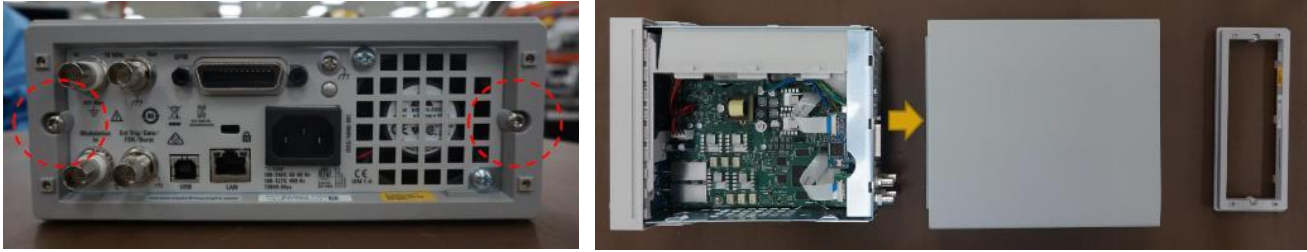
- 2) Loosen the two captive rear bezel screws, remove the bezel, and slide off the instrument cover.

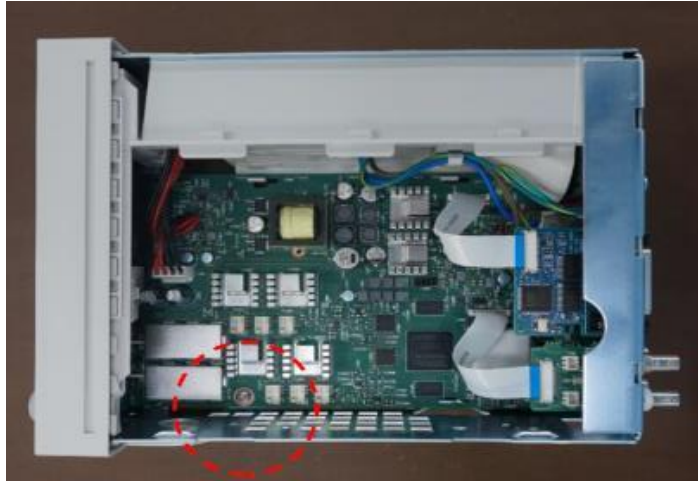
3) Remove the T15 screw holding the main board.

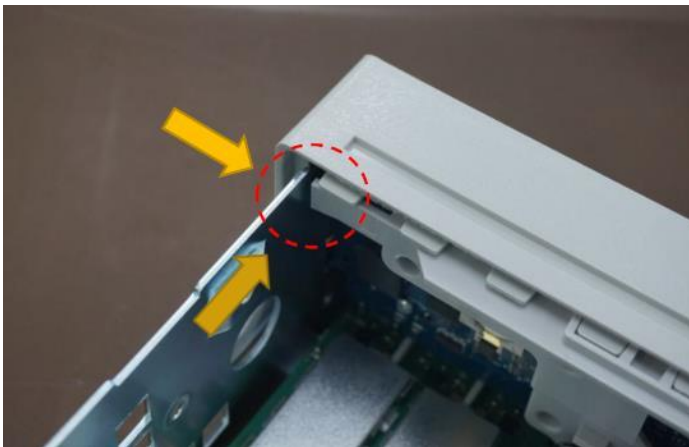
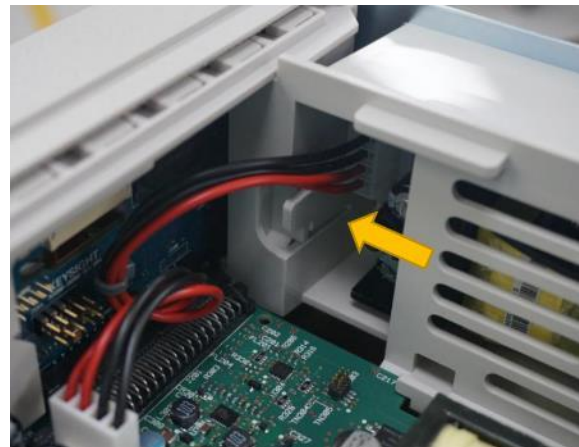
4) Press the latch on the left side of front panel, then press the latch on the right side of the front panel.

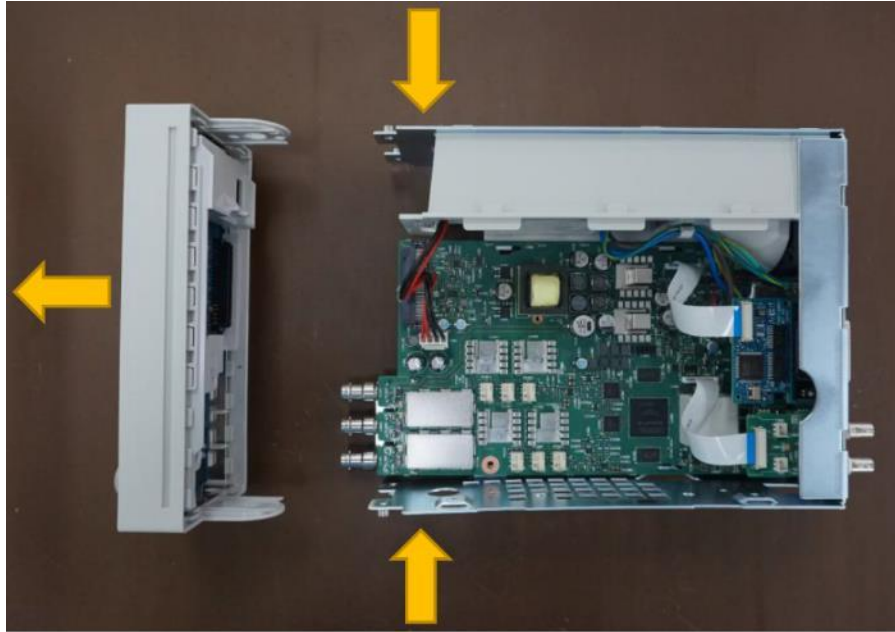
- 5) Push the sides of the metal chassis toward the center to disengage the studs on the sides of the front panel assembly. Then gently pull the front panel assembly straight back from the chassis. Note that the front panel assembly has an electrical connector to the main board. Be careful not to damage the connector.

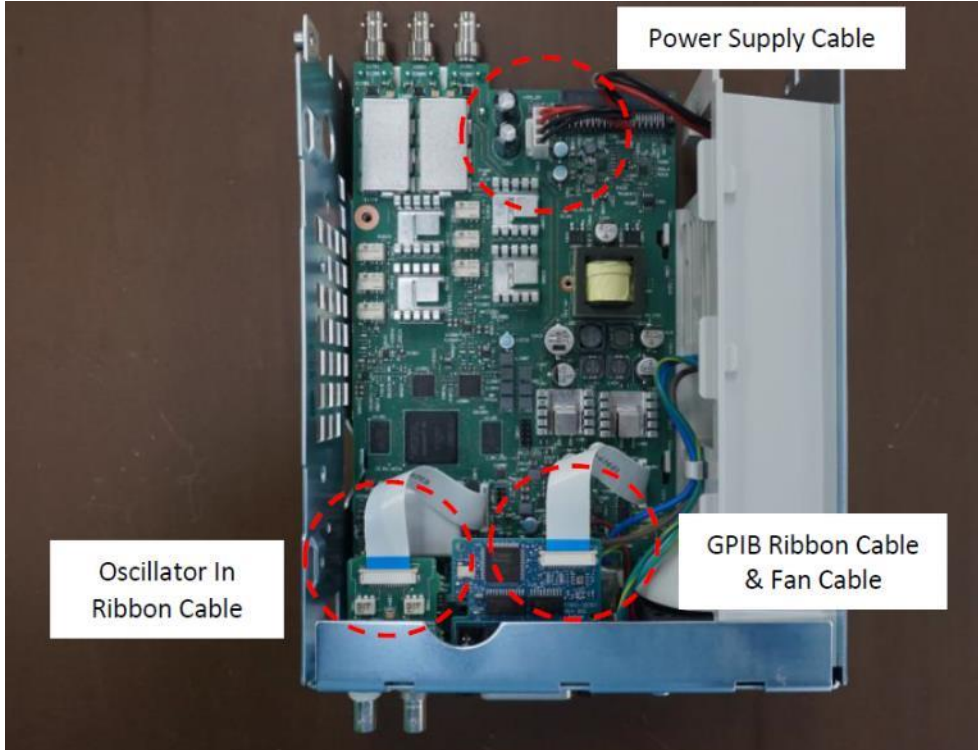
- 1) Disconnect the power supply connector from the main board. Disconnect the **GPIB** and **Oscillator In** ribbon cables. Disconnect the **Fan Power Cable** from the main board.

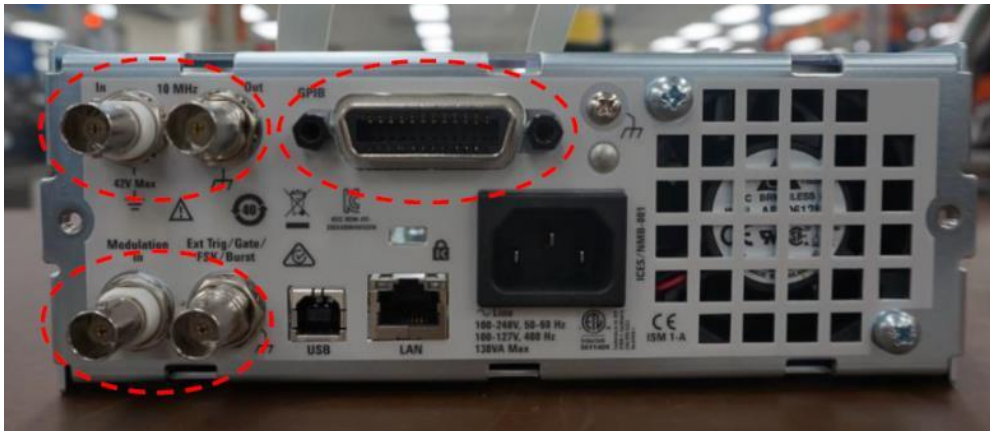
- 2) Loosen and remove the nuts securing the **10 MHz In**, **10 MHz Out**, **Modulation In** and **Ext Trig** BNC connectors to the rear panel. Remove the hex screws and washers securing the **GPIB PCA**.

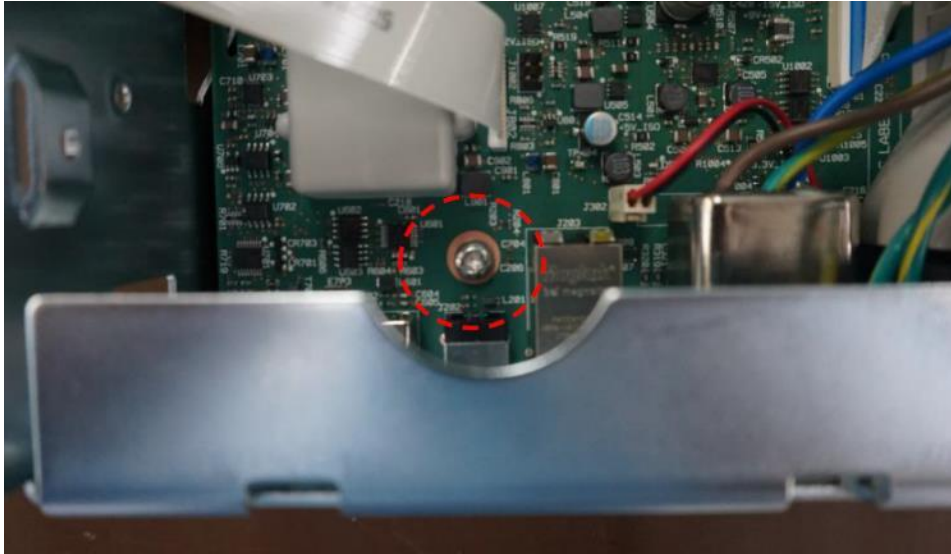
- 3) Remove the screw below the GPIB board which secures the main board to the chassis.

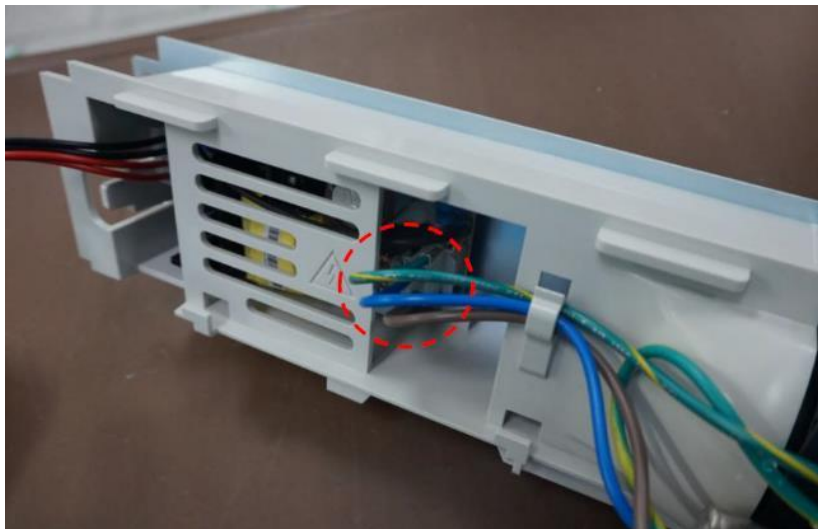
- 1) Disconnect the input power to the power supply board (blue and brown wires). Disconnect the green ground wire connector on the power supply board.

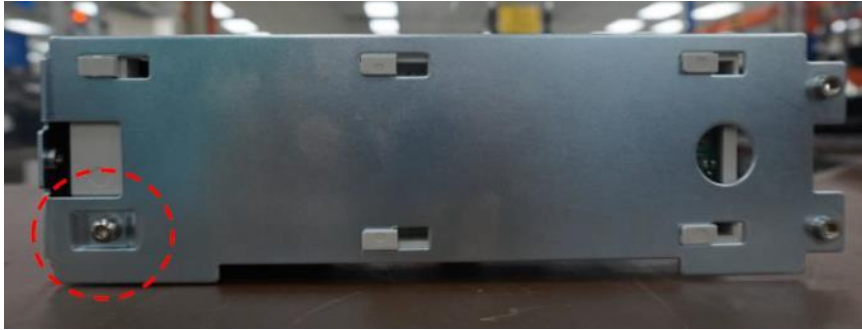
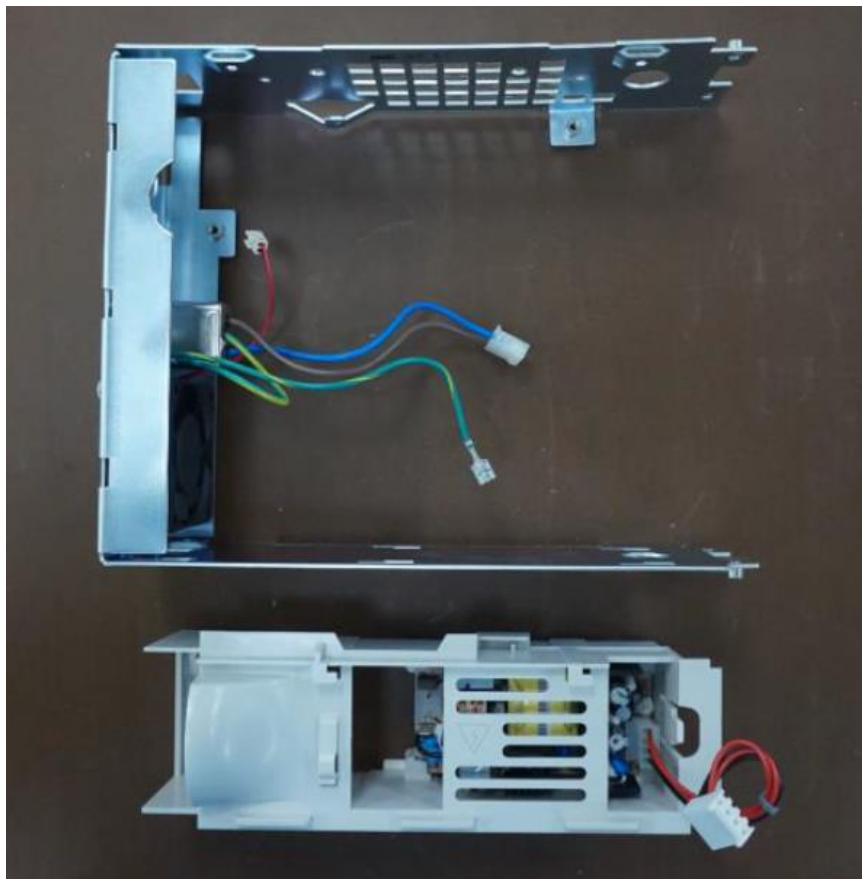
- 2) Remove the screw securing the power supply cover to the chassis. Then slide the power supply assembly toward the front of the instrument and remove it.

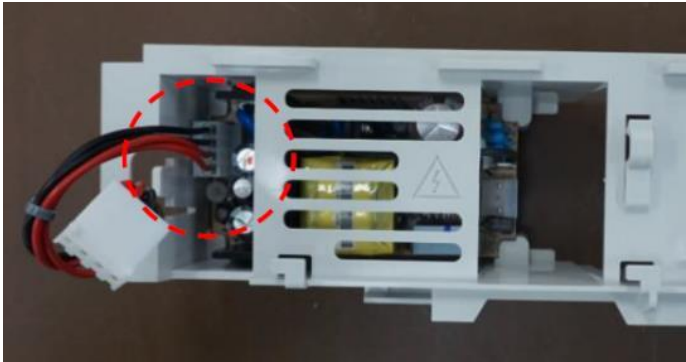
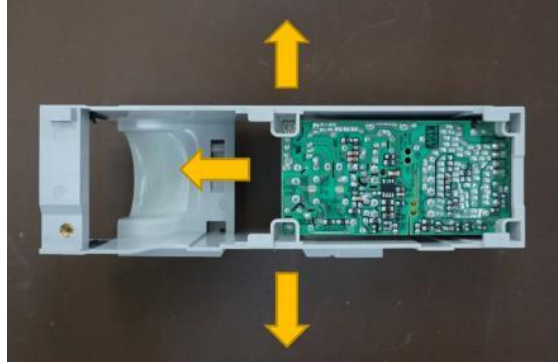
- 3) Remove the power supply cable from the power supply unit. Then pull the walls of the power supply cover to release the power supply.

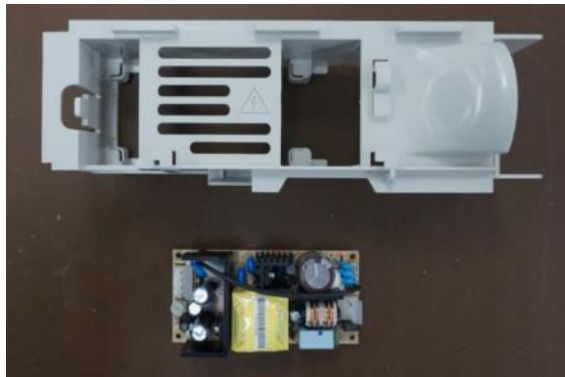
- 4) Remove the power supply from the power supply cover.

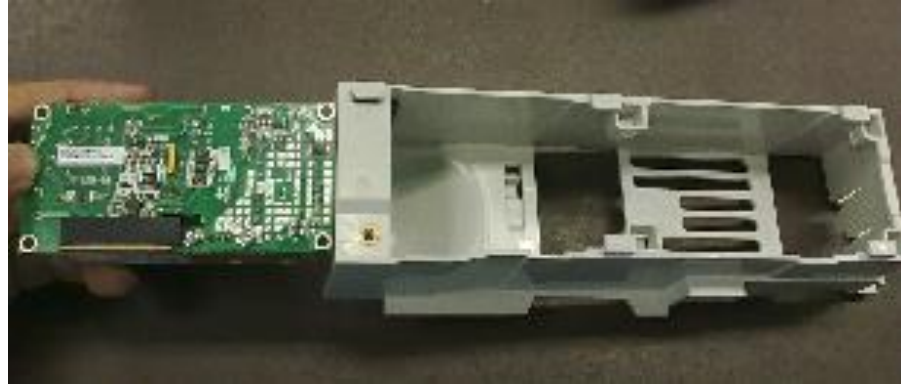
Figure 1

Take the New Power Supply (0950-6082) and slide it into the Power Supply Cover. Make sure the orientation of the power supply is correct as shown on Figure 1.

**NOTE: The illustrations below show the OLD XP power supply assembly. Be sure you are installing the NEW MeanWell power supply. Reference the photos at the beginning of this Service Note to be sure you have the correct supply.**

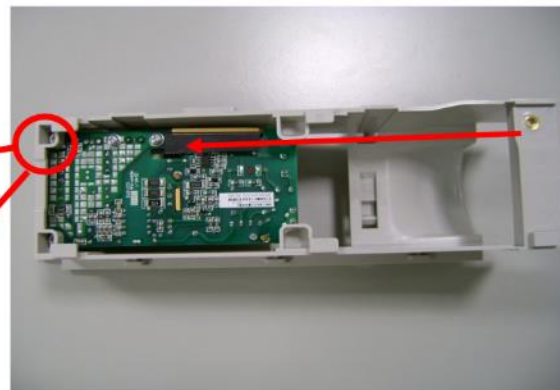
Figure 2b

Push the power supply into the cover as indicated by the red arrow until it reaches the end of the power supply cover, as shown in Figure 2b. Make sure the two edges of the power supply PCA are completely inserted into the slots on the power supply cover as shown in Figure 2c. Figure 2a shows the Power supply PCA edge is not properly inserted in the slots on the power supply cover.

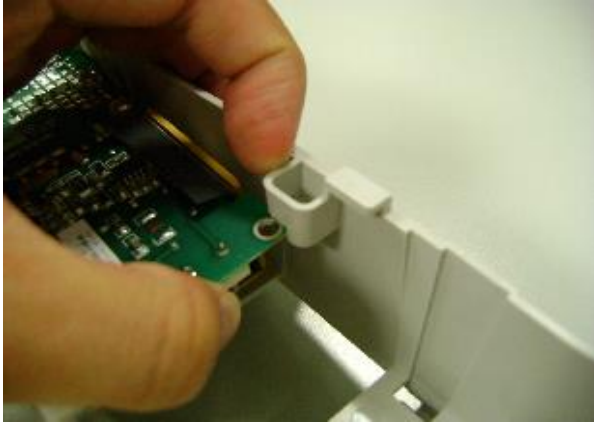
Figure 3a

Pull one side of the cover outward while pulling the Power Supply PCA upward, so that the power supply PCA slides into the slot on the Power supply cover as shown on Figure 3a. Do the same for the other edge of the power supply. The Power supply cover with the power supply properly installed is shown in Figure 3b.

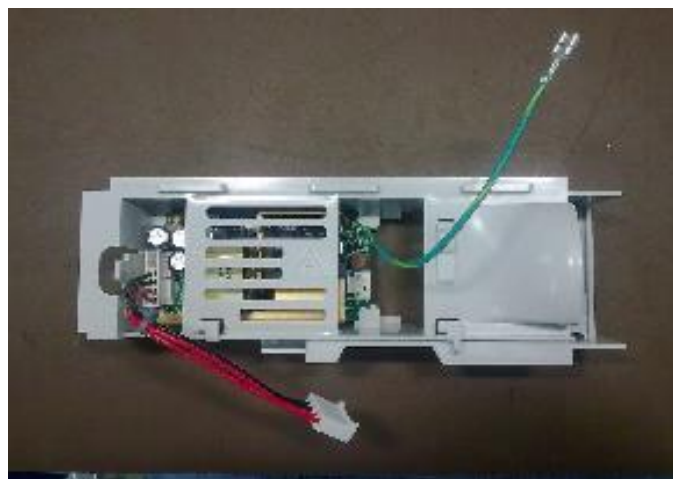
Figure 4

Install the Power Supply cable (53200-61619) and the Chassis Ground Cable (53200-61610) into the power supply connectors as shown in Figure 4.
