4155C-05

S E R V I C E N O T E

4155C Semiconductor Parameter Analyzer
4156C Precision Semiconductor Parameter Analyzer

LCD Picture Intermittently Reverses or is not Displayed

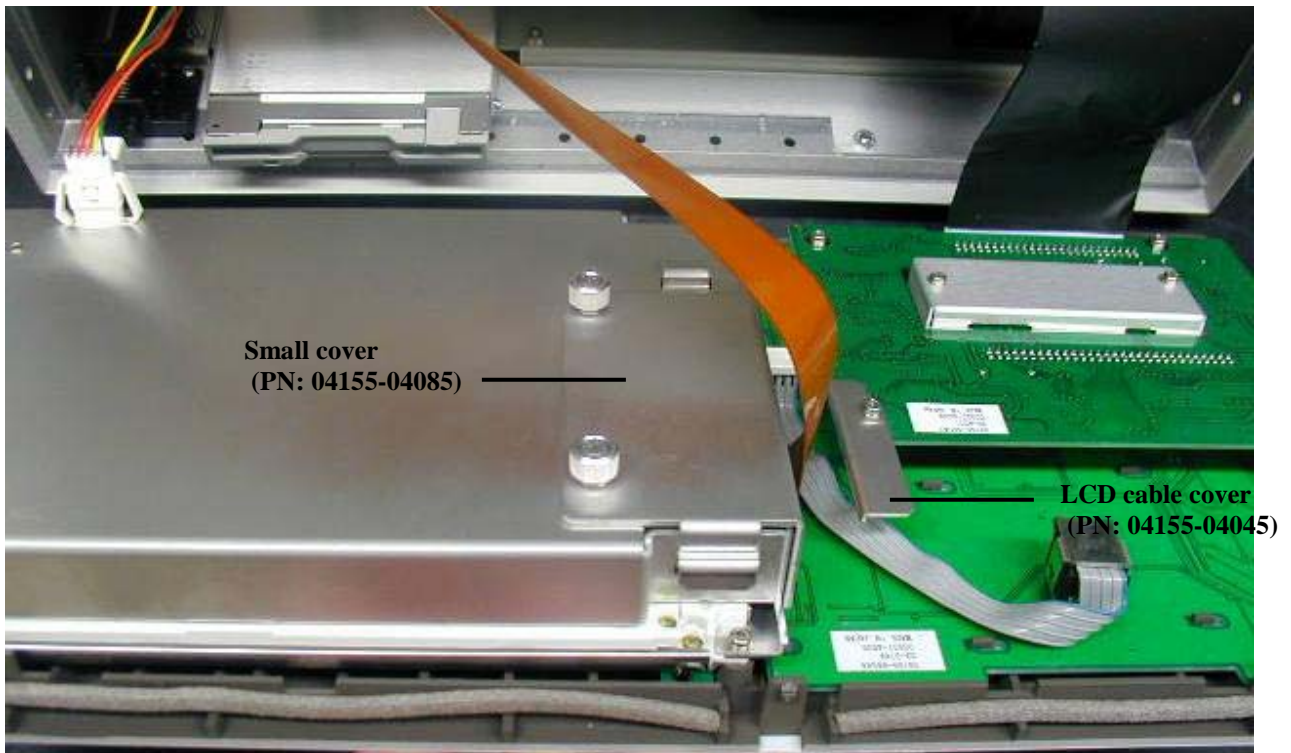
1. Confirm if the symptom happened or not.
2. Open the front panel assy., and check if LCD cable cover (04155-04045) has installed or not. If not, install it (This part will be provided as Service Note 4155C-04 or 4156C-04.)

3. Remove the original small cover 04155-04085

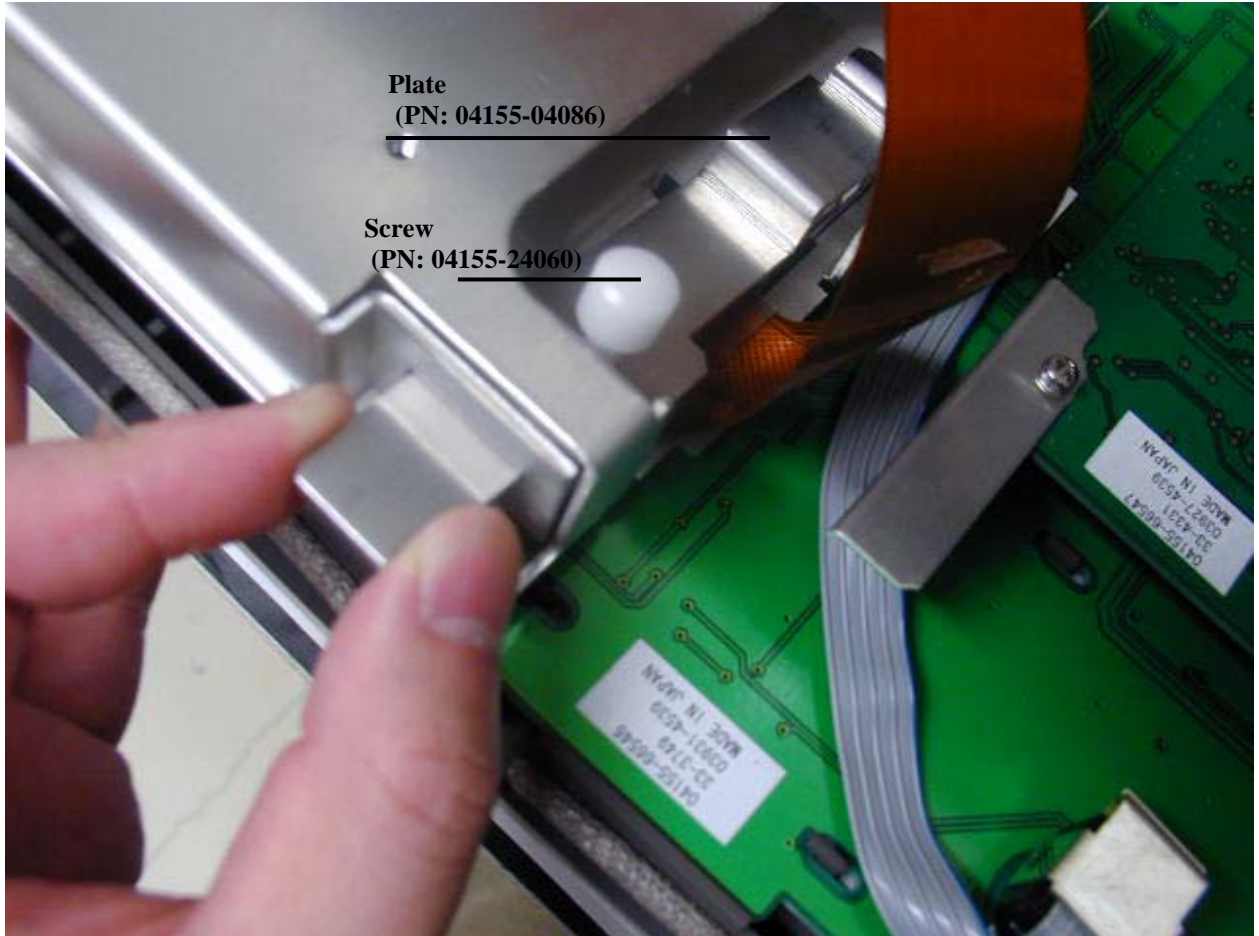
4. Insert the plate (PN: 04155-04086) and fix it using screw (PN: 04155-24060).

5. Install the new small cover (PN: 04155-04086).
6. Perform the diagnostics Interactive Test “LCD Test”.
