5DX-82-S

S E R V I C E N O T E

Agilent 5DX Series 2L, Series 3, and Series 5000 Systems

The E1135A/B/C PDU may not turn off when the EMO switch (emergency stop) is pressed.

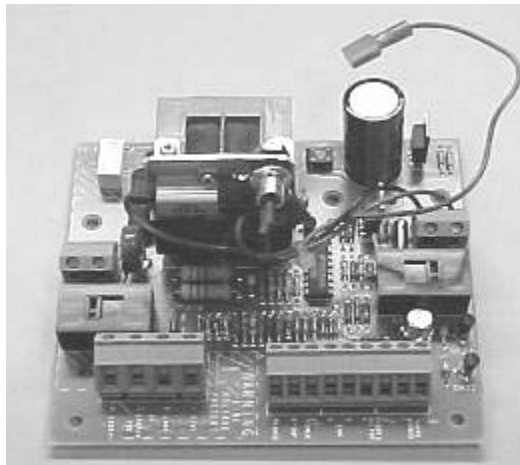
Fig 1

The solution is to replace the E1135-66501 control board in the PDU with a newer version (Fig 1) that incorporates a voltage regulator to the magnetic contactor.

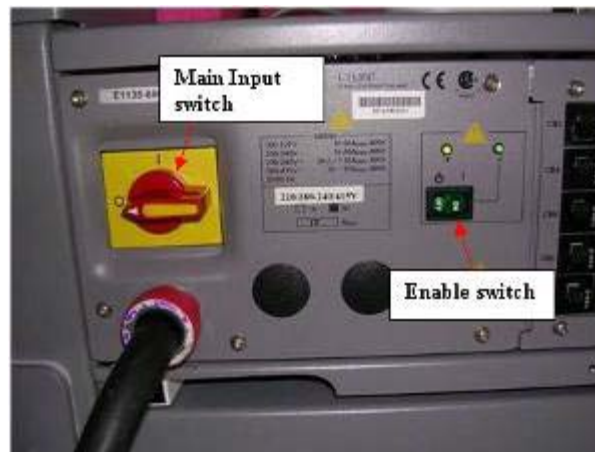
Fig 2

1. Perform the 5DX System shutdown procedure found in the System Administration Guide
2. The E1135C has a mains disconnect device. Set this Main Input Switch to “0” (Fig 2). This is a safety feature to prevent the accidental turn-on of power from the mains while carrying out the job as described in this safety service note.

19. Remove any “Lock Out / Tag Out” devices before proceeding.
20. Turn on the PDU by setting the Main Input Switch to “1” (E1135C’s ONLY!!!)
21. Turn on the PDU enable switch (Fig 2).
22. Test the safety feature of the PDU by pressing the EMO switch. The power will shut off immediately. This is observed by a click sound while the enable light will turn from green to yellow. The enable switch remains at the ‘1’ position.
23. Return the EMO switch back to its normal position.
24. Turn the enable switch to ‘0’ position and wait for 5 seconds before turning it back to ‘1’ position.
25. Observe the click sound and the green enable light.
26. Perform the 5DX System Startup procedure found in the System Administration Guide
27. Upon job completion, fill out and install the Service Note label (Part Number N7200-84366) to the PDU.

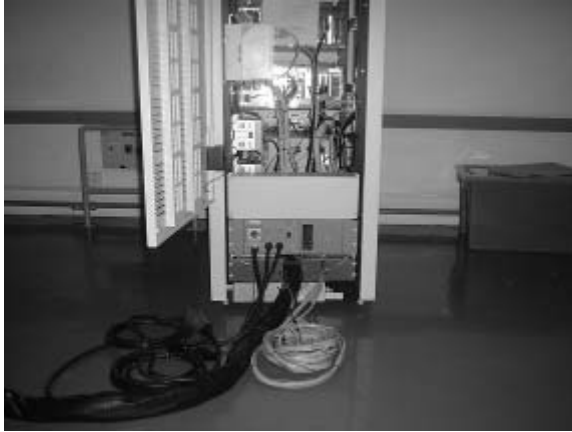
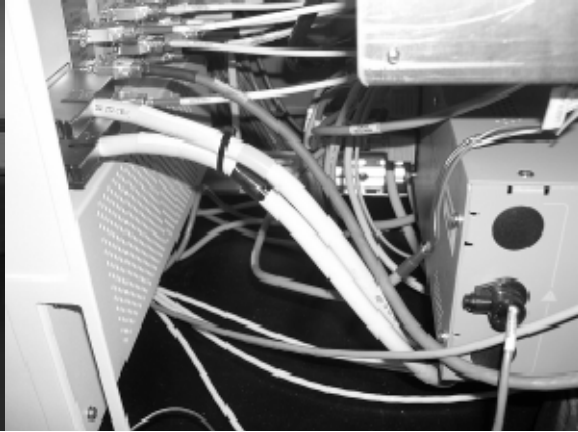
5. Unplug the power cords at the back of the PDU and remove the PDU from the Electronic Bay for disassembly (Fig 3 & 4). The power cords on the side of the PDU cannot be easily removed, so place the PDU horizontally on the floor near the system in such a way the power cords are not affected.

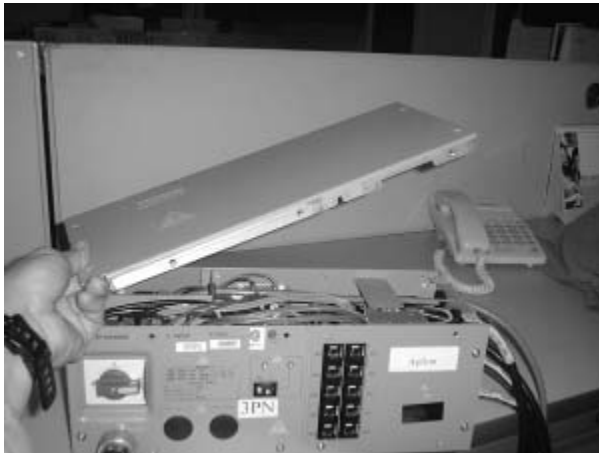
6. Remove the 17 M3.5 Torx screws holding the top and back covers of the PDU (Fig 5 & 6) using a T10 Torx driver. This needs to be done to access the E1135-66501 Control Board.

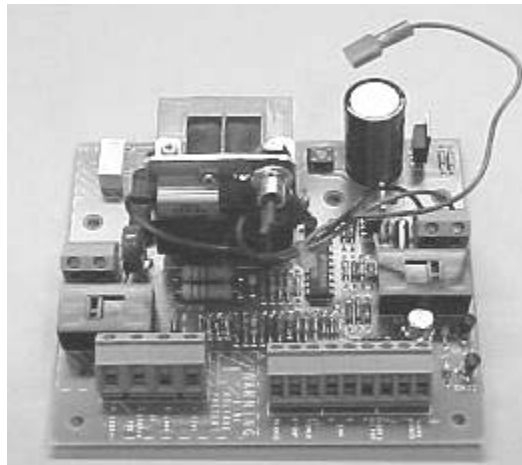
Fig 11

12. Remove the old control board from the PDU and discard.
13. Install the new control board (Fig 11) into the PDU using the five M4 Torx screws removed in step 12. Tighten these screws using a T20 Torx driver and torque to 16 inch-lb (1.81 n-meter)

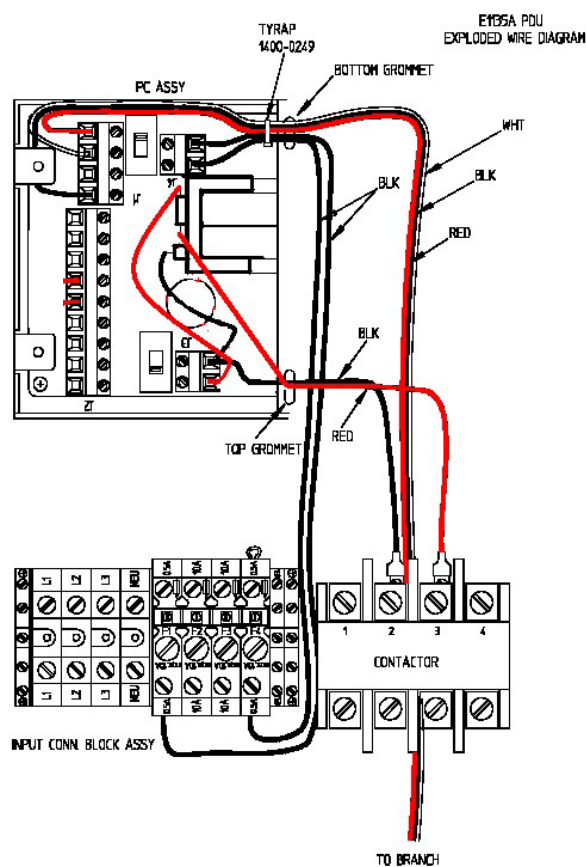
Fig 12

14. Re-wire the control board using the wiring diagram in Figure 12 and wires removed from J2 on the control board in step 9.

Control Board to Contactor Connections		
Black Wire Contactor Pin 2	to	Control Board J3 pin 2
Black Wire Control Board J3 pin 2	to	Regulator on Control Board
Red Wire Contactor Pin 3	to	Regulator on Control Board
Red Wire Control Board J3 pin 1	to	Regulator on Control Board

Note: Wires from Regulator to J3 on control board are already connected when received from SPD.

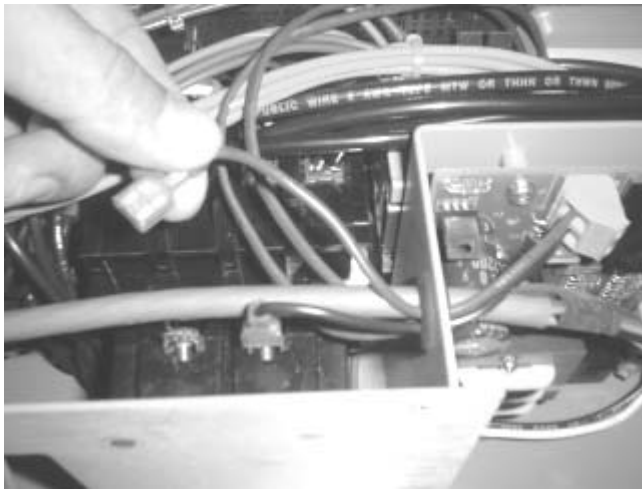
15. Figures 13, 14 and 15 show the new control board wiring.

(New Control board with voltage regulator)

Fig 15 (new Control Board with voltage regulator)
