66101A-08A

S E R V I C E N O T E

66101A DC Power Supply

The instrument will not communicate or will not complete self test.

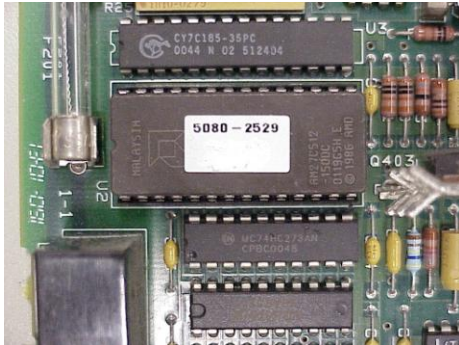
Figure 1

FIGURE 1 Is the Tested PCA P/N 66101-61022 note (Location of Circuit Reference "U2")

The Programmed ROM P/N 5080-2529 (Circuit Reference "U2") See [Figure 1](#).below for the location of "U2". The Programmed ROM Shows "U2" can be inspected with out taking the entire instrument apart see [figure 2](#) below. Inspect the ROM "U2" as described in [Diagrams "A & B"](#) below.

The ROM "U2" should be removed from the socket. (See [Figure 1](#)). The socket and the ROM should be inspected for contamination or other defects. The ROM is a ceramic part and can be damaged or broken if too much force is applied when reinstalled. [Diagram "B"](#) shows the ROM "U2" inserted correctly.

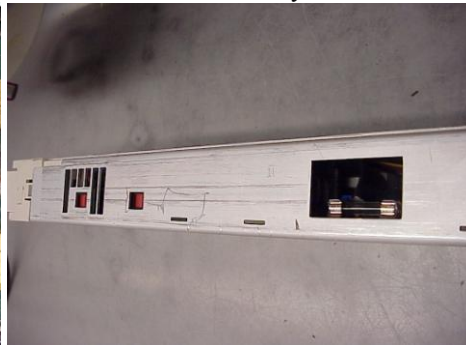
Figure 2

FIGURE 2 Is the bottom of a 6610XA module "U2" is located directly behind the fuse shown.
