# 66102A-07A

# S E R V I C E N O T E

## 66102A DC Power Supply

**The instrument will not communicate or will not complete self test.**

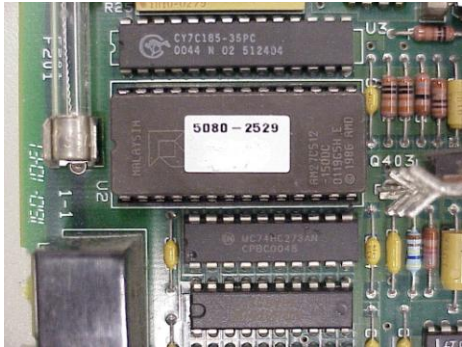
Figure 1

The Programmed ROM P/N 5080-2529 (Circuit Reference “U2”) See Figure 1.below for the location of “U2”. The Programmed ROM Shows “U2” can be inspected with out taking the entire instrument apart see figure 2 below. Inspect the ROM “U2” as described in Diagrams “A & B” below.

**FIGURE 1** Is the Tested PCA P/N 66101-61022 note (Location of Circuit Reference “U2”)

The ROM “U2” should be removed from the socket. (See Figure 1). The socket and the ROM should be inspected for contamination or other defects. The ROM is a ceramic part and can be damaged or broken if too much force is applied when reinstalled. Diagram “B” shows the ROM “U2” inserted correctly.

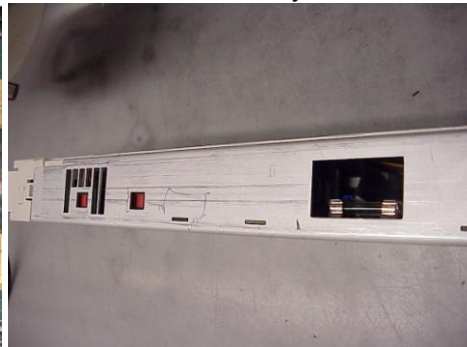
Figure 2

**FIGURE 2** Is the bottom of a 6610XA module “U2” is located directly behind the fuse shown.

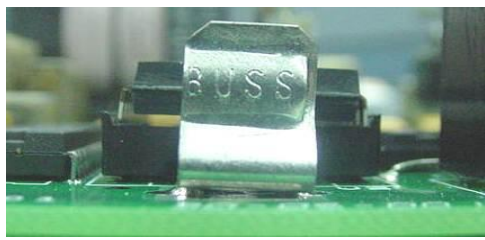
**Diagram A:** ROM not fully inserted

When the ROM “U2” is not inserted correctly See Diagram “A” for details, the instrument may exhibit the following faults:

These faults could also occur if the ROM or the socket is intermittent due to dirty or contaminated pins.

1. The instrument will not turn on
2. All of the segments on the Front Panel display are not light.
3. The instrument will fail self test or will not boot-up.
4. The instrument will not communicate & can not be calibrated.
