**6622A-12**

# S E R V I C E N O T E

## 6622A DC Power Supply

### Intermittent Power Transformer “Magma” Connections

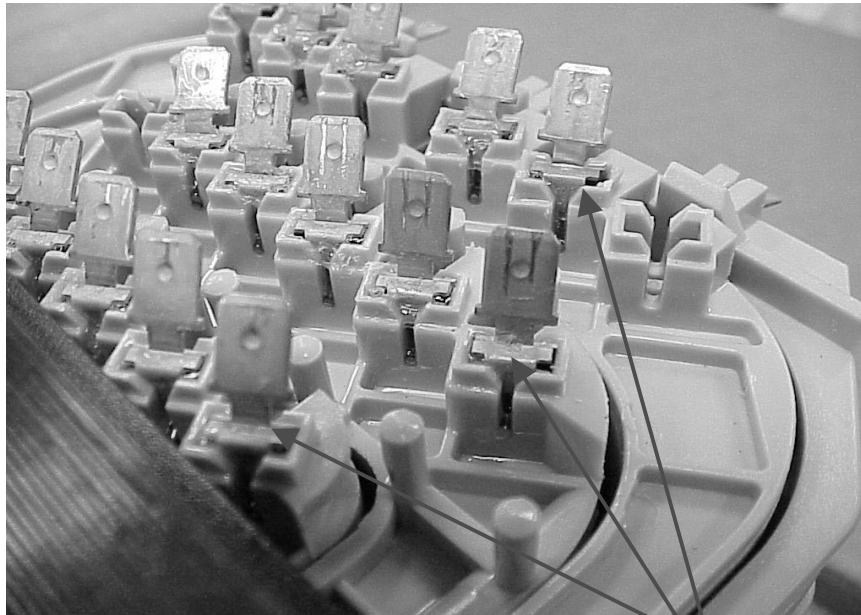
**Top View of Power Transformer:**

The power transformer vendor mistakenly installed the wrong “Magmates” in a run of power transformers. The incorrect “Magmates” have a # 43 stamped on them, which corresponds to a 15 gauge wire size. The correct size “Magmate” should be # 24 designed for a 19 gauge wire size.

Replace the Power Transformer with a new replacement Transformer, see the table above for the correct power transformer part number.

**NOTE:** Please inspect the new transformer for the correct “Magmate” number stamping.

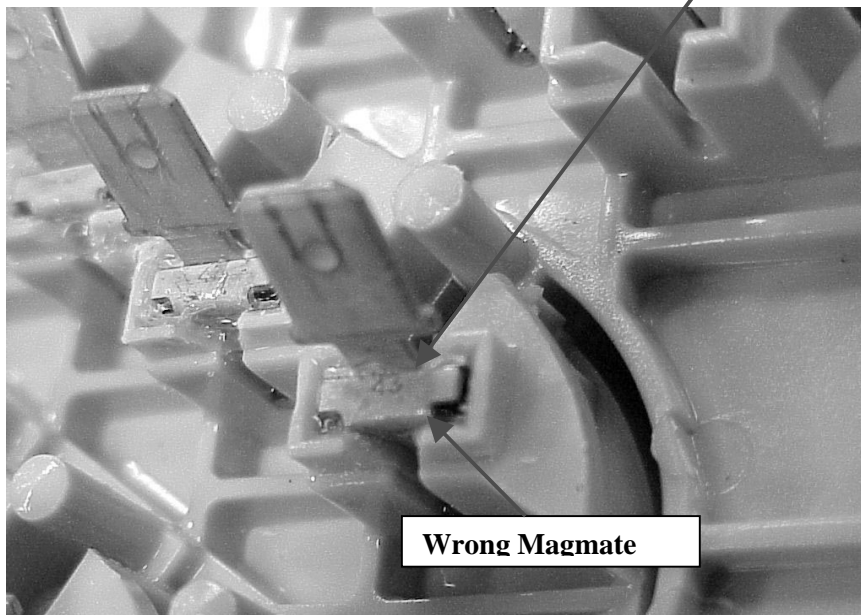
**Incorrect “Magmate” number 43 on the Surface, This should be number**

**Wrong Magmate**
