6626A-11

S E R V I C E N O T E

6626A DC Power Supply

Intermittent Power Transformer “Magma” Connections

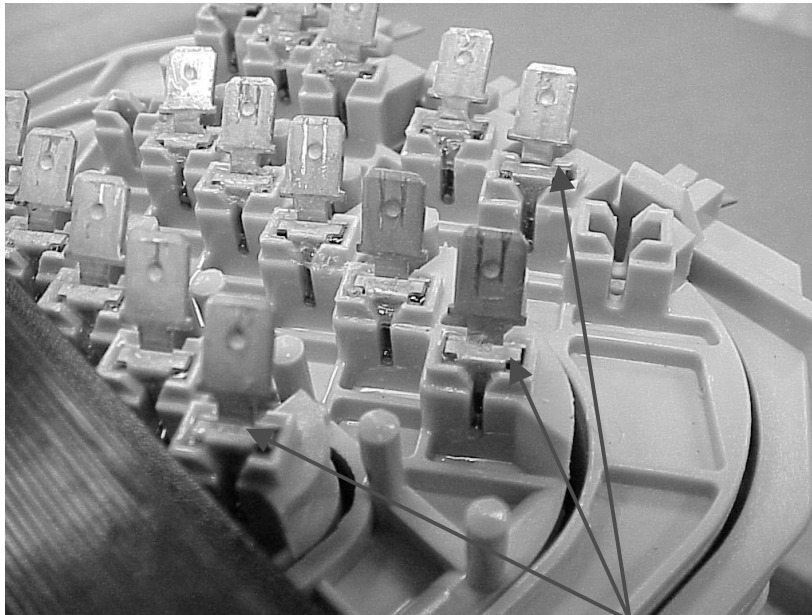
Top View of Power Transformer:

The power transformer vendor mistakenly installed the wrong “Magmates” in a run of power transformers. The incorrect “Magmates” have a # 43 stamped on them, which corresponds to a 15 gauge wire size. The correct size “Magmate” should be # 24 designed for a 19 gauge wire size.

Incorrect “Magmate” number 43 on the Surface, This should be number

Replace the Power Transformer with a new replacement Transformer, see the table above for the correct power transformer part number.

NOTE: Please inspect the new transformer for the correct “Magmate” number stamping.

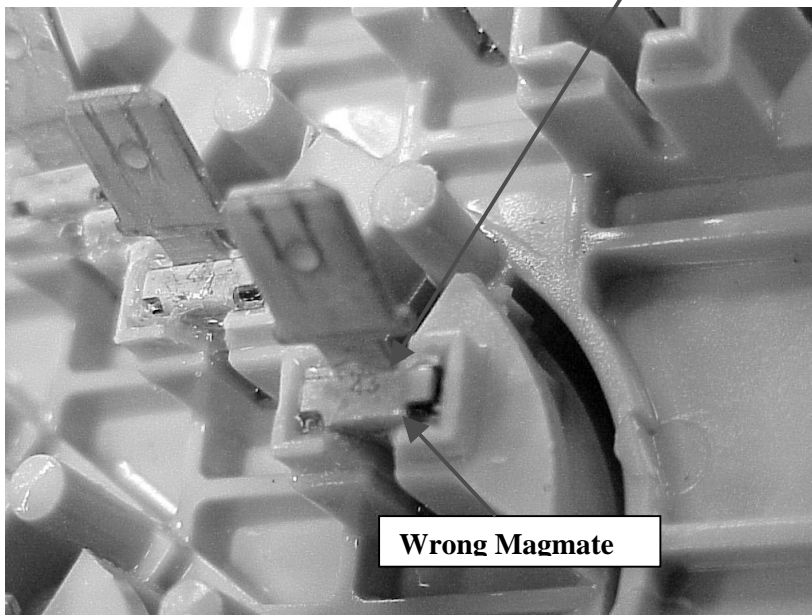
Wrong Magmate
