**6628A-11**

**S E R V I C E N O T E**

**6628A DC Power Supply**

**Intermittent Power Transformer “Magma” Connections**

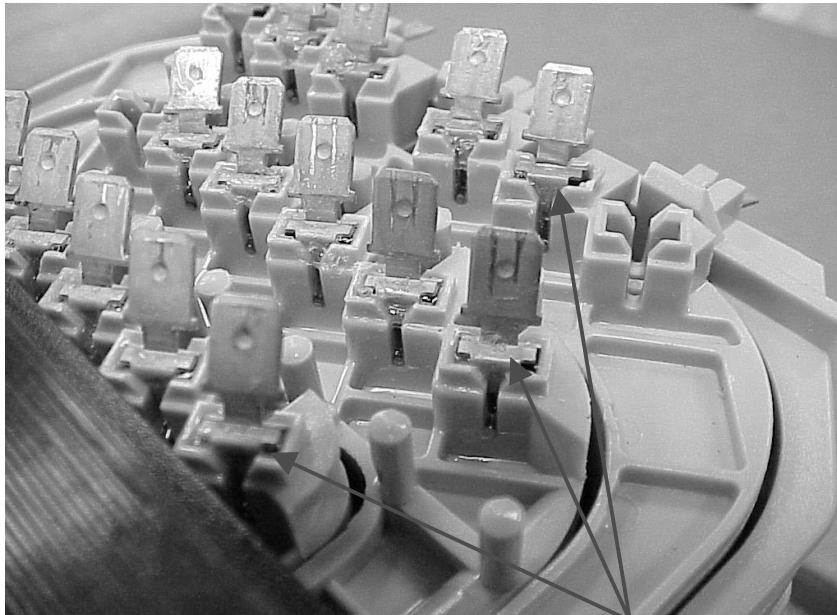
**Top View of Power Transformer:**

The power transformer vendor mistakenly installed the wrong “Magmates” in a run of power transformers. The incorrect “Magmates” have a # 43 stamped on them, which corresponds to a 15 gauge wire size. The correct size “Magmate” should be # 24 designed for a 19 gauge wire size.

Replace the Power Transformer with a new replacement Transformer, see the table above for the correct power transformer part number.

**NOTE:** Please inspect the new transformer for the correct “Magmate” number stamping.

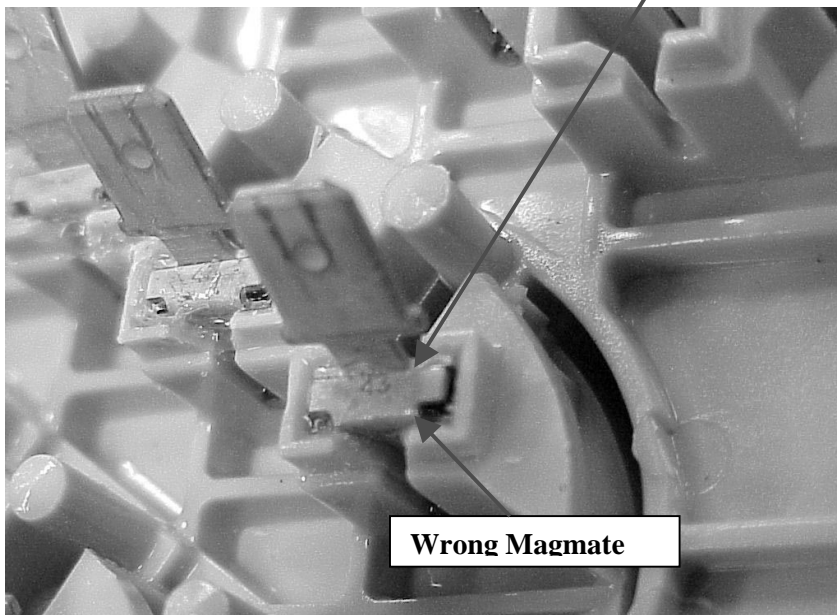
**Wrong Magmate**

**Incorrect “Magmate” number 43 on the Surface, This should be number**
