6629A-11

S E R V I C E N O T E

6629A DC Power Supply

Intermittent Power Transformer “Magma” Connections

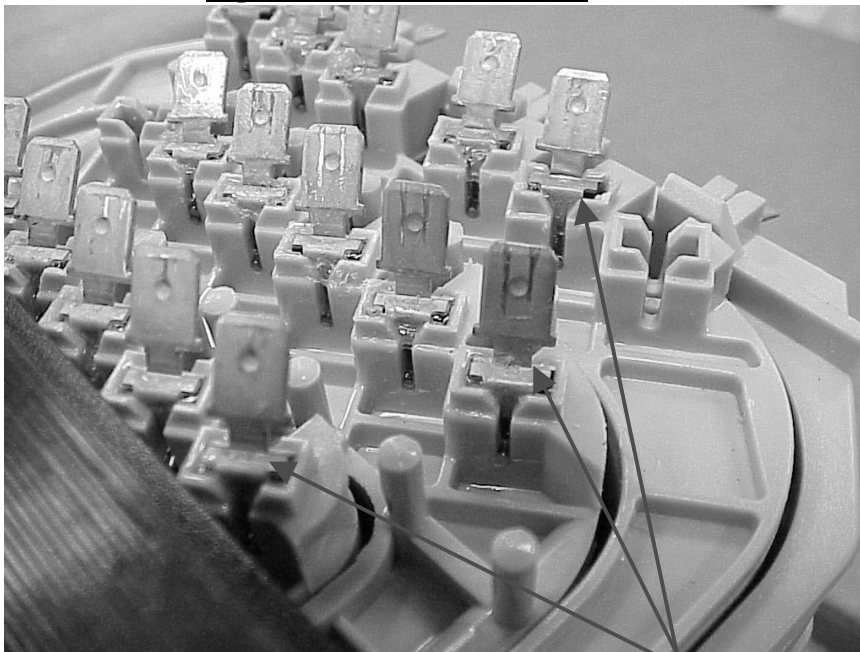
Top View of Power Transformer:

The power transformer vendor mistakenly installed the wrong “Magmates” in a run of power transformers. The incorrect “Magmates” have a # 43 stamped on them, which corresponds to a 15 gauge wire size. The correct size “Magmate” should be # 24 designed for a 19 gauge wire size.

Replace the Power Transformer with a new replacement Transformer, see the table above for the correct power transformer part number.

NOTE: Please inspect the new transformer for the correct “Magmate” number stamping.

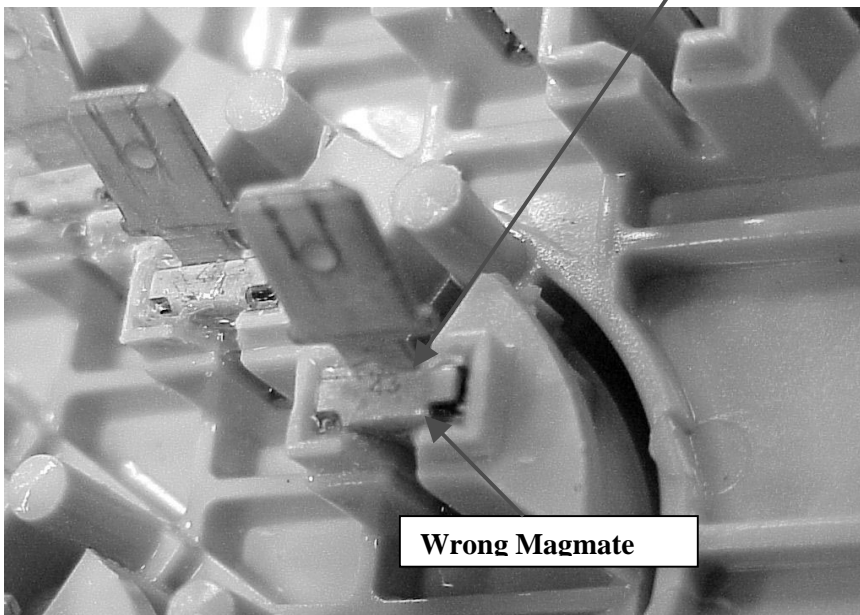
Wrong Magmate

Incorrect “Magmate” number 43 on the Surface, This should be number
