**8110A-01**

# S E R V I C E N O T E

## 8110A Pulse Pattern Generator

**Display failures (shifted lines and/or inverted display)**

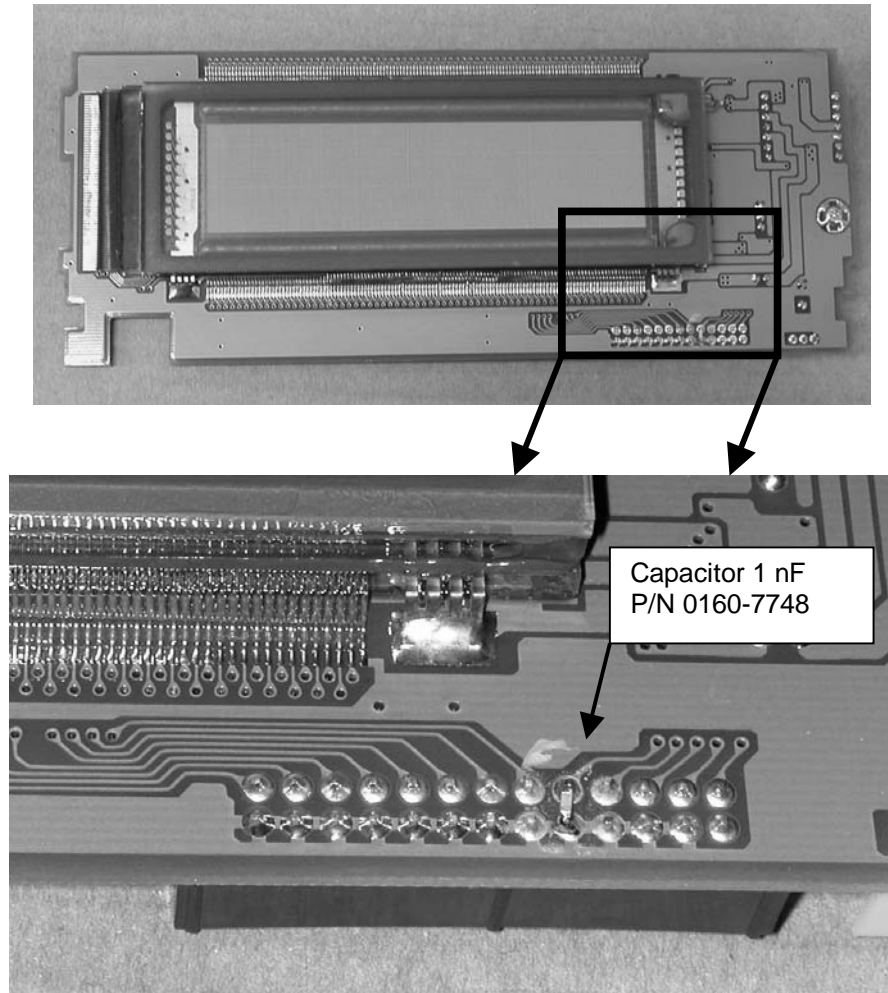
The front panel display shows shifting lines that are falling back to their normal state. Additionally an inverted display can occur.

To eliminate this problem solder a 1 nF capacitor between pin 17 and pin 18 at the back of the display module's signal connector. For the exact location please refer to the pictures below.
