**81130A-03B**

# S E R V I C E N O T E

## 81100 Family Pulse Pattern Generators

**Intermittent display failures  
(shifting lines, inverted, fully lit or completely dark display)**

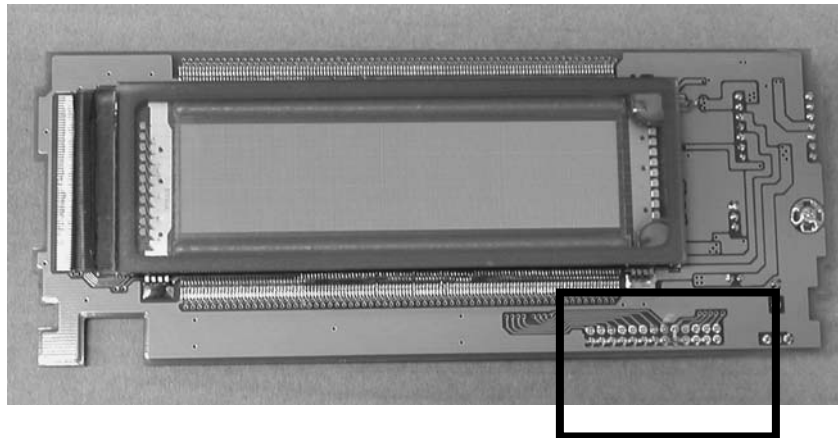
- Remove the front frame and unplug the connector cable from the 81100 mainframe.
- Carefully remove the display module from the front frame and check for a capacitor that might have been added during an earlier intermittent modification (see picture below). If there is such a capacitor, unsolder it from the module. Re-install the display into the front frame.

The following rework will improve the behavior of the display:

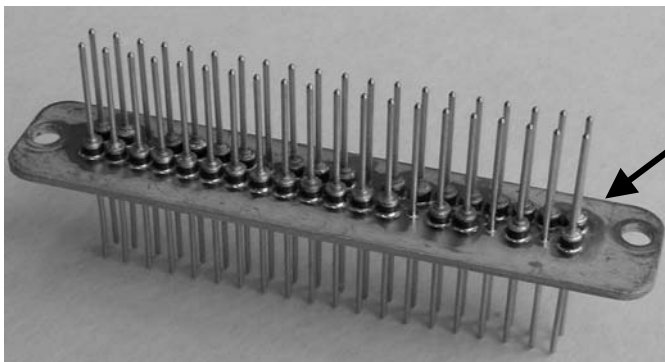
- On the 81100 mainframe replace the existing filter plate with the new filter plate, p/n 0960-0996. The new filter plate can be identified by a single connector pin that shows a red color code.
