81150A-04

S E R V I C E N O T E

81150A Pulse Function Arbitrary Noise Generator

Front panel USB connector does not work anymore, however the USB connector on the back still works.

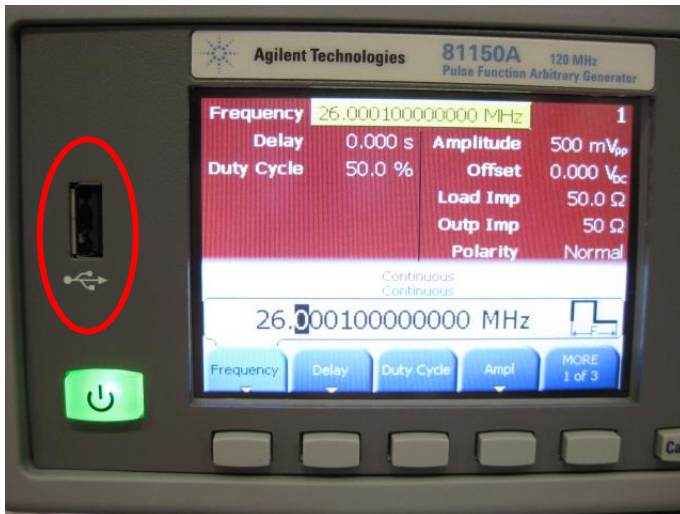
The USB connector on the front panel of the 81150A is not working. The next picture shows the front panel USB connector.

There is a failure on the mainboard and it needs to be replaced.

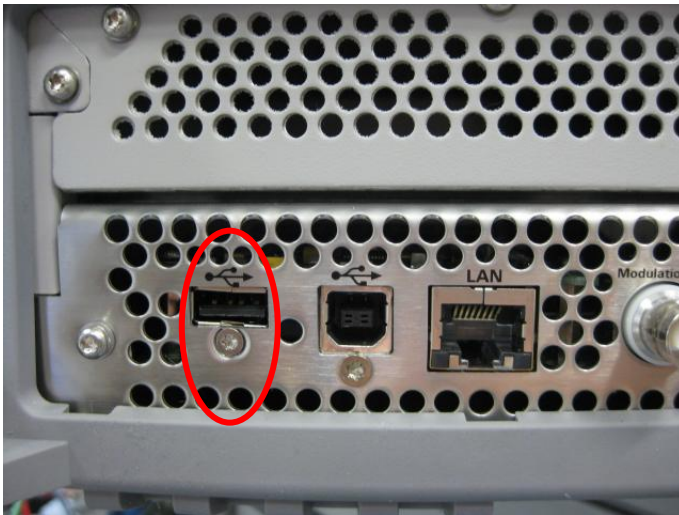
The USB connector on the back is still working. The next picture shows the USB connector on the back (the left one with the red circle).
