S E R V I C E N O T E

8166A Lightwave Multichannel System

Serials: DE396001001 / DE39600322

Recommended MOV removal in 8166A power supply

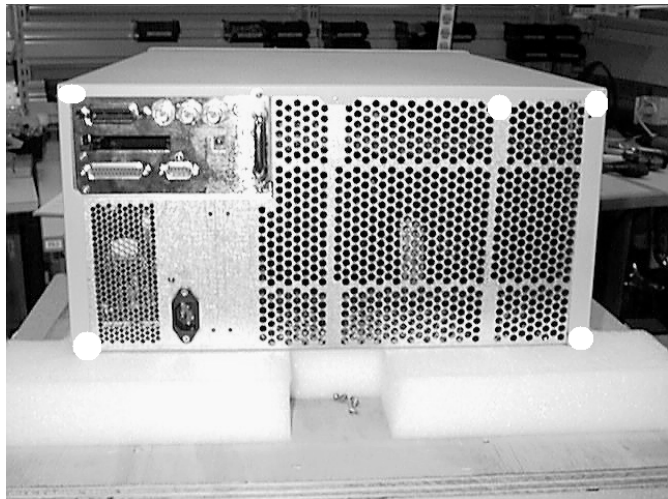
1. Open the instrument

- Unscrew the cover fixed with 5 ea M3.5x6, marked by

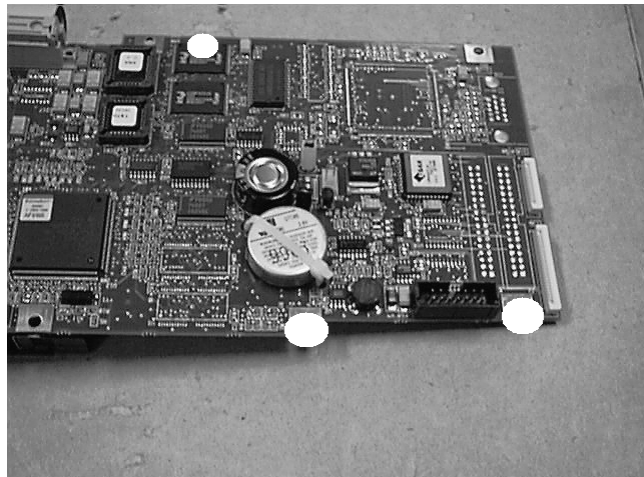
2. Remove the I/O-CPU Assy

- Disconnect the 2 flat cables leading to the display.
- Disconnect cable of Fan Assy, small, from CPU board assy.
- Unfasten 3 ea screws 0515-0372, marked by

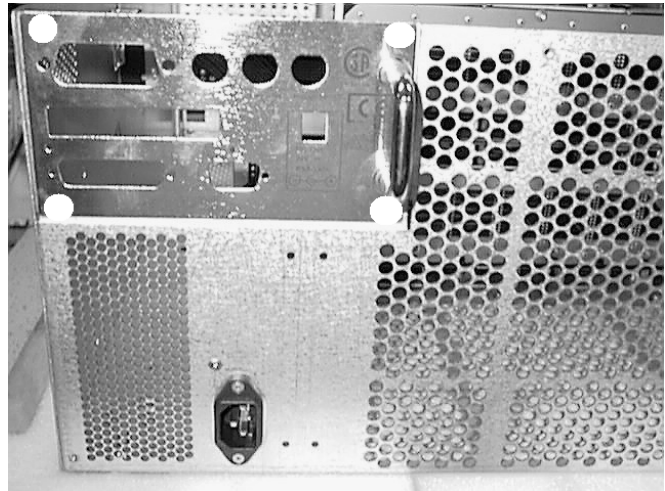
- Unfasten I/O-CPU Board Assy by unscrewing 4 ea screws, marked by

holding the board panel on the rear to the chassis
- Remove I/O-CPU Board Assy from chassis

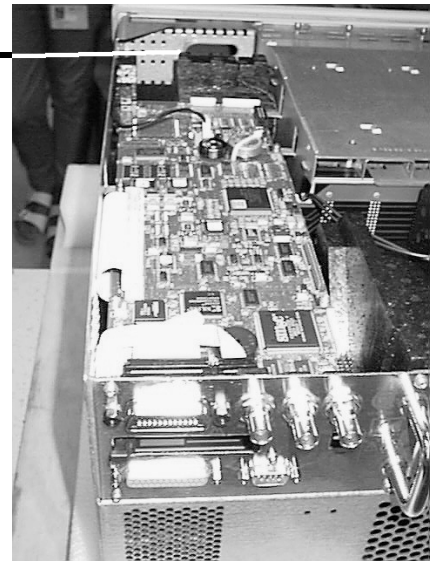
• **When re-assembling:**

Make sure the I/O board fits well into the connector on the back plane.

You can hold the back plane with a tool to not to let it move away

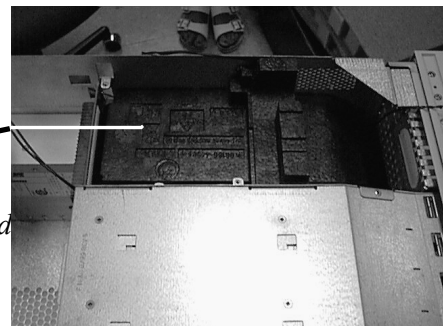
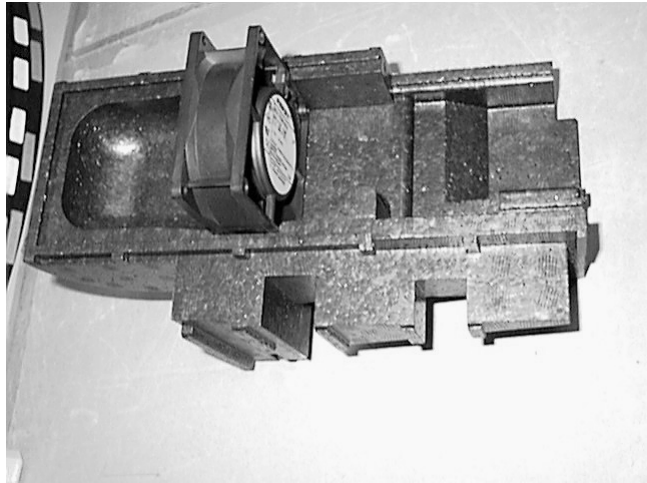
3. Remove the the Fan Assy, small

- Disconnect power supply cable (twisted, 2 wires black and red) from backplane
- Remove foam part, labeled 08166-44504

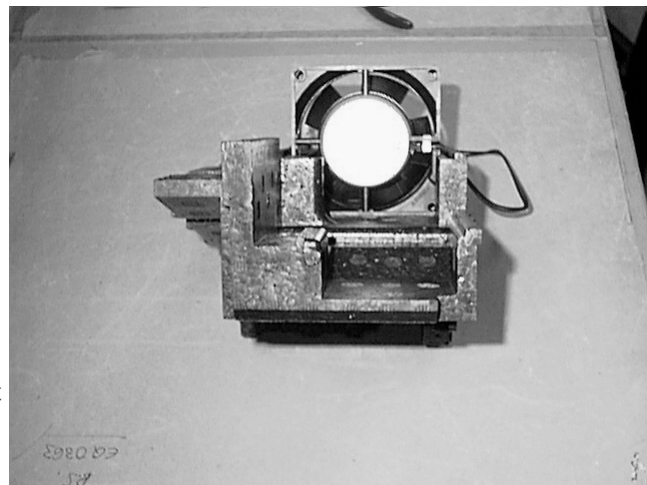
- Remove fan assy, small, and both foam parts, labeled 08166-44504 and -44503

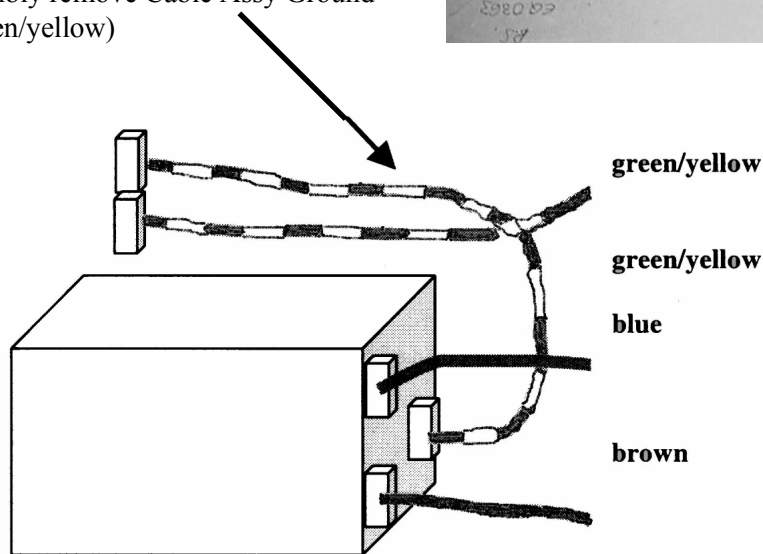
4. Remove the Power Supply Assy

- Remove foam parts, labeled 08166-44505 and -44506 above the power supply
- Disconnect power cables from power inlet
- Possibly remove Cable Assy Ground (green/yellow)

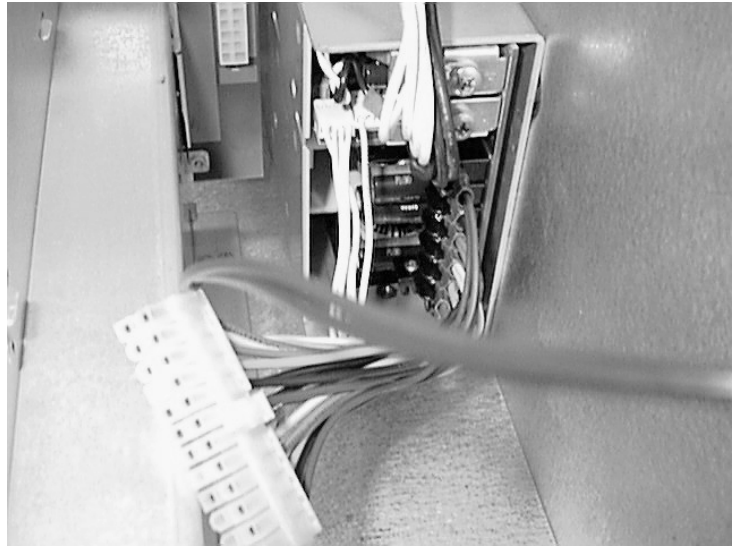
- Disconnect multiple single wire assy , colored cables, with white connector from back plane (mother board)
- Disconnect multiple single wire cable assy , black and white, with black connector from back plane (mother board)

Attention: When re-assembling check if all 4 wire cable assies and 1 wire cable are fixed well on the Power Supply Assy

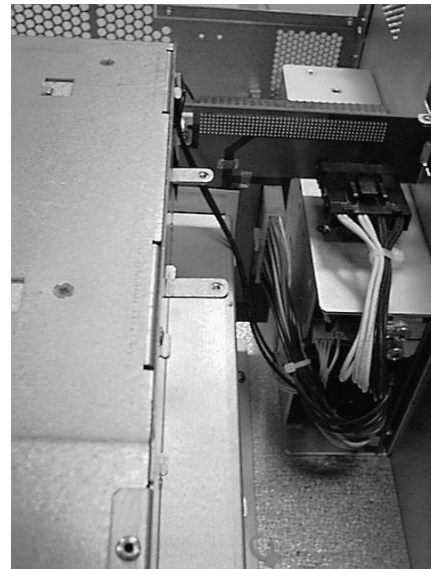
- Unfasten 4 ea interlock screws 0515-0390 on the left of the chassis
- Remove Power Supply Assy

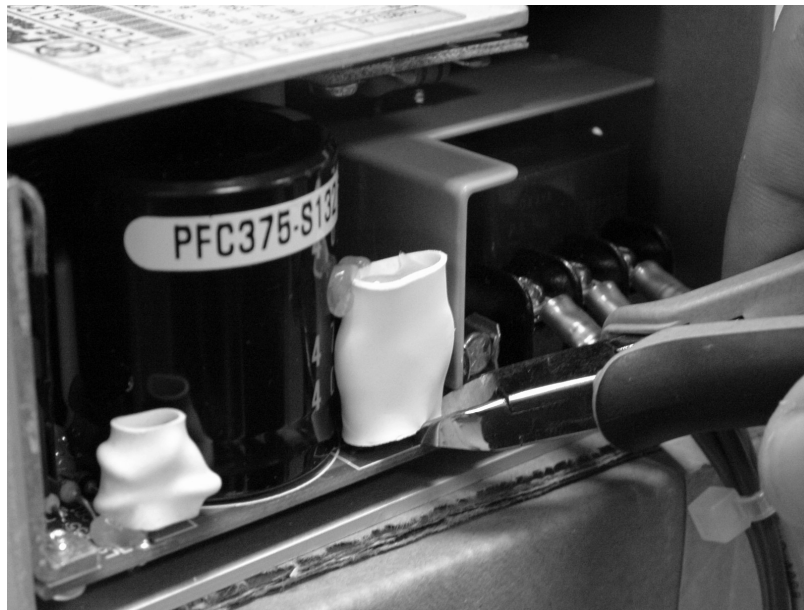
Figure 1: MOV shown while being removed by use of wire cutting pliers

The MOV is a component located on the rear of the power supply right between a big black capacitor (possibly with a label "PFC375-S150" on it) and the input power line cables. It's covered by a - mostly white - shrinking tube. Use wire cutting pliers to cut it off. See Figure 1 and Figure 2 on next page.

Photos showing a power supply of 8164A. That of the 8166A looks equal but with label "PFC375-S150" on the capacitor

- The MOV shall be removed without replacement (component is redundant)
- Disassemble the 8166A to get access to the power supply
- Remove the power supply from the chassis
- Cut off the MOV by use of wire cutting pliers
- Re-install the power supply
- Re-assemble the 8166A
- Perform a functional test
