DSO6054L-01-S

Safety Service Note

DSO6054L Oscilloscope, LXI, 4-channel, 500 MHz

POSSIBLE "SHOCK" HAZARD

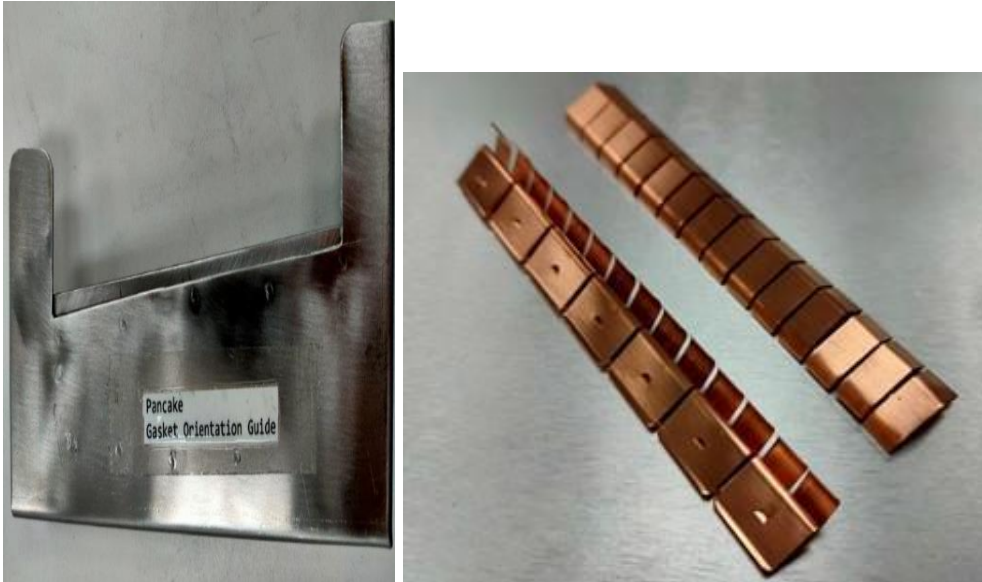
2. Prepare the Gasket Orientation Guide and 1pcs of the new Clip-on EMI Gasket Fingerstock (D6104-85405) as shown below:

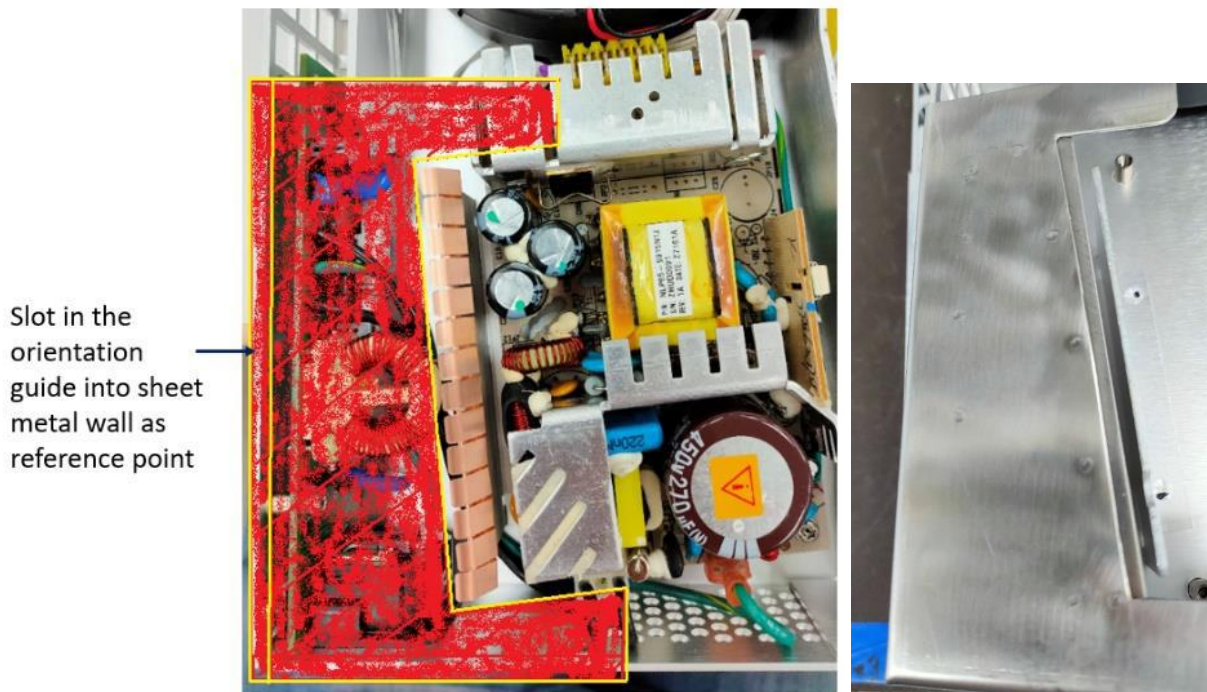
3. Slot in the Gasket Orientation Guide into the chassis as shown in the picture below:

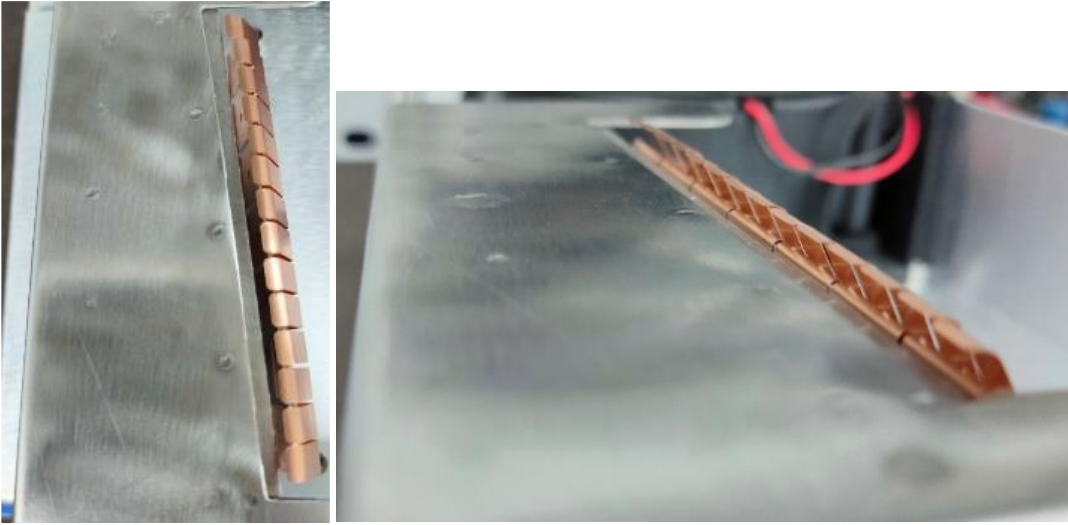
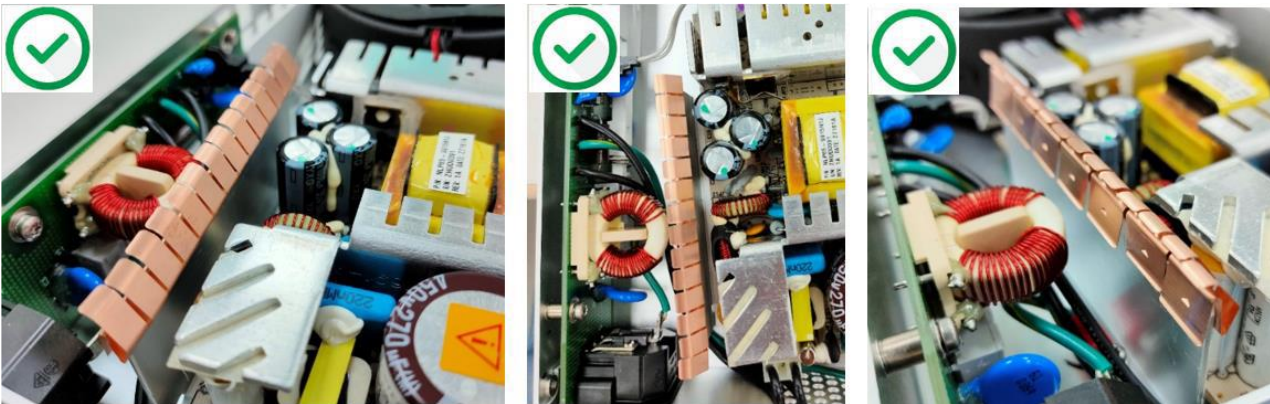
4. Insert the Clip-on EMI Gasket Fingerstock (D6104-85405) into the sheet metal divider and press it with finger force until it is fully inserted as shown in pictures below.

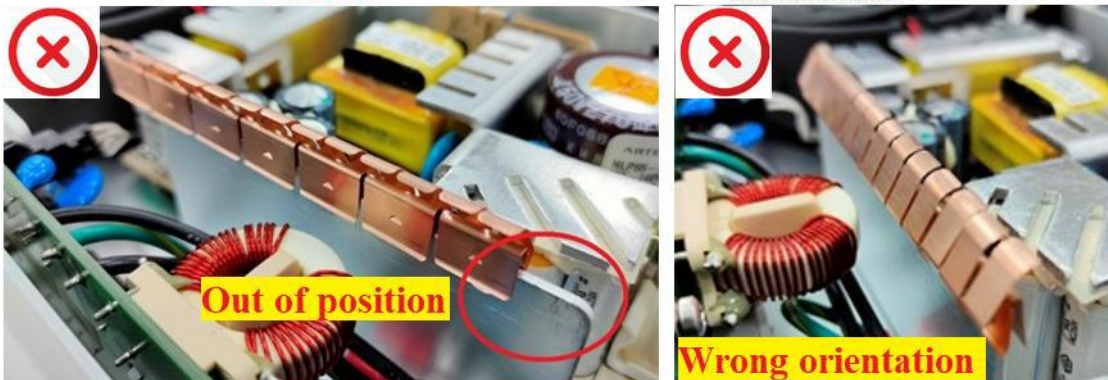
Example of **WRONG** placement of EMI gasket Fingerstock as below:

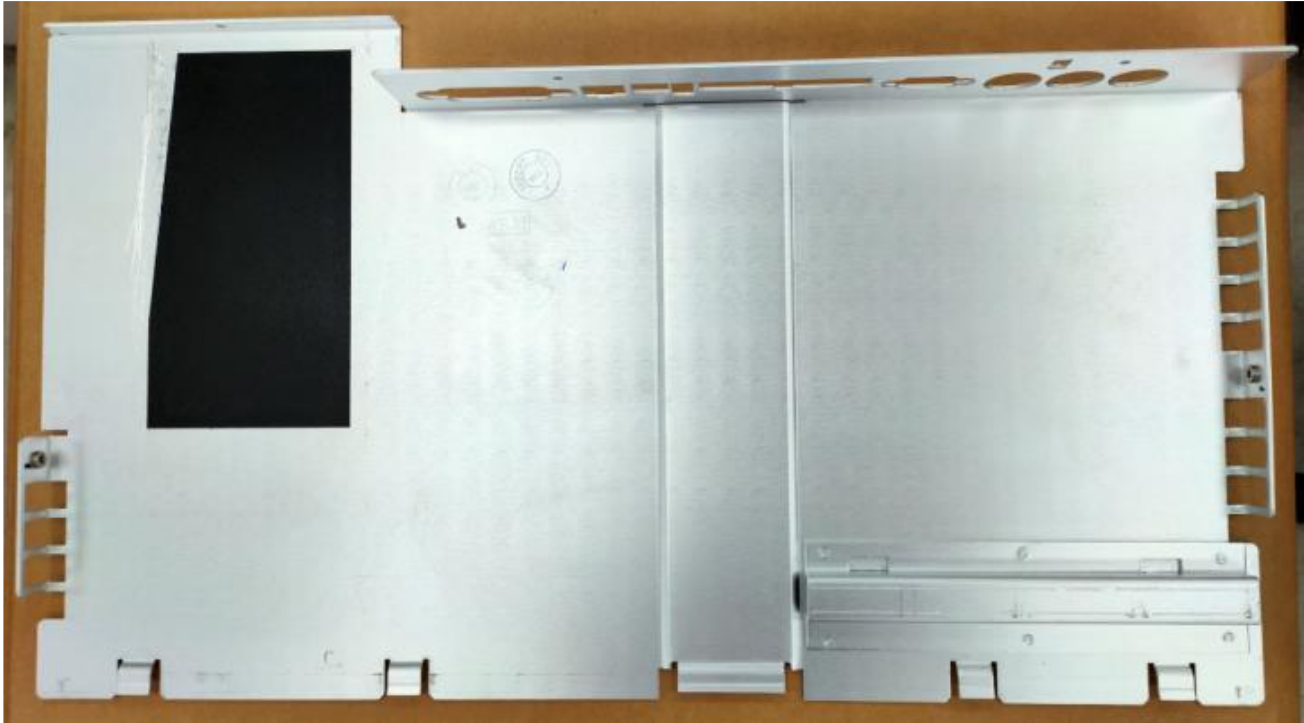
5. Apply the new Cover Assembly (D6104-00104) WITHOUT an EMI gasket attached to it.

6. Follow the instructions in step 1 in reversion order to assemble the new Cover Assembly (D6104-00104) onto the 6000L Series unit and complete assembly of the unit.
