**E3632A-04**

# S E R V I C E N O T E

## E3632A DC Power Supply

### Procedure to ensure tight fitting of the rear bumper

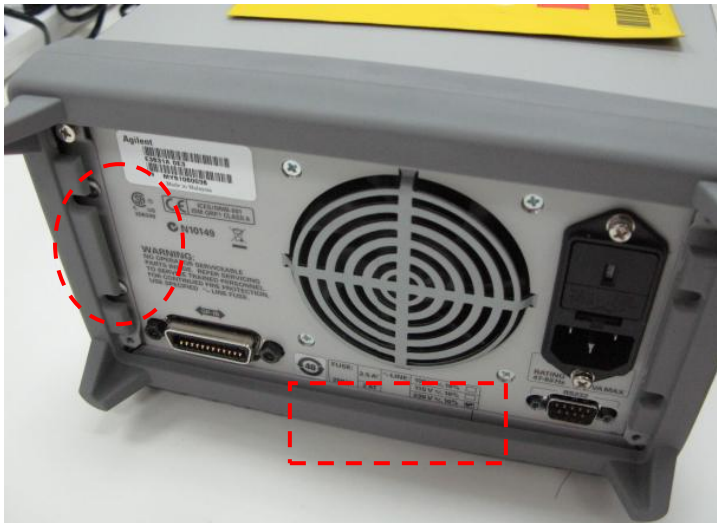
There is a new design rear bumper starting from serial number MY51250037. This bumper fits too tightly into the packaging foam material. During transportation, movements may cause the rear bumper to rub against the packaging foam and the rear bumper may become loose or slip out of the instrument chassis, as shown in the Figure 1 below. The foam design has already been modified to ensure good enough fitting.

Figure 1: Loose rear bumper – gap observed between bumper and chassis

If customers observe that their instrument's rear bumper has become loose or has slipped out, then the customer is advised to follow the following steps to properly fit the rear bumper back into the instrument chassis.

1. Make sure all four corners of the rear bumper are completely pushed inwards. A 'click' sound must be heard (Figure 2, see arrows marked '1').
2. Then, push the four sides of the bumper to make sure the whole bumper fits tightly into the instrument chassis. (Figure 2, see arrows marked '2').
3. These 2 steps will ensure a tight fitting of the rear bumper as shown in Figure 3 below.

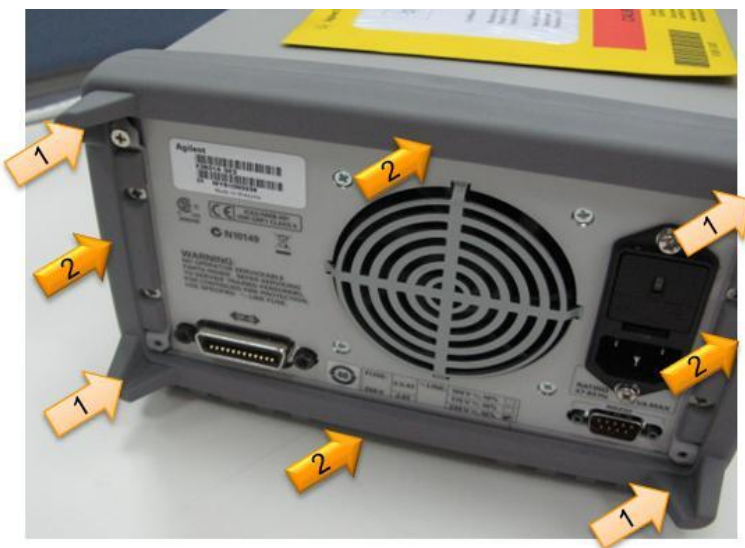
Figure 2: Proper fitting method for instrument rear bumper

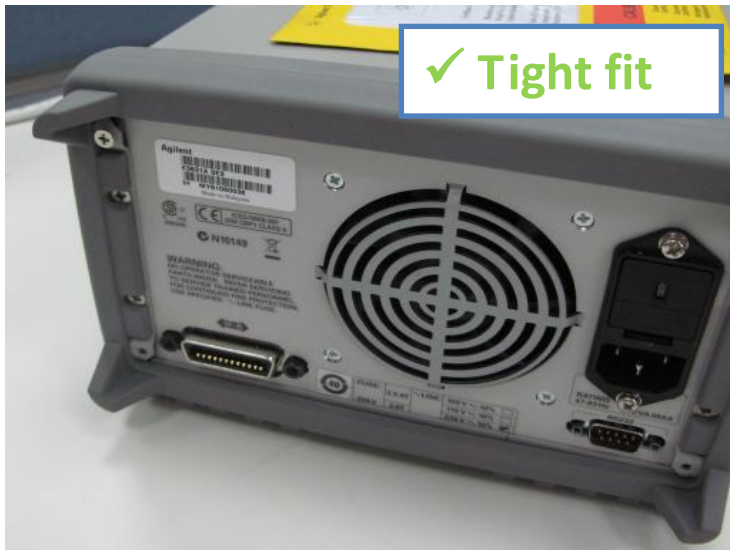
Figure 3: Tightly fitted rear bumper – no gap observed between the bumper and chassis
