**E3633A-05**

# S E R V I C E N O T E

## E3633A DC Power Supply

### Procedure to ensure tight fitting of the rear bumper

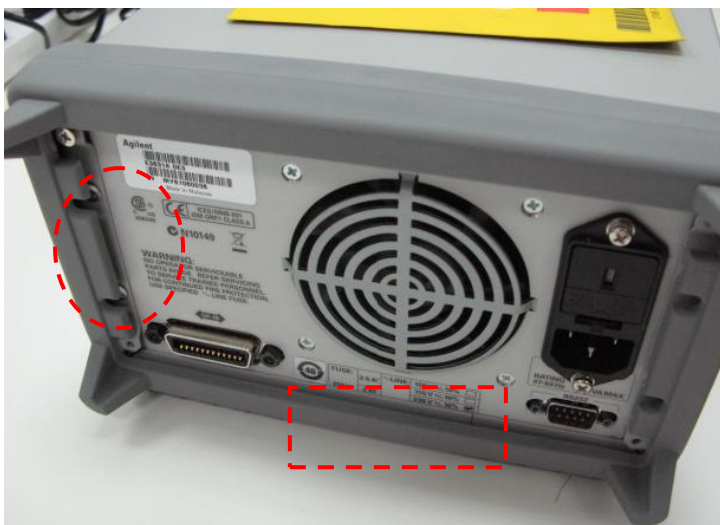
There is a new design rear bumper starting from serial number MY51240075. This bumper fits too tightly into the packaging foam material. During transportation, movements may cause the rear bumper to rub against the packaging foam and the rear bumper may become loose or slip out of the instrument chassis, as shown in the Figure 1 below. The foam design has already been modified to ensure good enough fitting.

Figure 1: Loose rear bumper – gap observed between bumper and chassis

If customers observe that their instrument's rear bumper has become loose or has slipped out, then the customer is advised to follow the following steps to properly fit the rear bumper back into the instrument chassis.

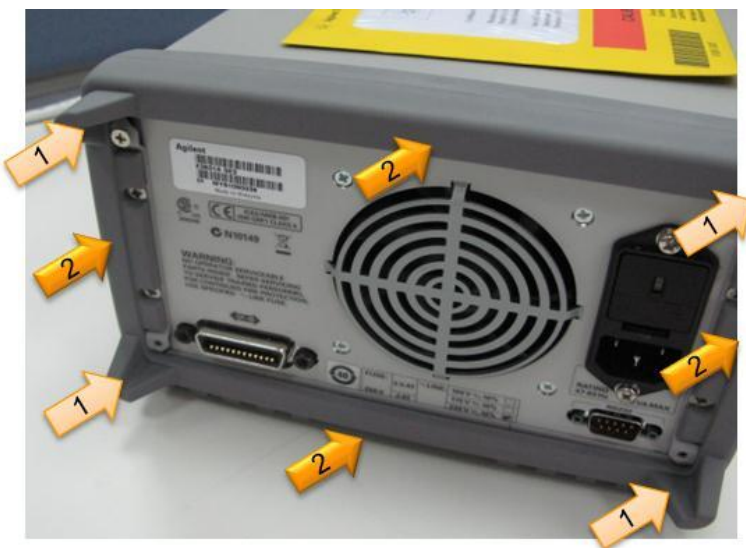
Figure 2: Proper fitting method for instrument rear bumper

1. Make sure all four corners of the rear bumper are completely pushed inwards. A 'click' sound must be heard (Figure 2, see arrows marked '1').
2. Then, push the four sides of the bumper to make sure the whole bumper fits tightly into the instrument chassis. (Figure 2, see arrows marked '2').
3. These 2 steps will ensure a tight fitting of the rear bumper as shown in Figure 3 below.

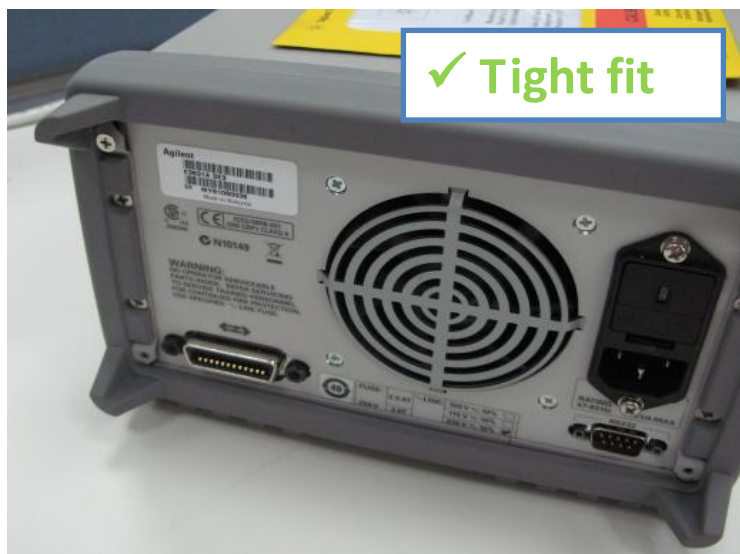
Figure 3: Tightly fitted rear bumper – no gap observed between the bumper and chassis
