**E3633A-05C****S E R V I C E N O T E**Supersedes:  
E3633A-05B**E3633A DC Power Supply****Serial Numbers: MY51240075 to MY53200002****Metal Strap Kit for tightening loose bumper and for fitting rear lock link in side-by-side rack mounting****Parts Required:**

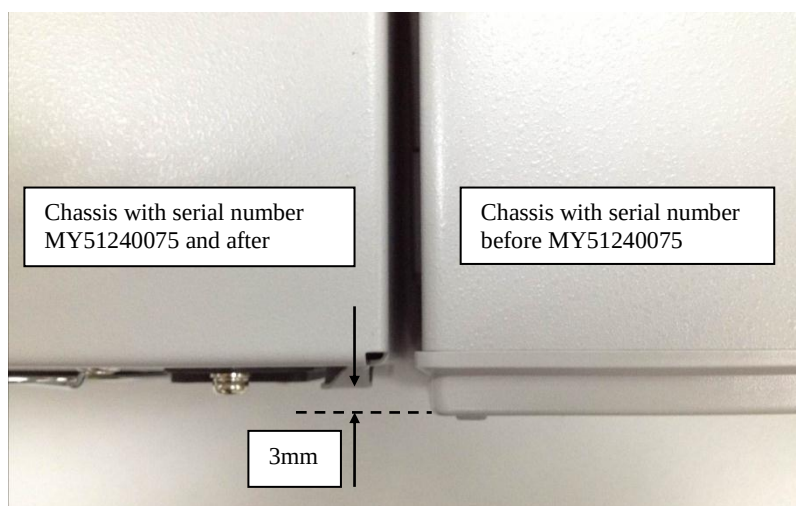
The chassis depth difference between the two designs is 3mm as shown in Table 1 and Figure 1 below.

Figure 1: Top view 3mm gap observed between two different chassis designs

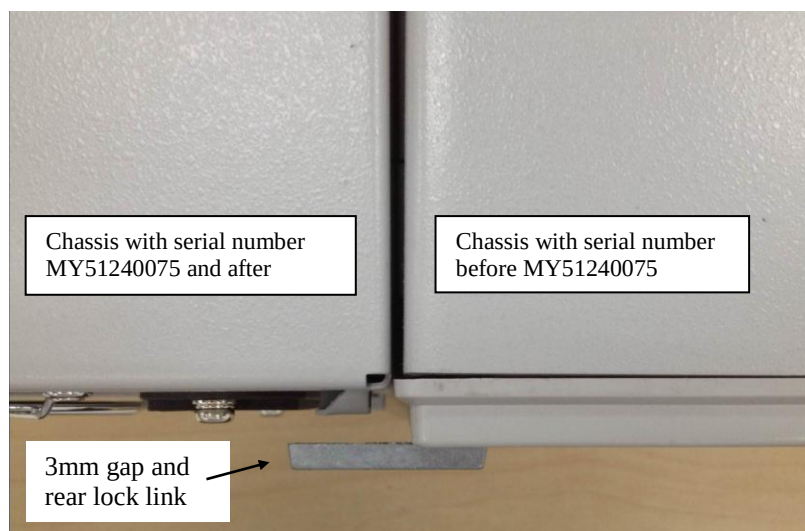
The 3 mm gap between the two different chassis may cause difficulties in securing them together using a rear lock link kit (part number 0050-2167) for side-by-side rack mounting as shown in Figure 2 below.

Figure 2: Top view 3mm gap observed on rear lock link for side-by-side rack mounting

Use metal strap (part number E3631-07901), and stack the provided two metal straps together to form 3mm thickness and secure it with the provided screws on the rear lock link as shown in Figure 4 below.
