E3633A-05D

S E R V I C E N O T E

E3633A DC Power Supply

Metal Strap Kit for tightening loose bumper and for fitting rear lock link in side-by-side rack mounting

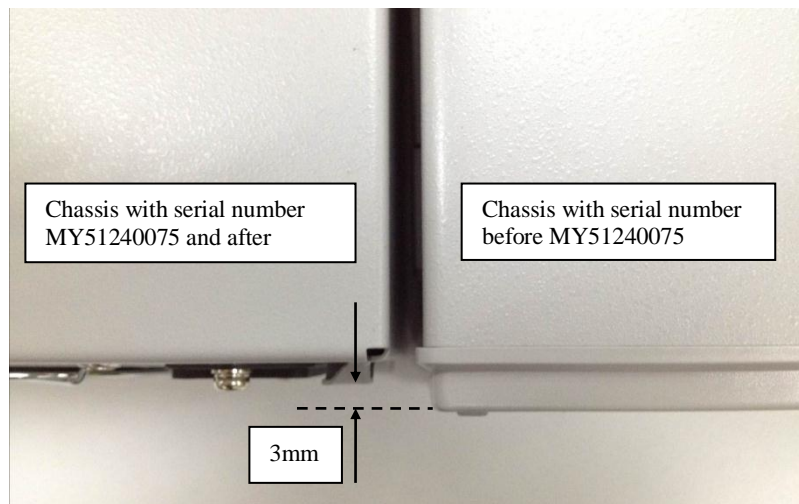
The chassis depth difference between the two designs is 3mm as shown in Table 1 and Figure 2 below.

Serial number range	Chassis depth
MY51240075 and after	345.2 mm
Before MY51240075	348.2 mm

Figure 2: Top view 3mm gap observed between two different chassis designs

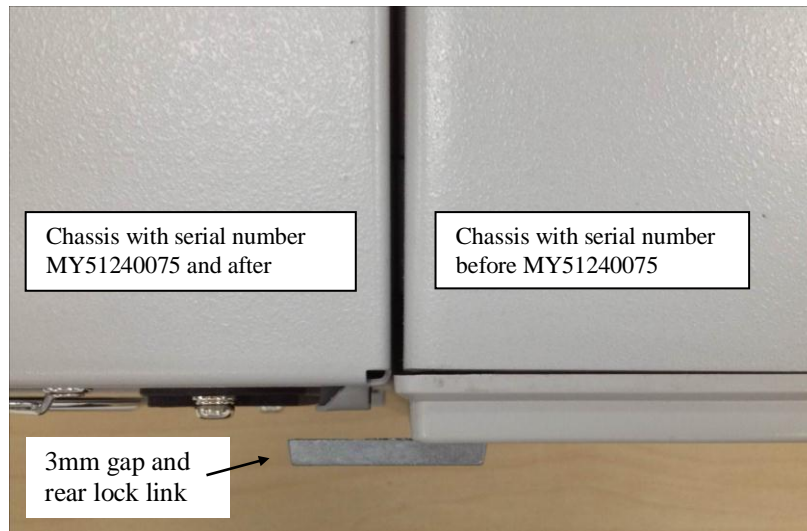
The 3 mm gap between the two different chassis may cause difficulties in securing them together using a rear lock link kit (part number 0050-2167) for side-by-side rack mounting as shown in Figure 3 below.

Figure 3: Top view 3mm gap observed on rear lock link for side-by-side rack mounting

Use metal strap (part number E3631-07901), and stack the provided two metal straps together to form 3mm thickness and secure it with the provided screws on the rear lock link as shown in Figure 5 below.
