# E3634A-05C

# S E R V I C E N O T E

## E3634A DC Power Supply

**Metal Strap Kit for tightening loose bumper and for fitting rear lock link in side-by-side rack mounting**

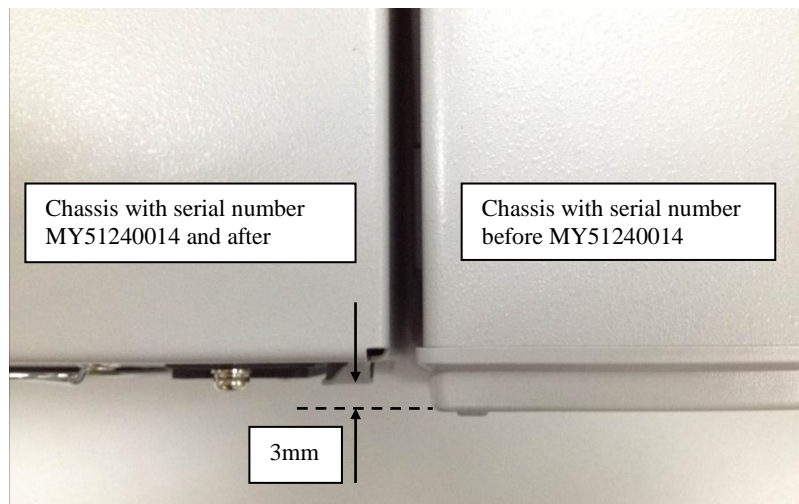
The chassis depth difference between the two designs is 3mm as shown in Table 1 and Figure 1 below.

Serial number range	Chassis depth
MY51240014 and after	345.2 mm
Before MY51240014	348.2 mm

Figure 1: Top view 3mm gap observed between two different chassis designs

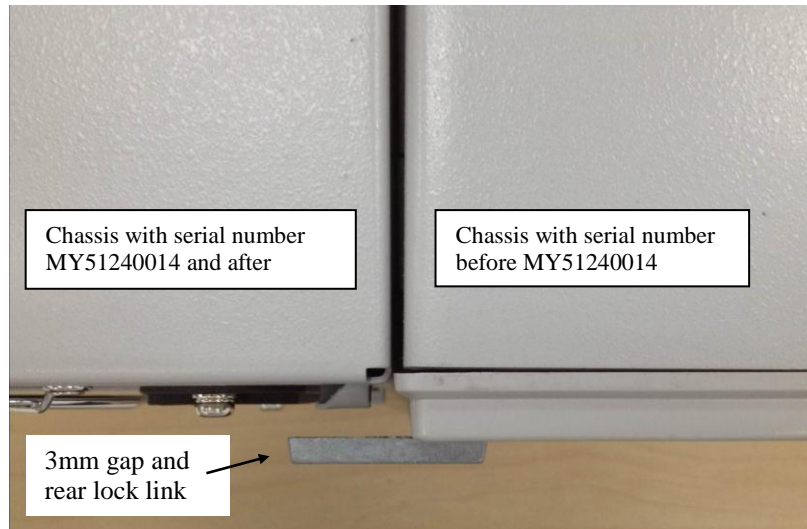
The 3 mm gap between the two different chassis may cause difficulties in securing them together using a rear lock link kit (part number 0050-2167) for side-by-side rack mounting as shown in Figure 2 below.

Figure 2: Top view 3mm gap observed on rear lock link for side-by-side rack mounting

Use metal strap (part number E3631-07901), and stack the provided two metal straps together to form 3mm thickness and secure it with the provided screws on the rear lock link as shown in Figure 4 below.

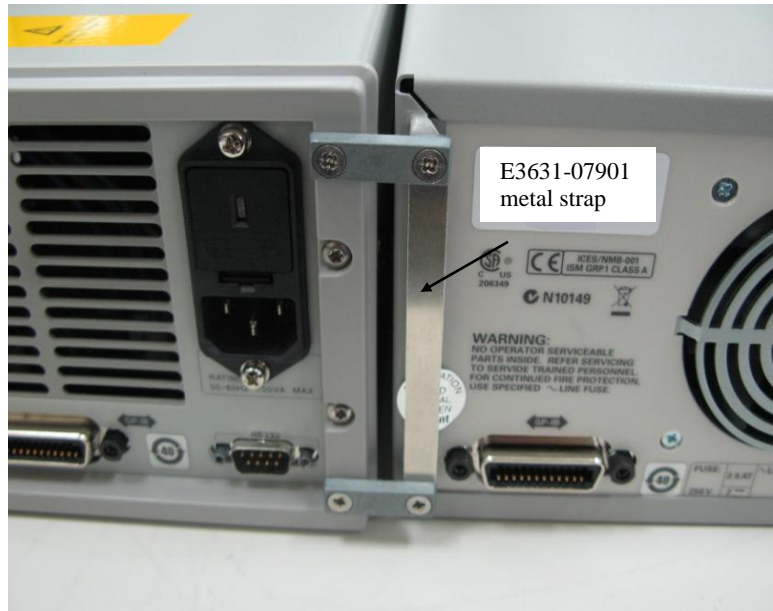
Figure 4: Rear view rear lock link secured with metal straps kit for side-by-side rack mounting
