E3646A-04C

S E R V I C E N O T E

E3646A DC Power Supply

Metal Strap Kit for tightening loose bumper and for fitting rear lock link in side-by-side rack mounting

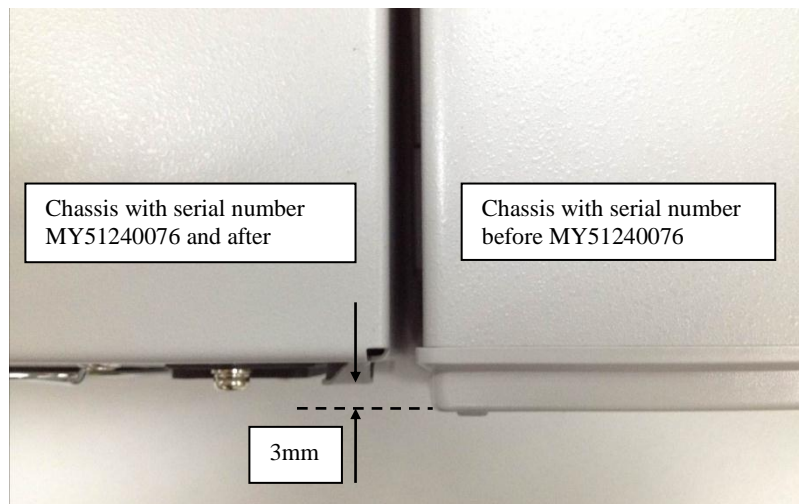
The chassis depth difference between the two designs is 3mm as shown in Table 1 and Figure 1 below.

Figure 1: Top view 3mm gap observed between two different chassis designs

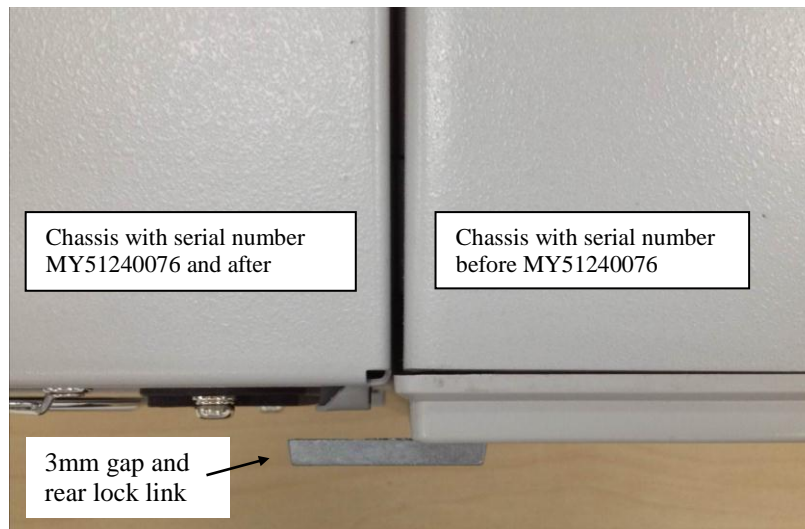
The 3 mm gap between the two different chassis may cause difficulties in securing them together using a rear lock link kit (part number 0050-2167) for side-by-side rack mounting as shown in Figure 2 below.

Figure 2: Top view 3mm gap observed on rear lock link for side-by-side rack mounting

Use metal strap (part number E3631-07901), and stack the provided two metal straps together to form 3mm thickness and secure it with the provided screws on the rear lock link as shown in Figure 4 below.

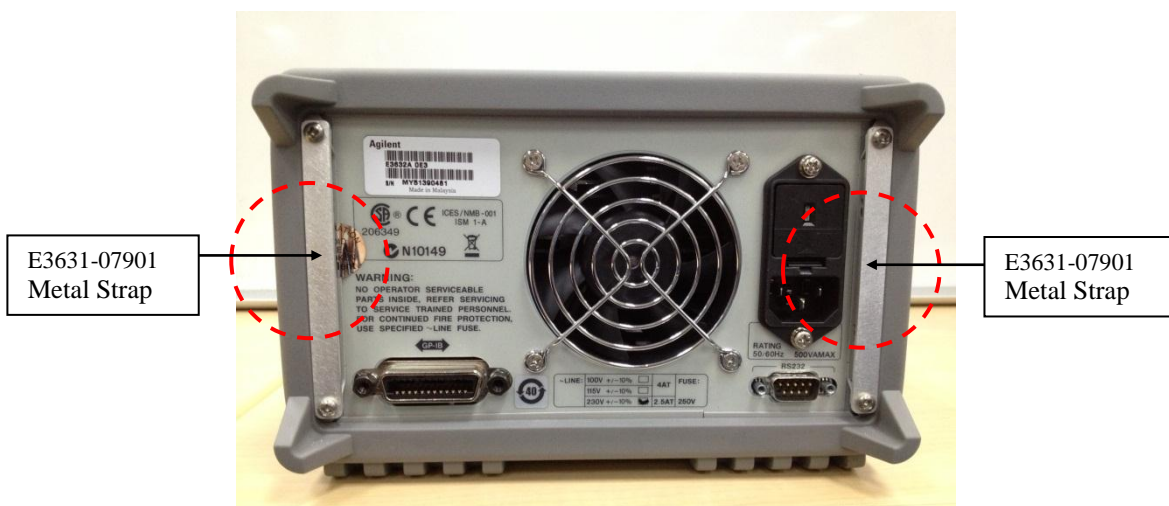
Figure 3: Secure with metal straps – no gap observed between the bumper and chassis

Use two metal straps (part number E3631-07901) to secure each side of the bumper as shown in Figure 3 below.
