**E3647A-04**

# S E R V I C E N O T E

## E3647A DC Power Supply

### Procedure to ensure tight fitting of the rear bumper

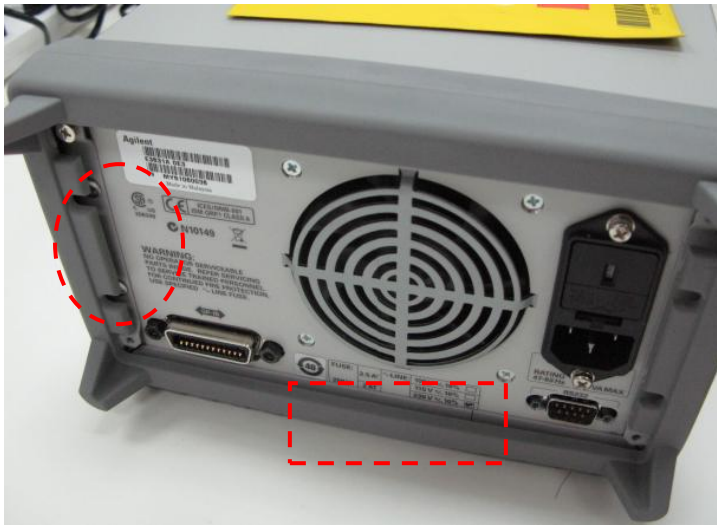
There is a new design rear bumper starting from serial number MY51240108. This bumper fits too tightly into the packaging foam material. During transportation, movements may cause the rear bumper to rub against the packaging foam and the rear bumper may become loose or slip out of the instrument chassis, as shown in the Figure 1 below. The foam design has already been modified to ensure good enough fitting.

Figure 1: Loose rear bumper – gap observed between bumper and chassis

If customers observe that their instrument's rear bumper has become loose or has slipped out, then the customer is advised to follow the following steps to properly fit the rear bumper back into the instrument chassis.
