**E3647A-04C****S E R V I C E                      N O T E**Supersedes:  
E3647A-04B**E3647A DC Power Supply****Serial Numbers: MY51240108 to MY53200004****Metal Strap Kit for tightening loose bumper and for fitting rear lock link in side-by-side rack mounting****Parts Required:**

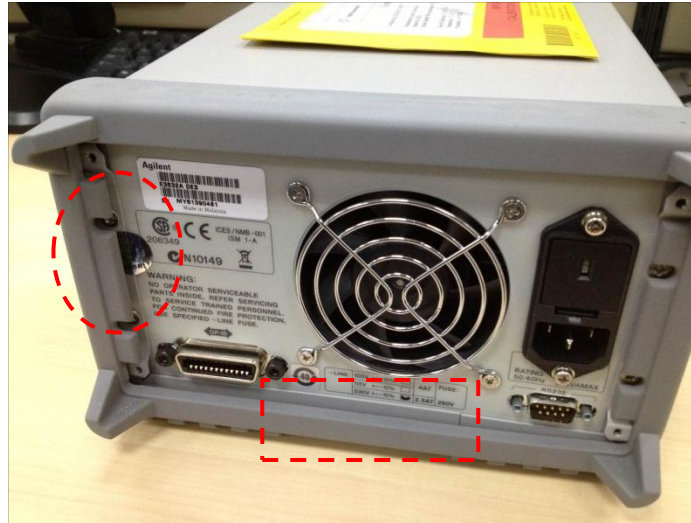
There is a new rear bumper design starting from serial number MY51240108. The rear bumper may become loose or it may slip out of the instrument chassis when force is applied to the rear bumper, as shown in Figure 1 below.

Figure 1: Loose rear bumper – gap observed between bumper and chassis

Use two metal straps (part number E3631-07901) to secure each side of the bumper as shown in Figure 3 below.

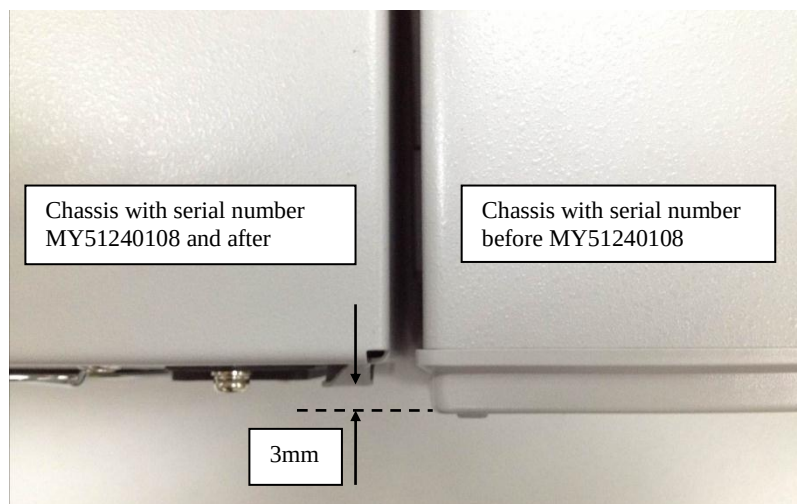
The chassis depth difference between the two designs is 3mm as shown in Table 1 and Figure 1 below.

Figure 1: Top view 3mm gap observed between two different chassis designs

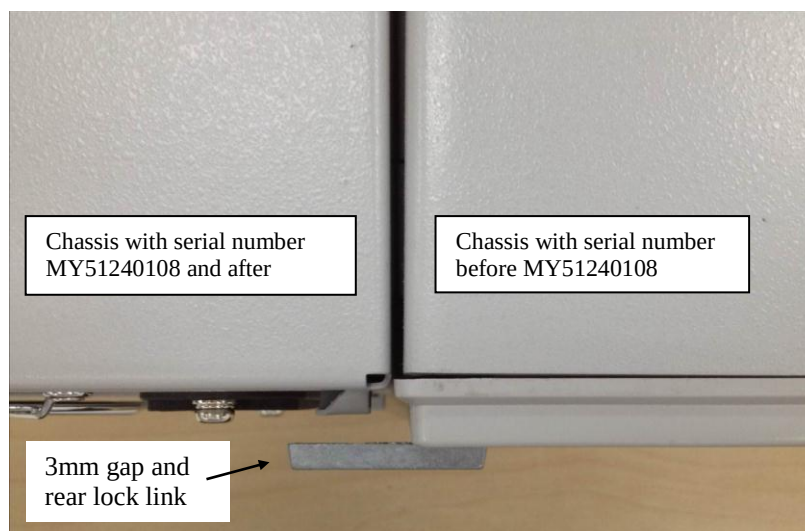
The 3 mm gap between the two different chassis may cause difficulties in securing them together using a rear lock link kit (part number 0050-2167) for side-by-side rack mounting as shown in Figure 2 below.

Figure 2: Top view 3mm gap observed on rear lock link for side-by-side rack mounting

Use metal strap (part number E3631-07901), and stack the provided two metal straps together to form 3mm thickness and secure it with the provided screws on the rear lock link as shown in Figure 4 below.

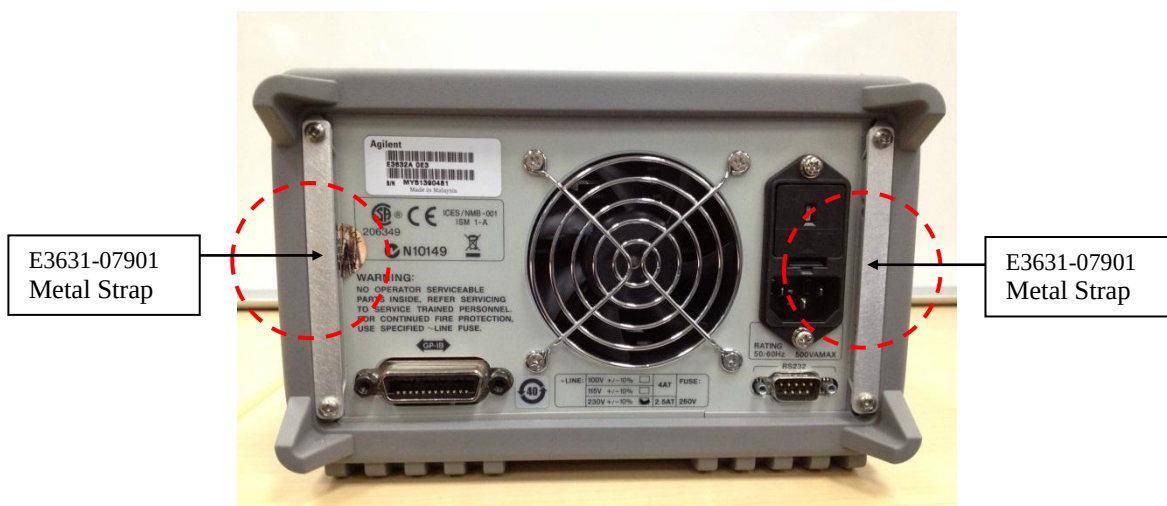
Figure 3: Secure with metal straps – no gap observed between the bumper and chassis

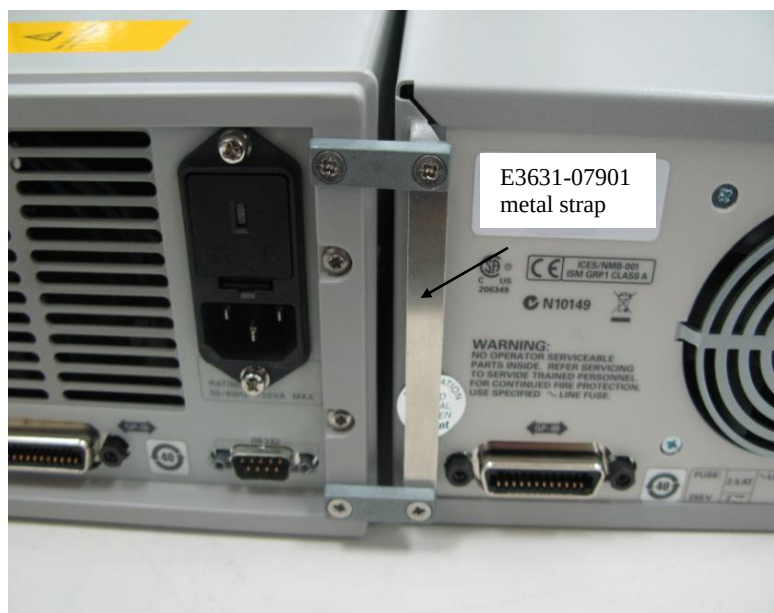
Figure 4: Rear view rear lock link secured with metal straps kit for side-by-side rack mounting
