E3648A-04C

S E R V I C E N O T E

E3648A DC Power Supply

Metal Strap Kit for tightening loose bumper and for fitting rear lock link in side-by-side rack mounting

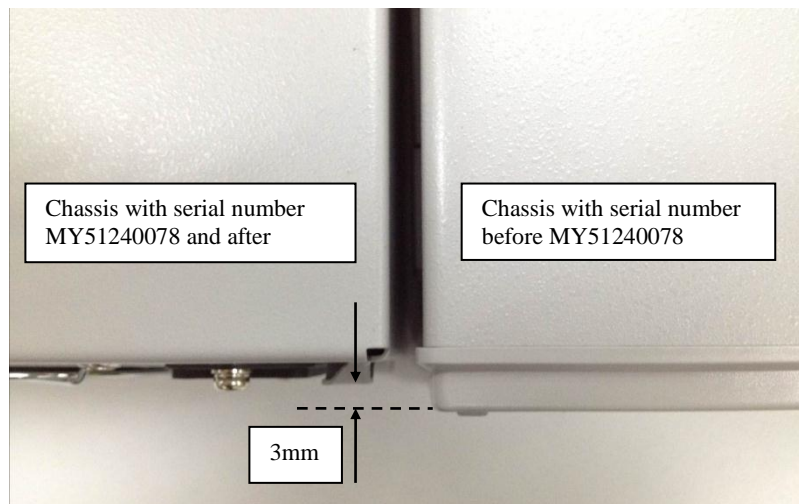
The chassis depth difference between the two designs is 3mm as shown in Table 1 and Figure 1 below.

Serial number range	Chassis depth
MY51240078 and after	345.2 mm
Before MY51240078	348.2 mm

Figure 1: Top view 3mm gap observed between two different chassis designs

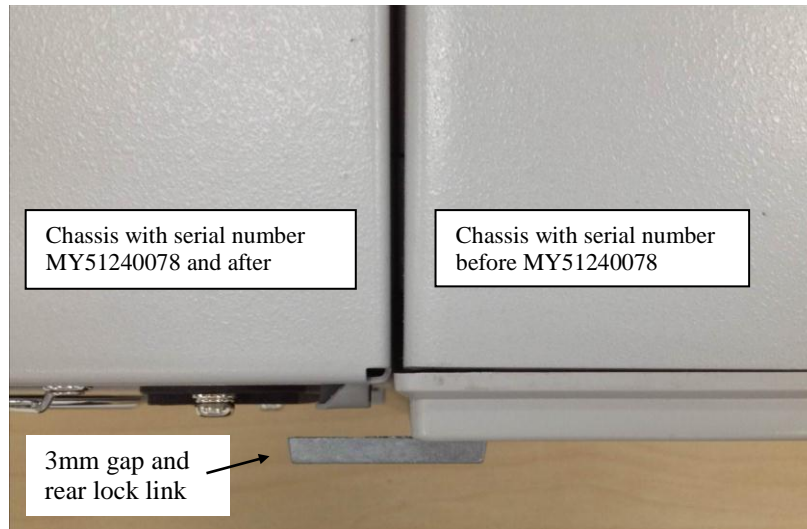
The 3 mm gap between the two different chassis may cause difficulties in securing them together using a rear lock link kit (part number 0050-2167) for side-by-side rack mounting as shown in Figure 2 below.

Figure 2: Top view 3mm gap observed on rear lock link for side-by-side rack mounting

Use metal strap (part number E3631-07901), and stack the provided two metal straps together to form 3mm thickness and secure it with the provided screws on the rear lock link as shown in Figure 4 below.

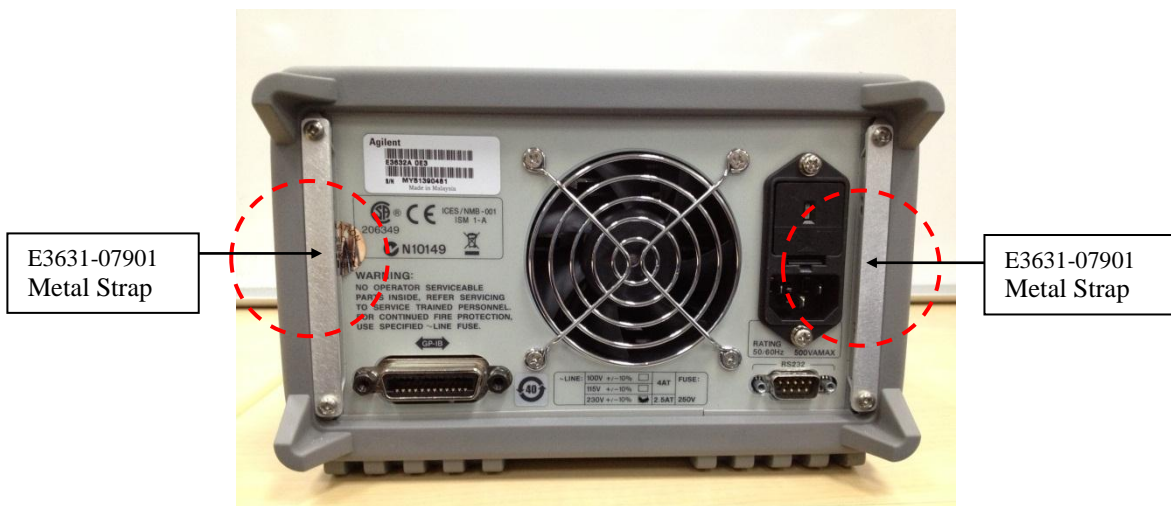
Figure 3: Secure with metal straps – no gap observed between the bumper and chassis

Use two metal straps (part number E3631-07901) to secure each side of the bumper as shown in Figure 3 below.

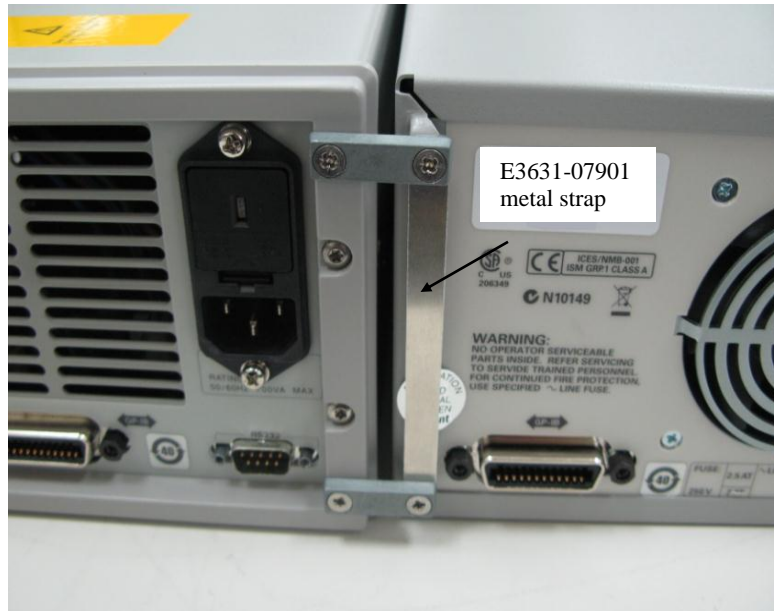
Figure 4: Rear view rear lock link secured with metal straps kit for side-by-side rack mounting
