**E3649A-04C****S E R V I C E N O T E**Supersedes:  
E3649A-04B**E3649A DC Power Supply****Serial Numbers: MY51240078 to MY53190006****Metal Strap Kit for tightening loose bumper and for fitting rear lock link in side-by-side rack mounting****Parts Required:**

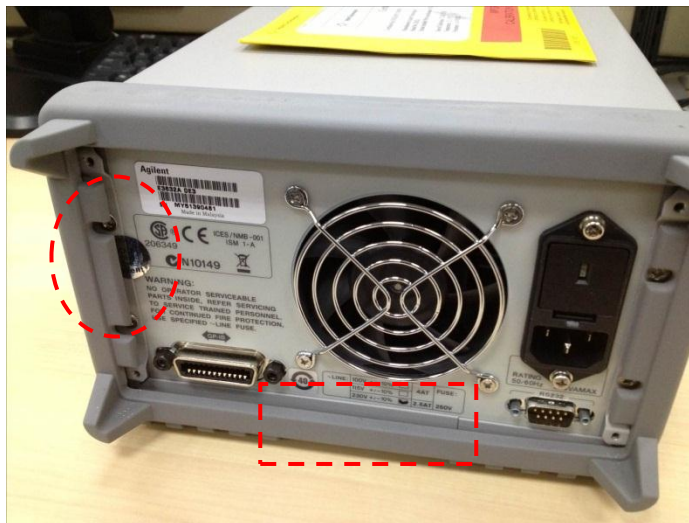
There is a new rear bumper design starting from serial number MY51240078. The rear bumper may become loose or it may slip out of the instrument chassis when force is applied to the rear bumper, as shown in Figure 1 below.

Figure 1: Loose rear bumper – gap observed between bumper and chassis

Use two metal straps (part number E3631-07901) to secure each side of the bumper as shown in Figure 3 below.

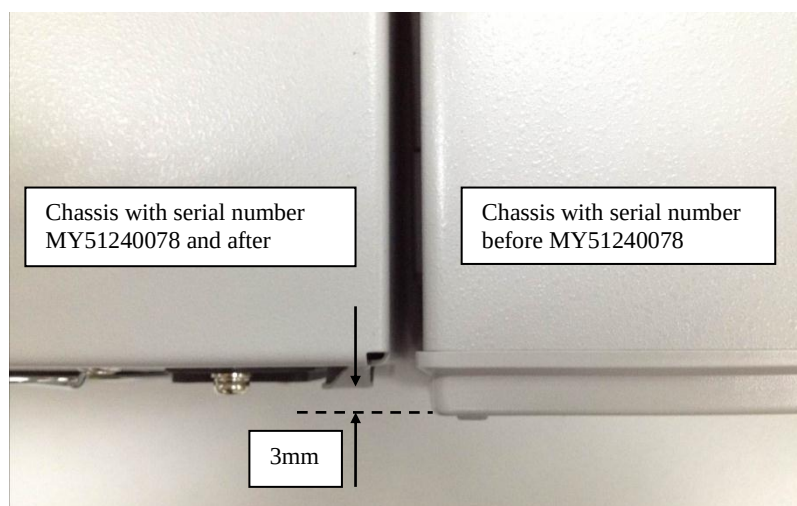
The chassis depth difference between the two designs is 3mm as shown in Table 1 and Figure 1 below.

Figure 1: Top view 3mm gap observed between two different chassis designs

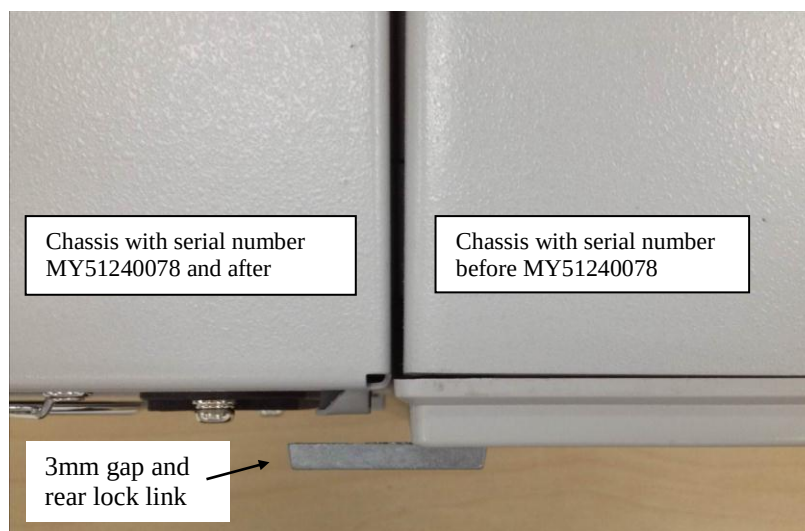
The 3 mm gap between the two different chassis may cause difficulties in securing them together using a rear lock link kit (part number 0050-2167) for side-by-side rack mounting as shown in Figure 2 below.

Figure 2: Top view 3mm gap observed on rear lock link for side-by-side rack mounting

Use metal strap (part number E3631-07901), and stack the provided two metal straps together to form 3mm thickness and secure it with the provided screws on the rear lock link as shown in Figure 4 below.

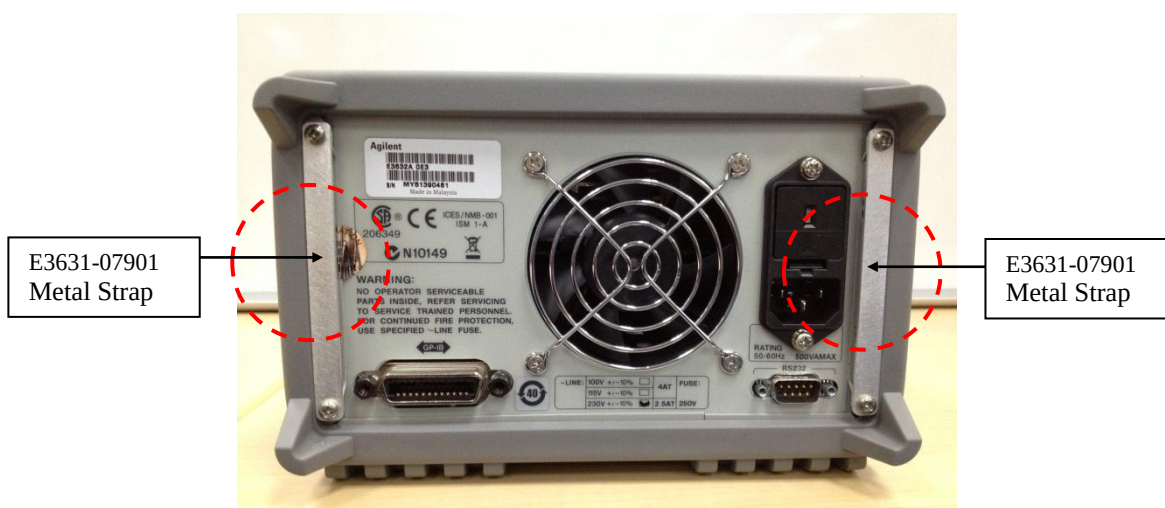
Figure 3: Secure with metal straps – no gap observed between the bumper and chassis

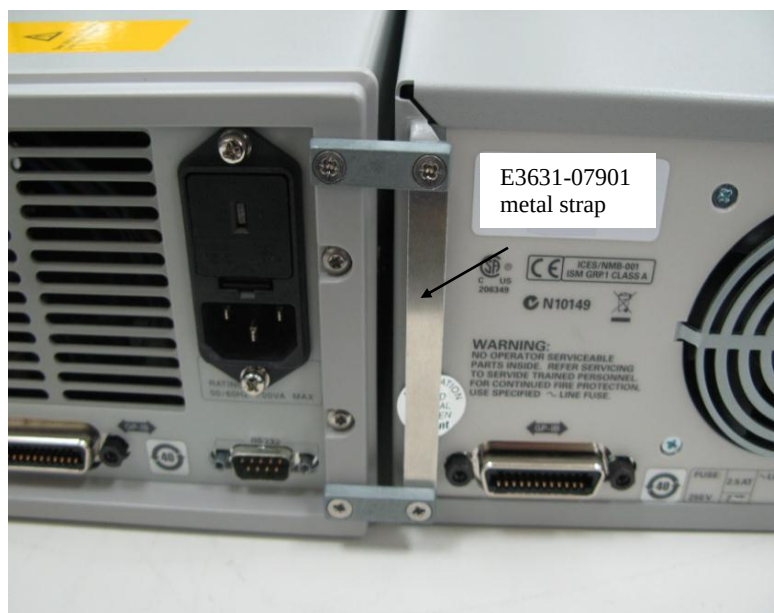
Figure 4: Rear view rear lock link secured with metal straps kit for side-by-side rack mounting
