E3649A-04D

S E R V I C E N O T E

E3649A DC Power Supply

Metal Strap Kit for tightening loose bumper and for fitting rear lock link in side-by-side rack mounting

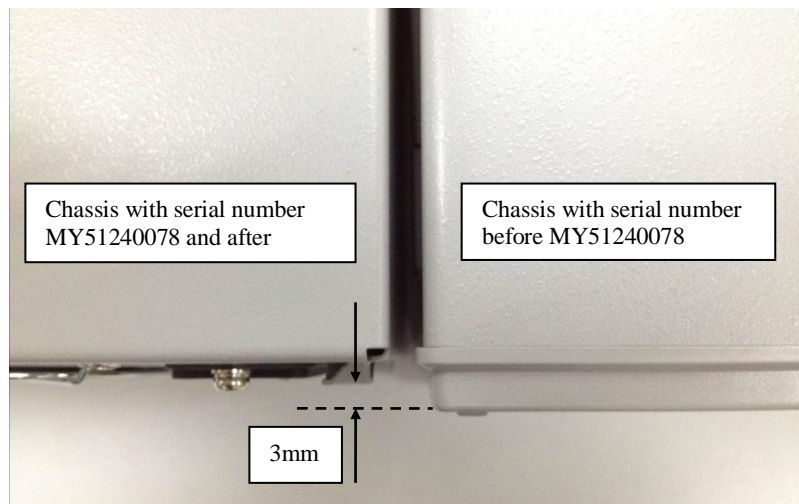
The chassis depth difference between the two designs is 3mm as shown in Table 1 and Figure 2 below.

Serial number range	Chassis depth
MY51240078 and after	345.2 mm
Before MY51240078	348.2 mm

Figure 2: Top view 3mm gap observed between two different chassis designs

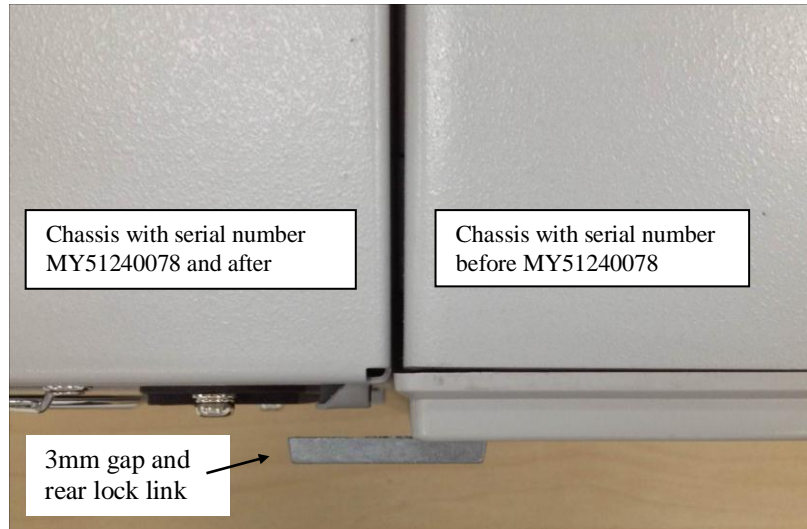
The 3 mm gap between the two different chassis may cause difficulties in securing them together using a rear lock link kit (part number 0050-2167) for side-by-side rack mounting as shown in Figure 3 below.

Figure 3: Top view 3mm gap observed on rear lock link for side-by-side rack mounting

Use metal strap (part number E3631-07901), and stack the provided two metal straps together to form 3mm thickness and secure it with the provided screws on the rear lock link as shown in Figure 5 below.
