E8362C-01A

S E R V I C E N O T E

E8362C PNA Microwave Network Analyzers

A new touchscreen display inverter shield is available to improve PNA noise floor performance.

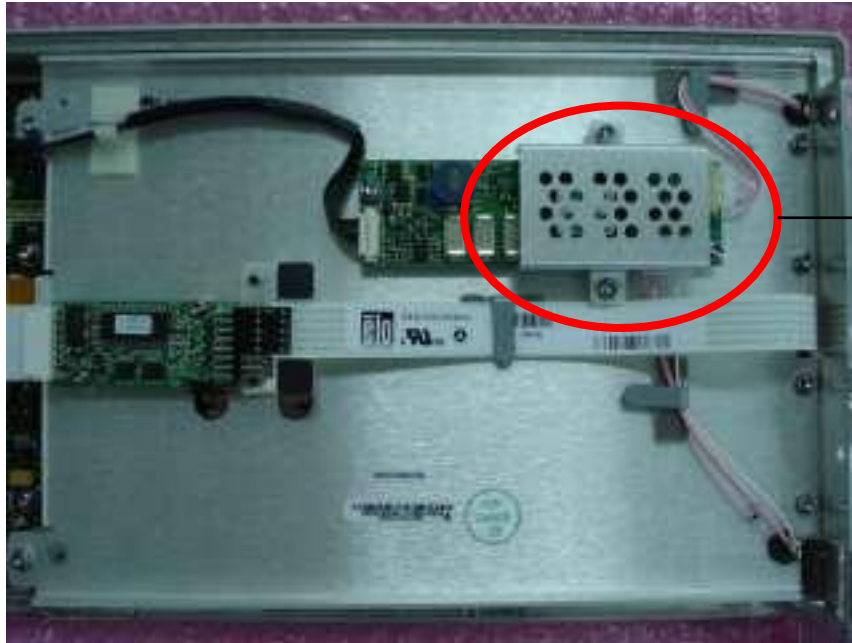
Some PNA C-models may exhibit poor noise floor performance caused by inverter shield N5230-00013.

If a PNA C-model exhibits poor noise performance, examine the inverter shield to see if it is the N5230-00013. Figure 1 shows that the N5230-00013 shield has vent holes. If present, replace the old shield (N5230-00013) with the new shield (N5230-00017) as per the following instructions.

Figure 1: Old inverter shield N5230-00013

7. Follow the instructions in the subsection "Removal Procedure."
8. Once the front panel has been removed from the PNA, place it on a flat surface. Figure 1 shows that the N5230-00013 inverter shield has vent holes.
