E8364CH85-02A

S E R V I C E N O T E

E8364CH85 PNA Microwave Network Analyzers

A new touchscreen display inverter shield is available to improve PNA noise floor performance.

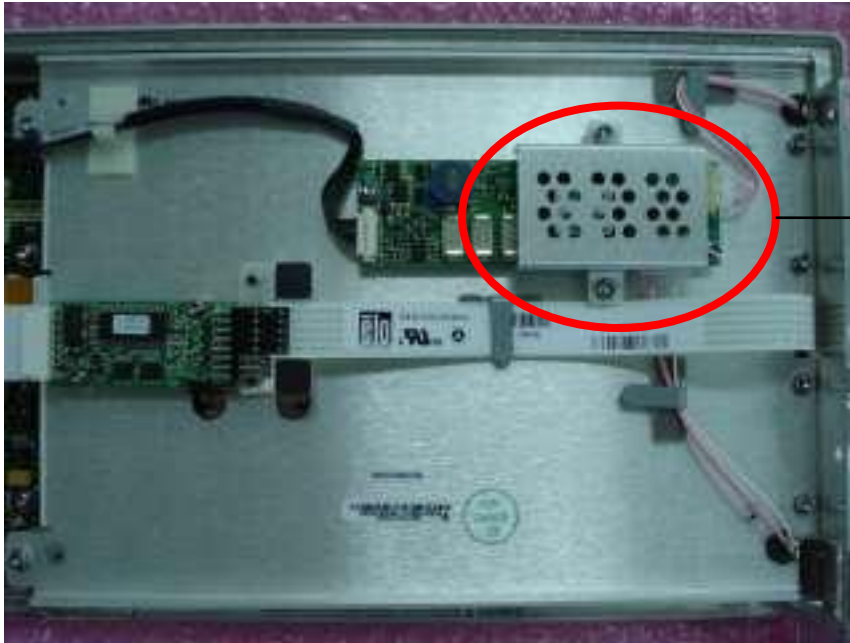
Some PNA C-models may exhibit poor noise floor performance caused by inverter shield N5230-00013.

7. Follow the instructions in the subsection "Removal Procedure."
8. Once the front panel has been removed from the PNA, place it on a flat surface. Figure 1 shows that the N5230-00013 inverter shield has vent holes.

Figure 1: Old inverter shield N5230-00013

If a PNA C-model exhibits poor noise performance, examine the inverter shield to see if it is the N5230-00013. Figure 1 shows that the N5230-00013 shield has vent holes. If present, replace the old shield (N5230-00013) with the new shield (N5230-00017) as per the following instructions.
