S E R V I C E N O T E

J2522B Internet Advisor

Possible fire hazard

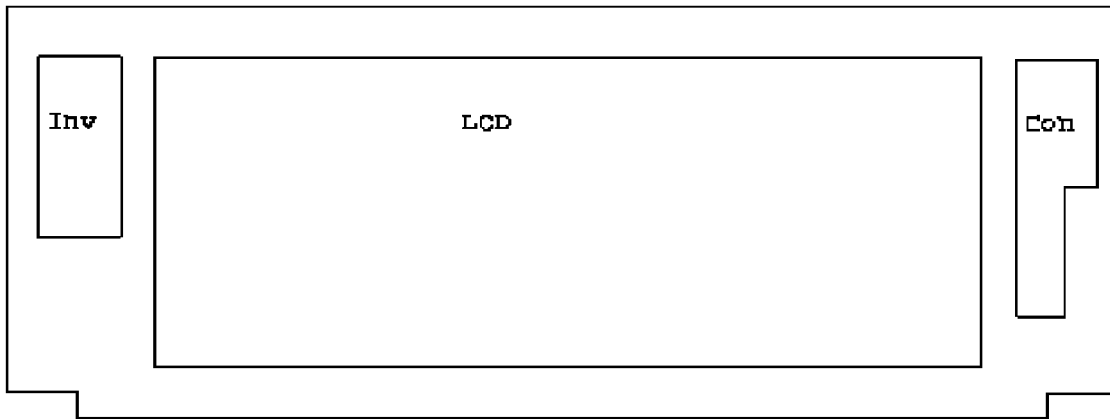
Note Drawing shown with the rear panel removed.

1. Remove the back panel from the display by removing 6 painted screws.
2. Locate 0950-2937 (note drawing marker “Inv”), remove 2 screws and cables from the board and remove the inverter board from the display assembly.
3. Replace the board with 0950-2937 with different LOT number.
