L4532A-01

S E R V I C E N O T E

L4532A - 20 MSa/s, 2 Channel LXI Digitizer

BNC O-RING must be moved from old to new L4532-66703 Channel Board

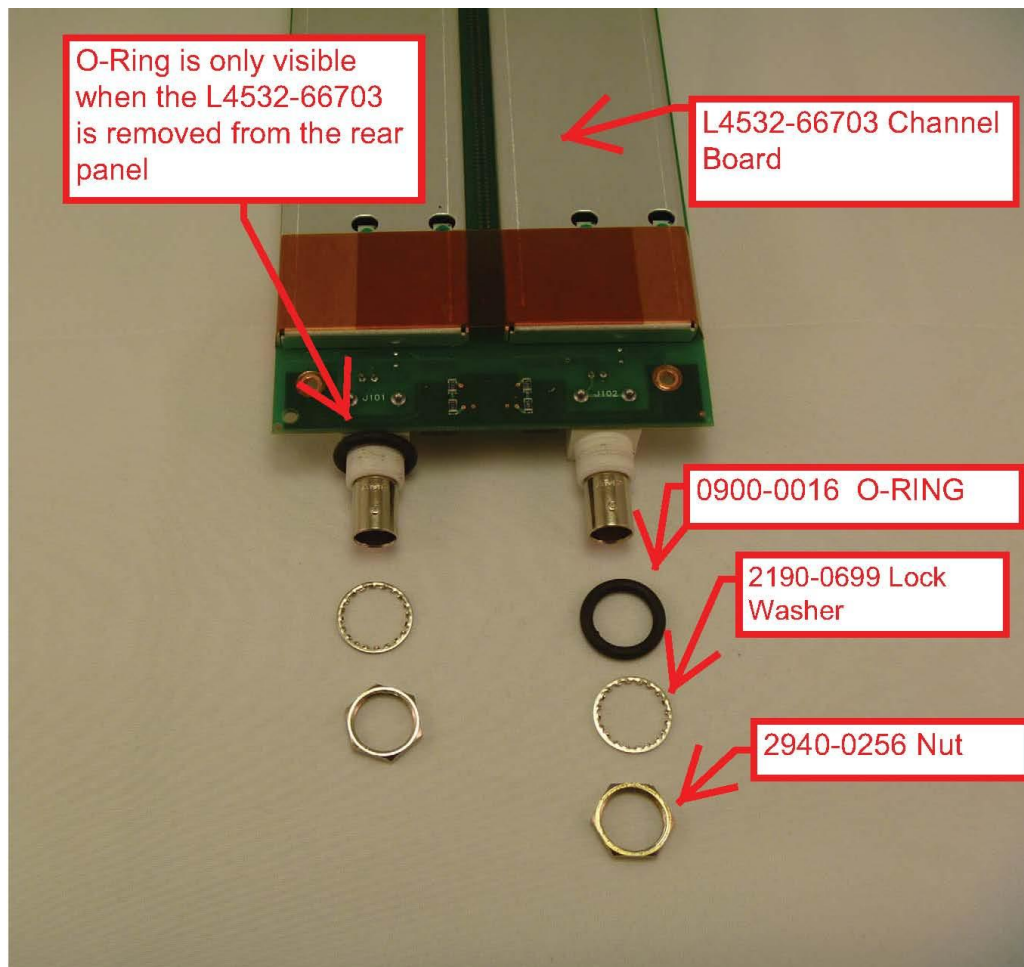
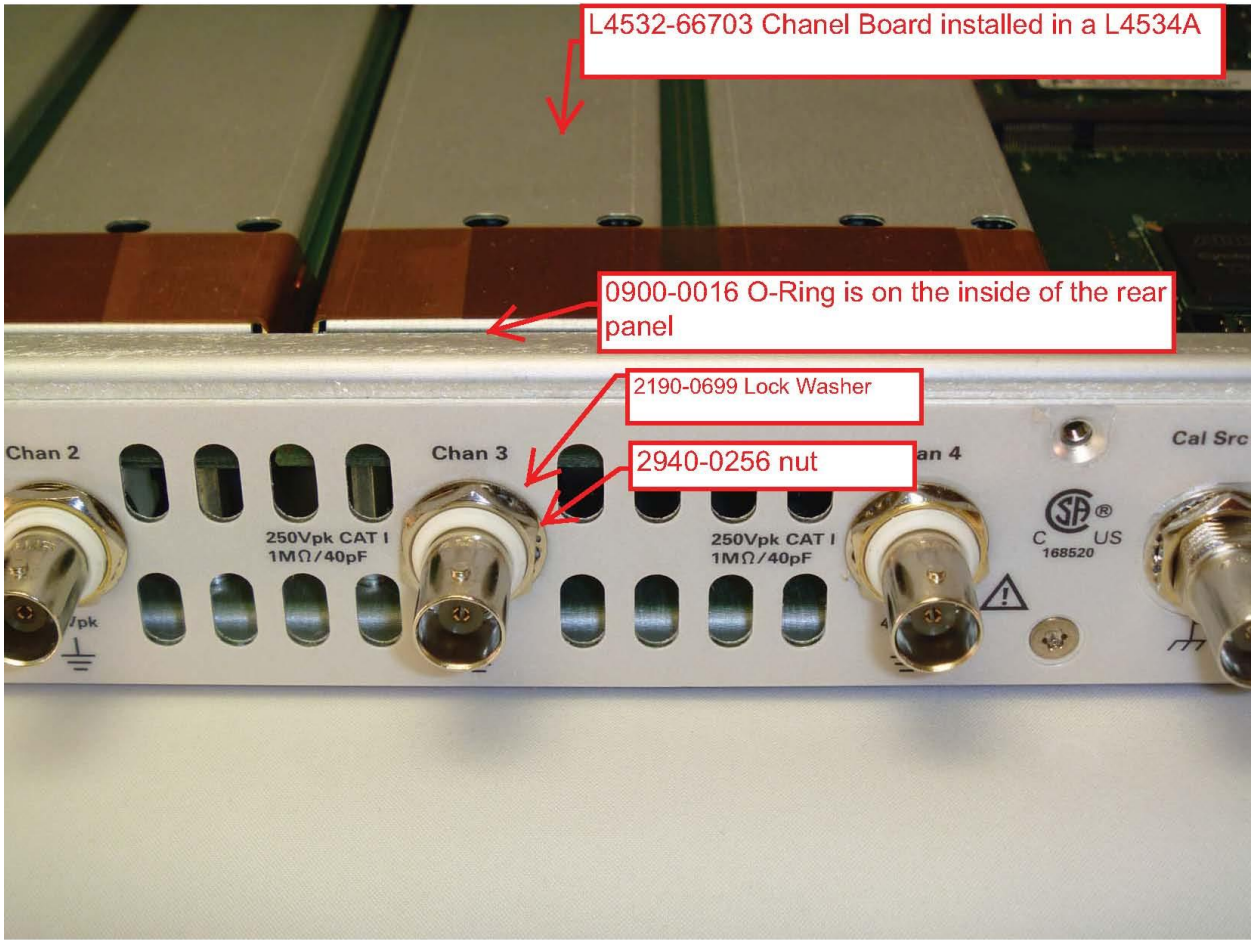
The rubber O-ring is installed on the BNC such that the O-ring will be on the inside of the instrument rear panel. The outside of the instrument rear panel will contain a lock washer and a Nut.

If the L4532-66703 channel board has failed and needs replacing, then remove the Nut, the lock washer and the O-Ring from the original L4532-66703 channel board and transfer it to a new board L4532-66703.
