N6950A-02

# Modification Recommended Service Note

## N6950A – Advanced Power System, DC Power Supply, 9V, 100A, 1000W

**The Problem** – Charge Present on the AC terminal when unplugging the unit.

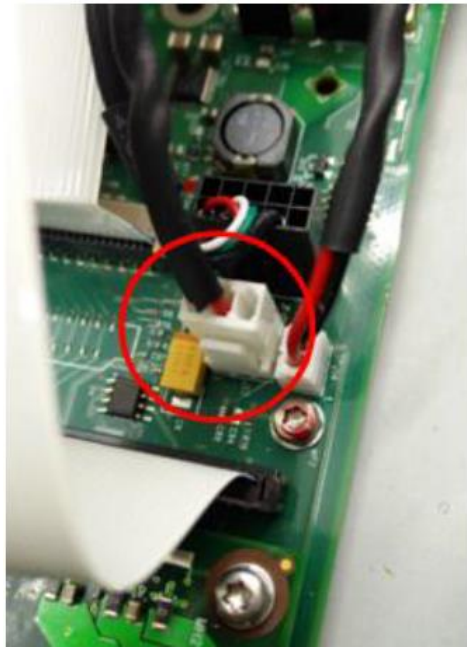
Figure 5

5. Remove AC line cable from constellation PCA Figure 5.
