N7954A-02

Modification Recommended Service Note

N7954A – Advanced Power System, Dynamic DC Power Supply, 80V, 12.5A, 1000W

The Problem – Charge Present on the AC terminal when unplugging the unit.

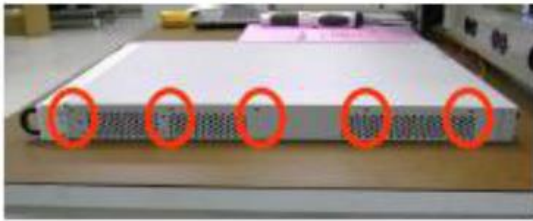
Figure 2

2. Unscrew total of 14 screws from left, right and bottom side as shown in **Figure 2**.

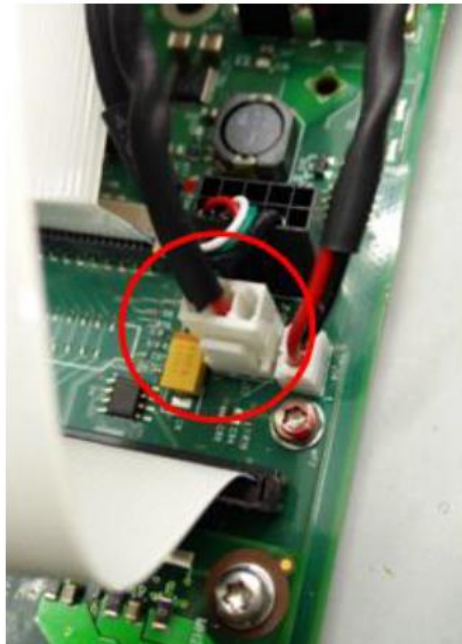
Figure 5

5. Remove AC line cable from constellation PCA Figure 5.

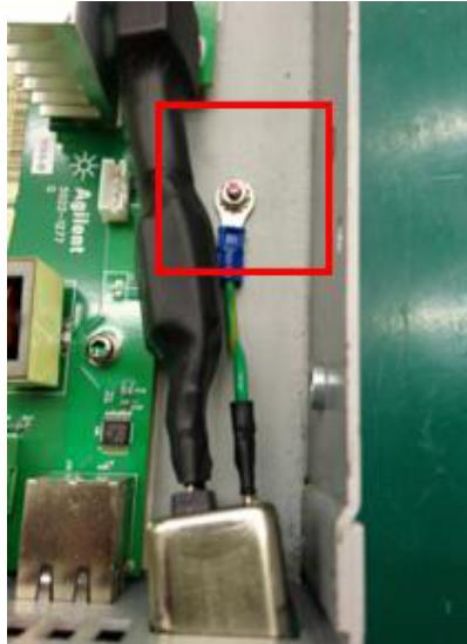
Figure 13

14. Secure grounding cable AC line cable with nut as shown in *Figure 13*.
