3070-74-S

S E R V I C E N O T E

Agilent 3070 Series 3 Board Test Systems

POSSIBLE ELECTRICAL SHOCK HAZARD

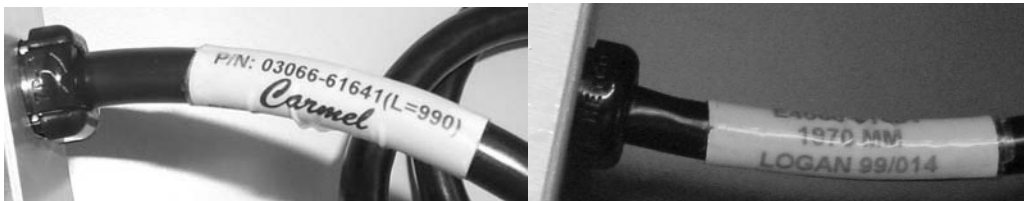
Agilent has identified a potential electrical safety hazard for a limited number of Agilent 3070 test systems related to the power outlet boxes used in the systems. In some 3070 Power outlet boxes, part numbers 03066-61641 and E4000-81603, the line, neutral, and ground wires are only connected by solder, without any type of mechanical connection causing a potential electrical safety hazard. Only outlet boxes with Agilent part numbers 03066-61641 and E4000-81603 manufactured by Carmel from Dec, 2002 to Aug 2004 have this problem. All outlet boxes manufactured by Logan with Agilent part numbers 03066-61635, 03066-61641, E4000-81601, E4000-81603, E4000-81623, and E4000-81610 are assembled to Agilent's specifications and are not affected by this safety alert. The outlet boxes with four sockets, Agilent Part Number E4000-61623, used in the support bay on some Series II and all Series 3 systems were all manufactured by Logan and are not affected by this safety alert.

- The solution involves replacing suspect power outlet boxes with new assemblies. The outlet box assembly consists of an outlet box with 3 receptacles, a 3 conductor power cord and an IEC320 Plug (Hubbell H320P). A service note compliance sticker will be attached to the system upon completion of the replacement and testing of the outlet box. The outlet box is attached to the 3070 frame via two Torx T20 type screws (0515-1922). The two Torx screws (0515-1922) will be reused on the new outlet box assembly. The Hubbell connector mates with a plug (see picture below) connected to the PDU E1135C.
