44474A-01A

S E R V I C E N O T E

April 28, 2008

Defective connectors shipped with 44470A, 44471A, 44473A, 44474A

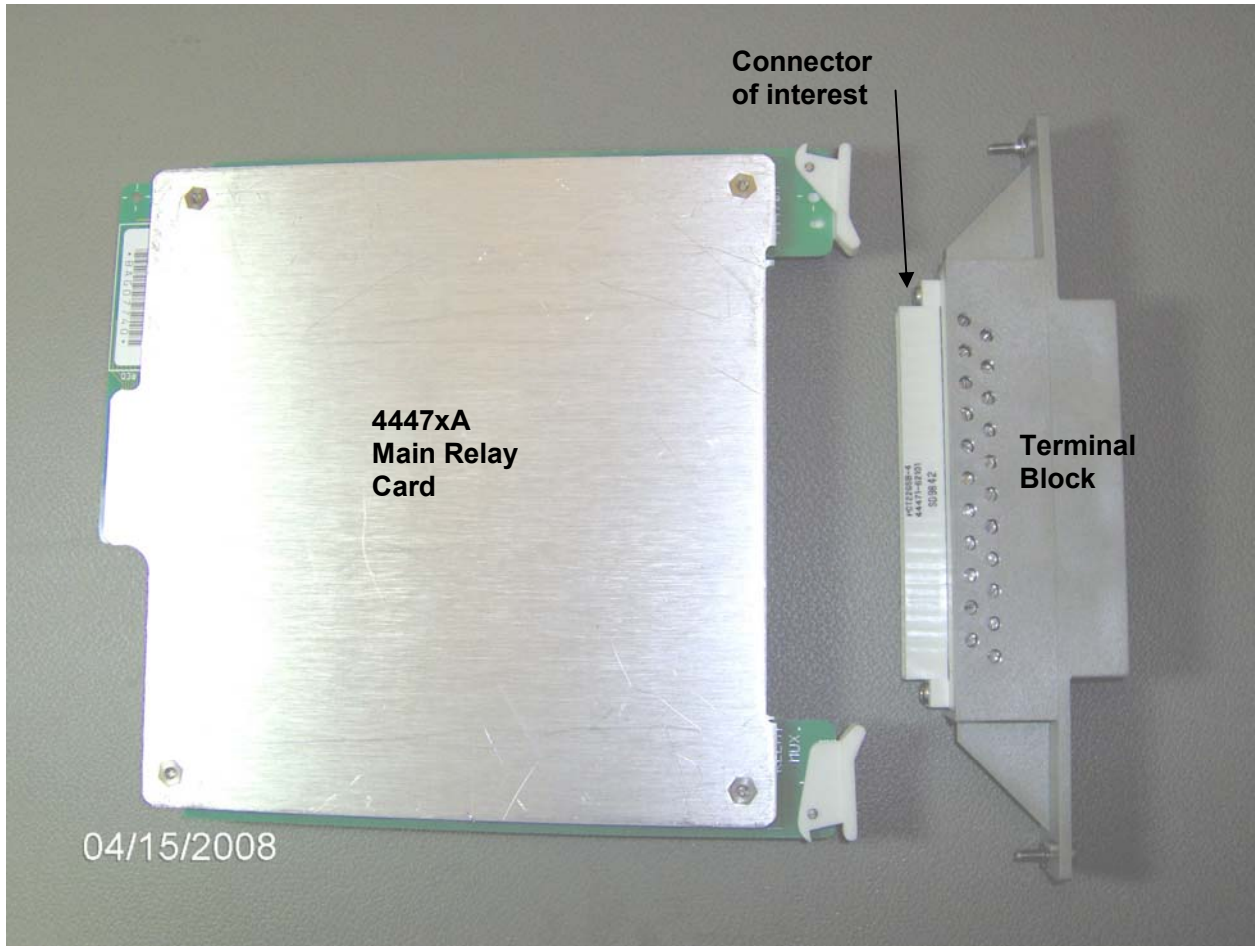
The 44470A, 44471A, 44473A, and 44474A contain a main relay card and a removable screw terminal block (see Figure 1). Some of the removable terminal blocks that were shipped between 1-Jan-2008 and 08-April-2008 have a defective connector that results in half of the pins being unconnected.

Figure 1: Main Relay Card and Terminal Block

The procedure to correct the defective connectors is very simple. One must replace the defective connector with a good connector (see connector part numbers list on page 2). The customer may perform this procedure or have an Agilent-qualified person perform this procedure.
