E5071C-08

S E R V I C E N O T E

E5071C - ENA Series Network Analyzer, 9 kHz to 20 GHz

The measurement data is unstable due to a Receiver Port degradation, though a user performs calibration.

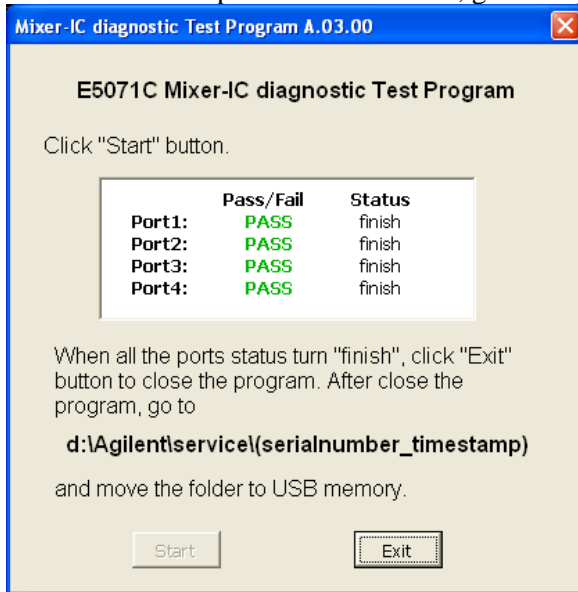
2-A.When all the ports result in **PASS**, go to Step-3 and Step-4.

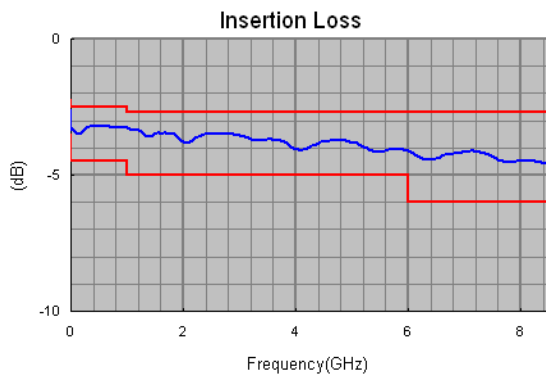
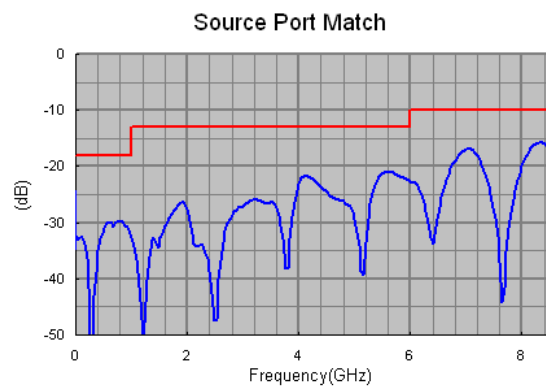
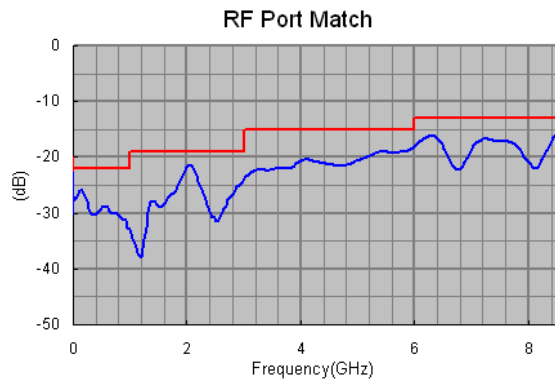
Fig 3. Example of measurement data

Note: When the bridge failure is shown, EOS(Excessive Over Stress) by customer is highly suspected. For this case, this service note is NOT applied.
