E9902G-01

Modification Recommended Service Note

Keysight i3070 Series 6 In-Circuit Test System

Intermittent T3610 errors during Diagnostics (DGN) on certain batches of pin cards in MUX system with XTPB cards installed.

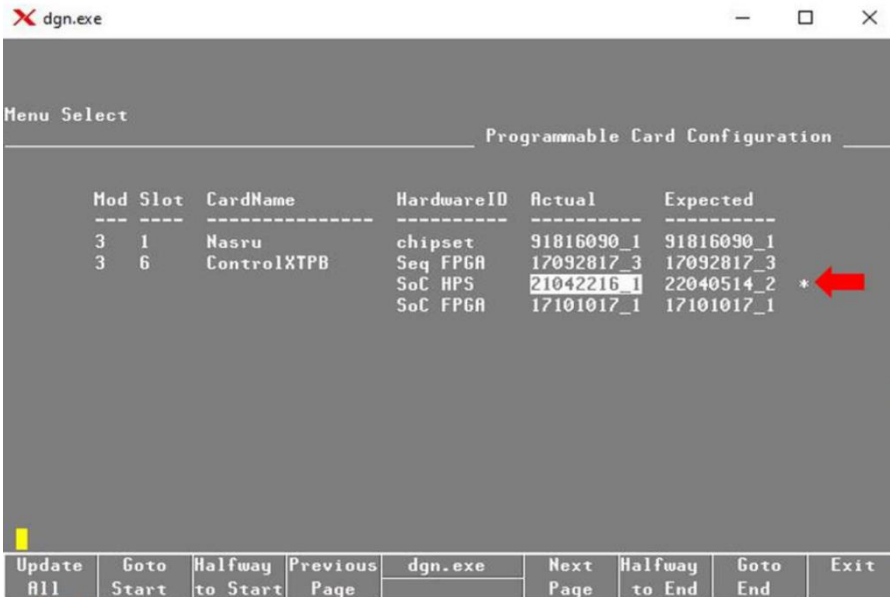
3. Launch DGN.
4. Select Configuration > Programmable Card Config.
5. Any available firmware updates will be highlighted as shown below:

1. Download the following firmware update file (XTPB_SoC_HPS_Mux.img) from [Keysight i3070 Control XTPB card firmware update | Keysight](#)
2. Copy the file to C:\I3070_ICT\lib folder in the i3070 system controller after renaming the original file there.

6. Select “Update All” to begin the update.
7. Whenever the User Account Control dialog box appears, select “Yes” to allow the system to proceed.
8. When installation is completed, reboot the testhead.
