Resolving IrDA Physical Layer Implementation Problems

Application Note 1120

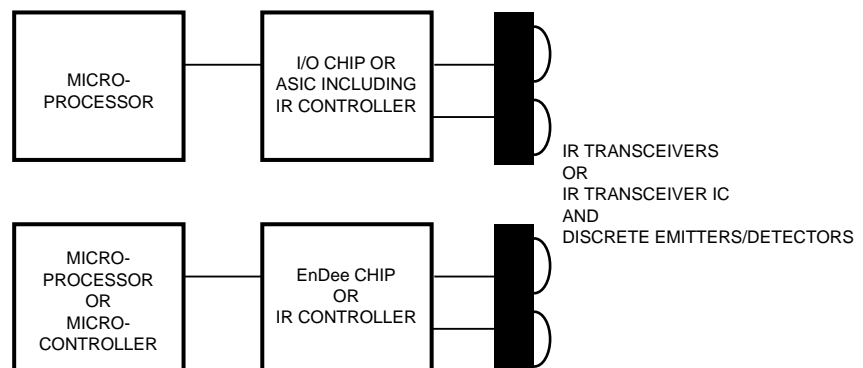
Figure 1.

Figure 1 shows two general implementations of IrDA using Hewlett-Packard components.

- In the other implementation using an Encode-Decode (EnDec) chip, the UART, microprocessor, or microcontroller should disable its serial input during transmission of a frame. If the serial input is enabled during transmission of a frame, unwanted interrupts to the microprocessor or microcontroller will be generated.
- A latency period must be allowed for between the reception of a data frame and
