86100D-11

Modification Available Performance Enhancement Service Note

86100D Infiniium DCA-X Wide-Bandwidth Oscilloscope Mainframe

An upgrade to Windows 10 is available for some 86100D DCA-X mainframes. Availability is dependent upon the version of CPU motherboard installed. See text below for determining CPU version.

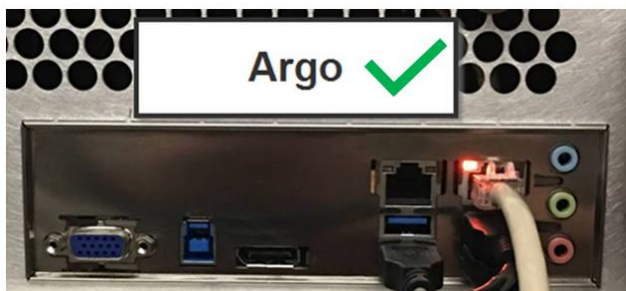
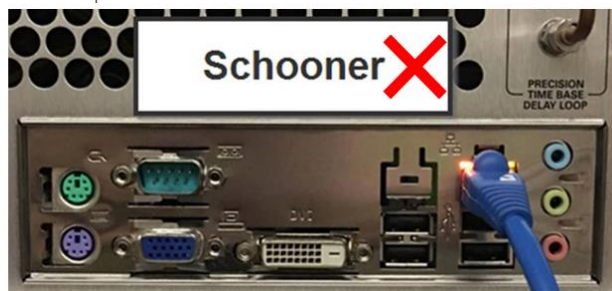
2. Visual. The connections available on the 86100D rear panel differ for the two CPUs:

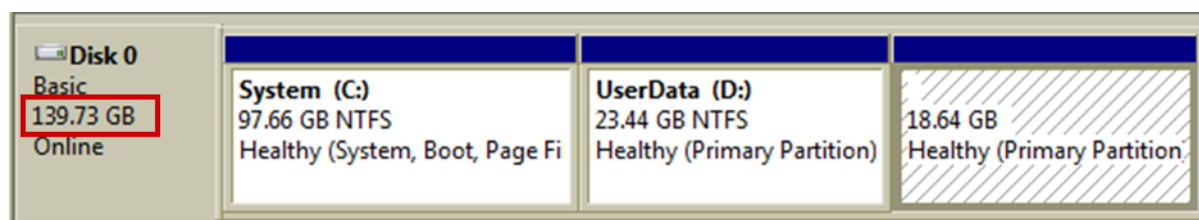
Open the Disk Management utility (Start > Run > compmgmt.msc > Storage > Disk Management) and note the total drive size (139.73 GB in the example below):

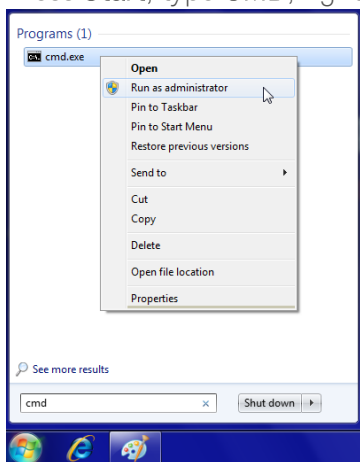
- a. Press **Start**, type **CMD**, right click on **CMD** and select **Run as Administrator**

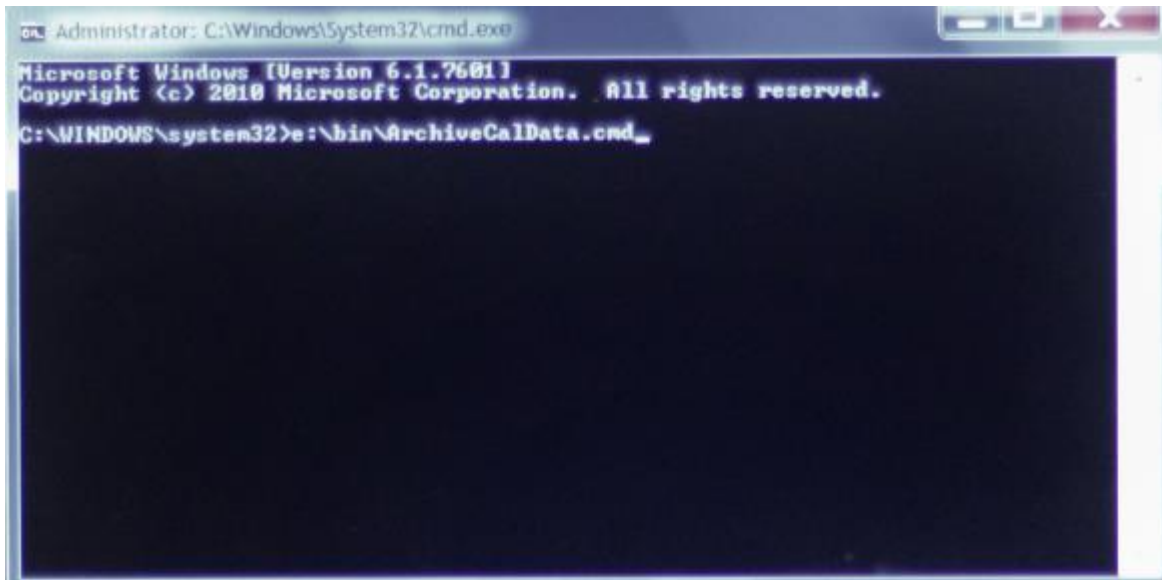
6. When the command prompt opens, run the command `e:\bin\ArchiveCalData.cmd`
 - a. Note that the drive assigned by Windows when the USB stick is inserted may be different than E:\. If so, use that drive letter instead of E:\

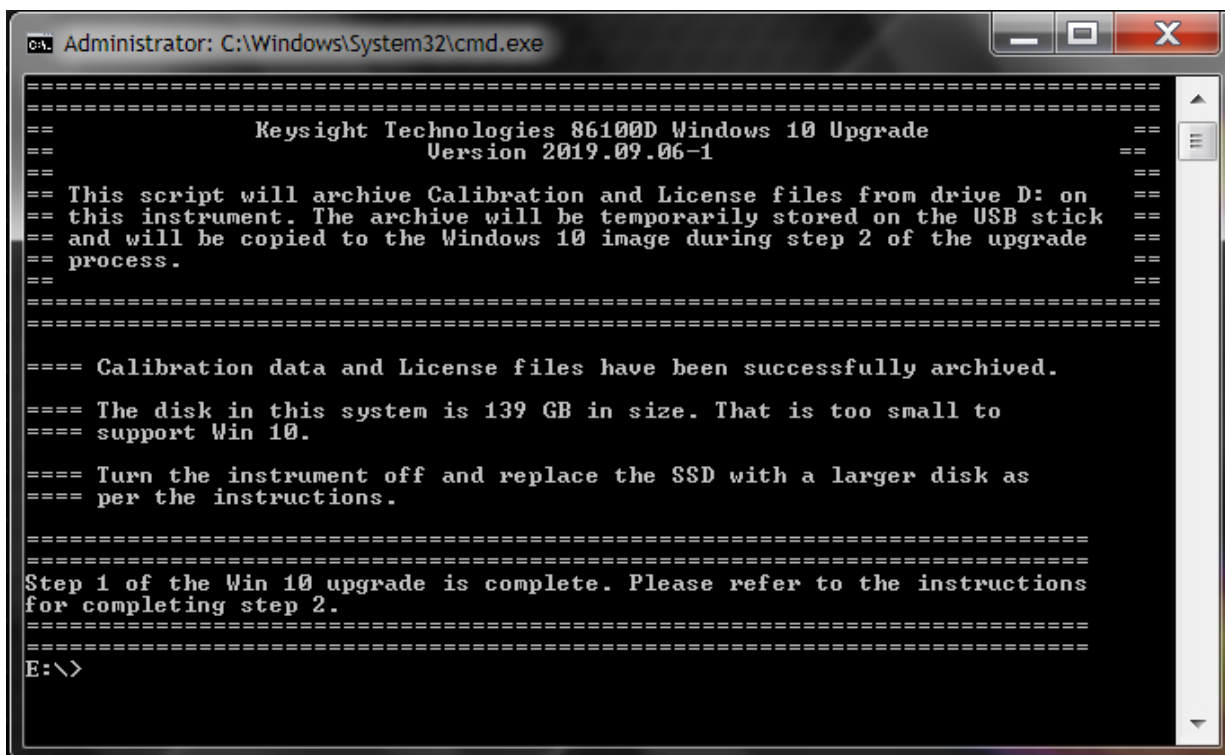
7. The following will be displayed when ArchiveCalData.cmd has completed:

The upgrade process is partially automated and does require some interaction on the part of the technician, including replacing the HDD if the original drive size is < 200 GB. The upgrade utility will check the drive size and prompt for replacement if needed (see screen capture at the end of STEP 1 below).

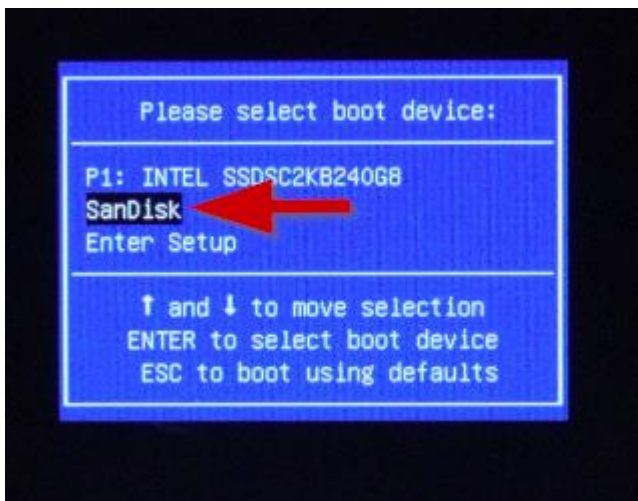
10. If the USB drive has been removed, re-insert it in a rear-panel port
11. Connect a USB keyboard and mouse to the instrument
12. Restart the instrument and boot from the USB drive:
 - a. Watch for prompt and press the F12 key
 - b. Select the USB drive in the Boot Menu (typically, "SanDisk")

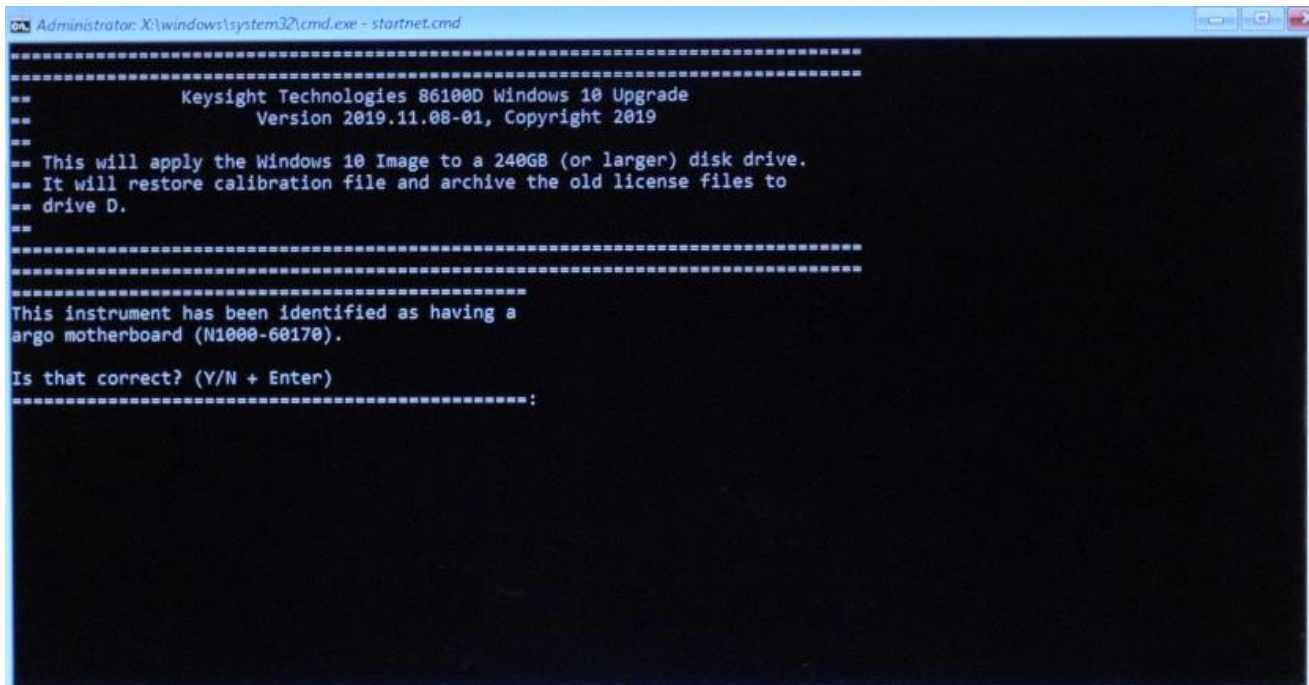
13. The CPU version is identified (it will take a few moments to get to this screen):

```
Administrator: X:\windows\system32\cmd.exe - startnet.cmd
=====  
Keysight Technologies 86100D Windows 10 Upgrade  
Version 2019.11.08-01, Copyright 2019  
== This will apply the Windows 10 Image to a 240GB (or larger) disk drive.  
== It will restore calibration file and archive the old license files to  
== drive D.  
=====  
This instrument has been identified as having a  
argo motherboard (N1000-60170).  
Is that correct? (Y/N + Enter)  
=====:
```

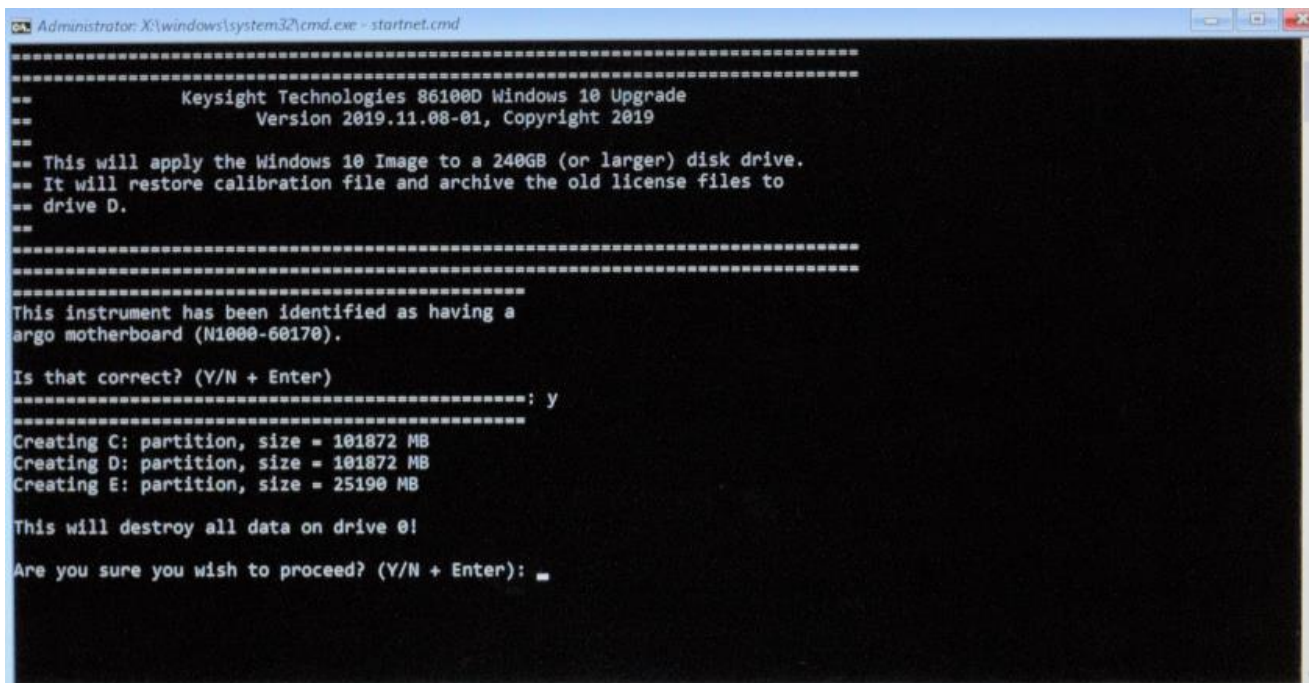
14. Partition size notification:

```
Administrator: X:\windows\system32\cmd.exe - startnet.cmd
=====  
Keysight Technologies 86100D Windows 10 Upgrade  
Version 2019.11.08-01, Copyright 2019  
== This will apply the Windows 10 Image to a 240GB (or larger) disk drive.  
== It will restore calibration file and archive the old license files to  
== drive D.  
=====  
This instrument has been identified as having a  
argo motherboard (N1000-60170).  
Is that correct? (Y/N + Enter)  
=====: y  
Creating C: partition, size = 101872 MB  
Creating D: partition, size = 101872 MB  
Creating E: partition, size = 25190 MB  
This will destroy all data on drive 0!  
Are you sure you wish to proceed? (Y/N + Enter): _
```

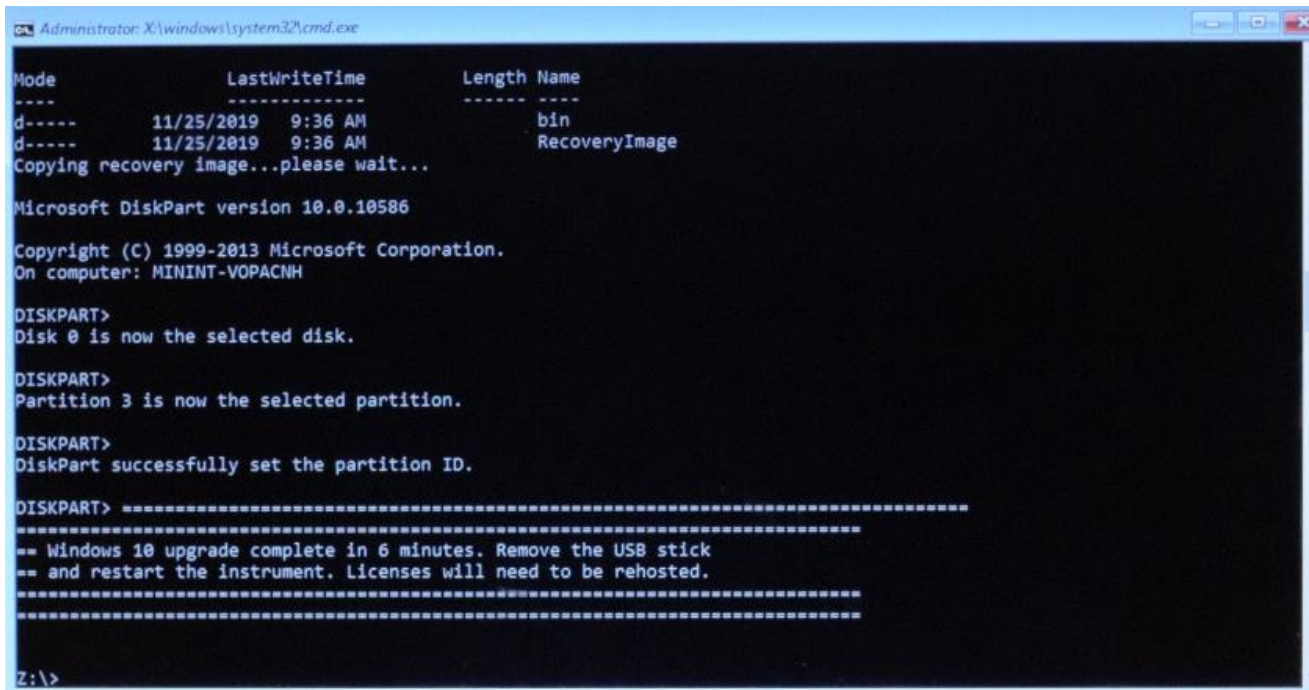
17. Image application complete:
