# Modification Available Performance Enhancement Service Note

## 86100D DCA-X Wide-Bandwidth Oscilloscope Mainframe

Serial Numbers: ALL

An upgrade to Windows 10 is available for all 86100D DCA-X mainframes. Units with older CPU version will also require a CPU upgrade. See text below for determining CPU version.

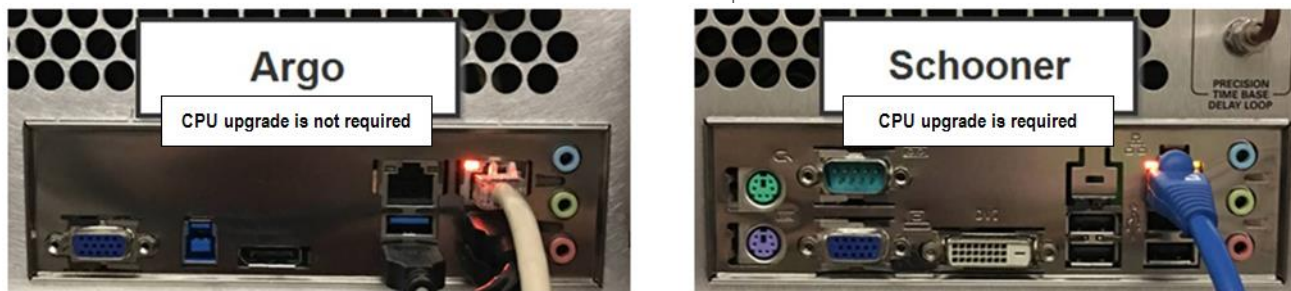
1. Serial Number:
  - a. SN  $\geq$  MY55400101 → Argo CPU. CPU upgrade is not required.
  - b. SN  $<$  MY55400101 → May have either Argo or Schooner CPU. Further evaluation is required.
2. Visual. The connections available on the 86100D rear panel differ for the two CPUs:

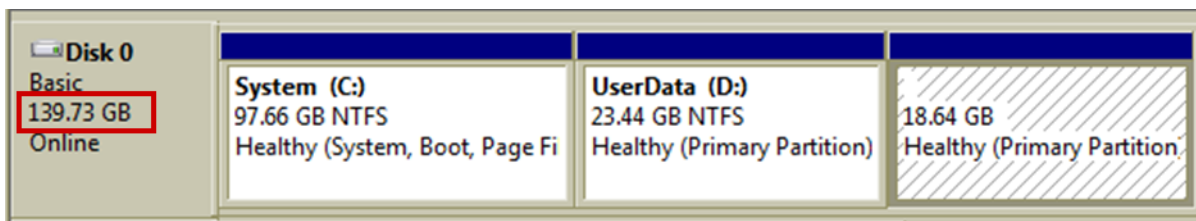
Open the Disk Management utility (Start > Run > compmgmt.msc > Storage > Disk Management) and note the total drive size (139.73 GB in the example below):

For Argo Win10 upgrades, there are two Windows 10 upgrade kits available (order only one): 86100-60211 or 86100-60212. The minimum recommended HDD size for running Windows 10 on an 86100D is 200 GB. Therefore, a new HDD is required if the installed HDD is < 200 GB.

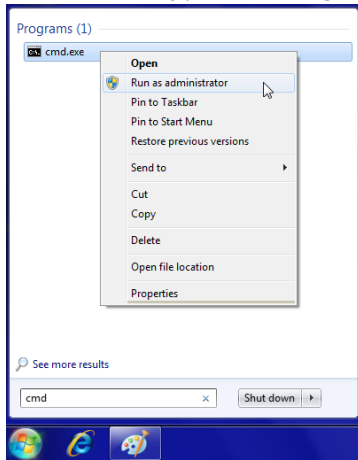
- a. Press **Start**, type **CMD**, right click on **CMD** and select **Run as Administrator**

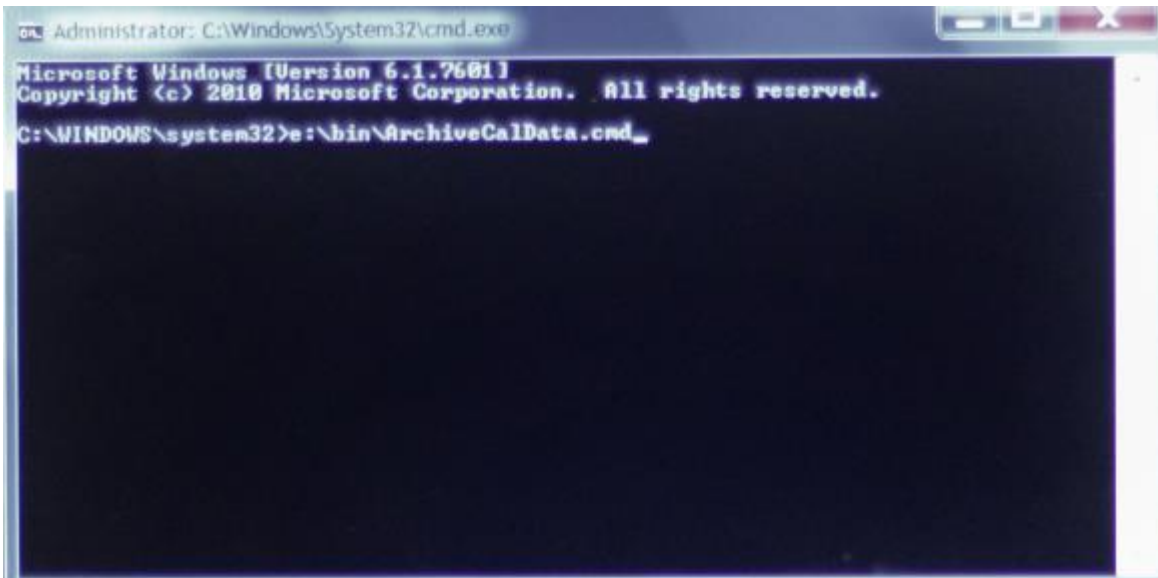
6. When the command prompt opens, run the command **e:\bin\ArchiveCalData.cmd**
  - a. Note that the drive assigned by Windows when the USB stick is inserted may be different than E:\. If so, use that drive letter instead of E:\

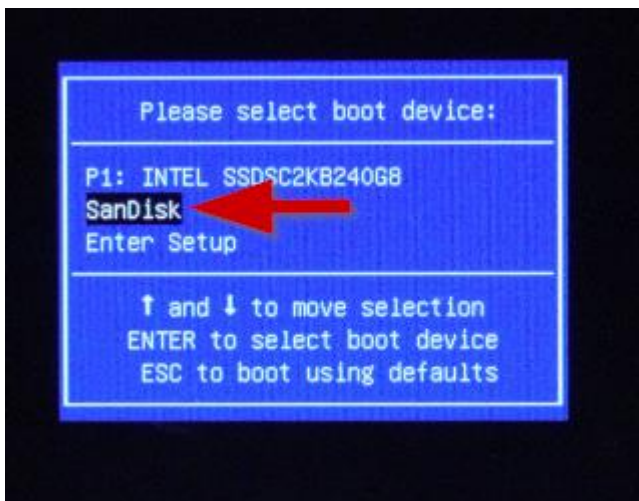
10. If the USB drive has been removed, re-insert it in a rear-panel port
11. Connect a USB keyboard and mouse to the instrument
12. Restart the instrument and boot from the USB drive:
  - a. Watch for prompt and press the F12 key
  - b. Select the USB drive in the Boot Menu (typically, "SanDisk")

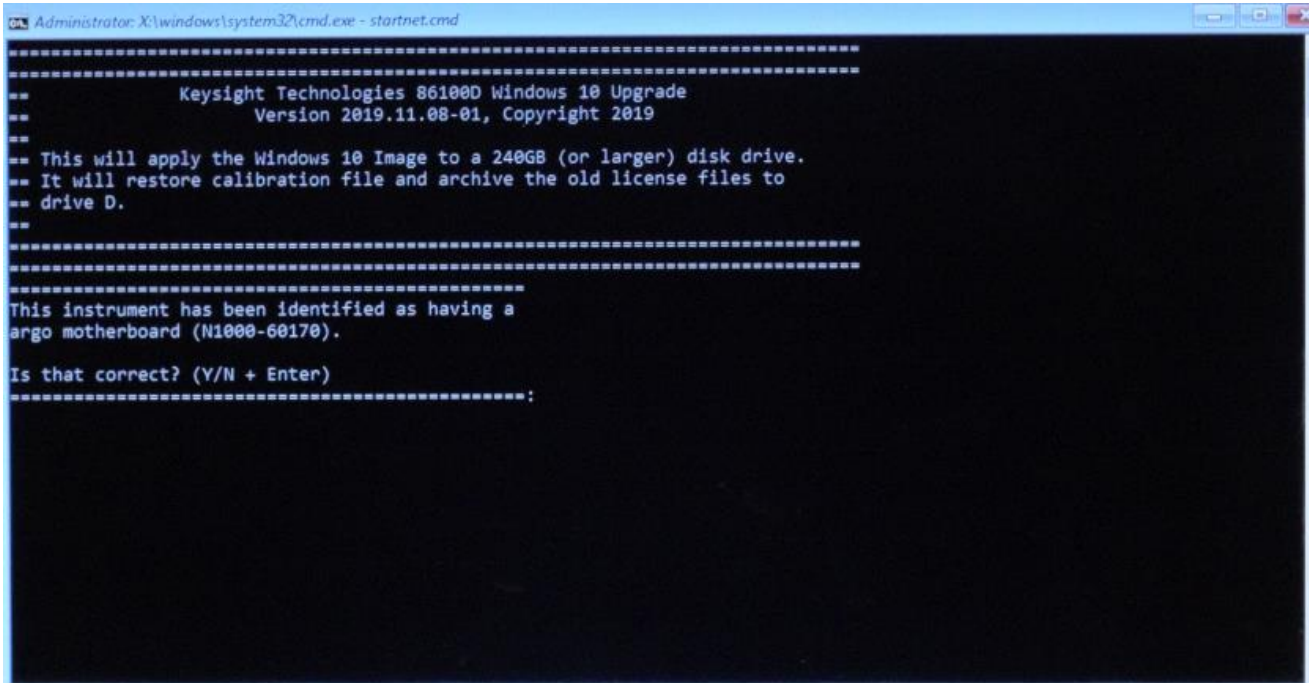
- 13. The CPU version is identified (it will take a few moments to get to this screen):
  - a. If a Schooner CPU is detected at this time, an error message will be displayed and the upgrade process will be aborted.
