B2911A-02

Modification Recommended Service Note

B2911A Precision Source/Measure Unit, 1ch, 10fA resolution, 210V, 3A DC/10.5A pulse

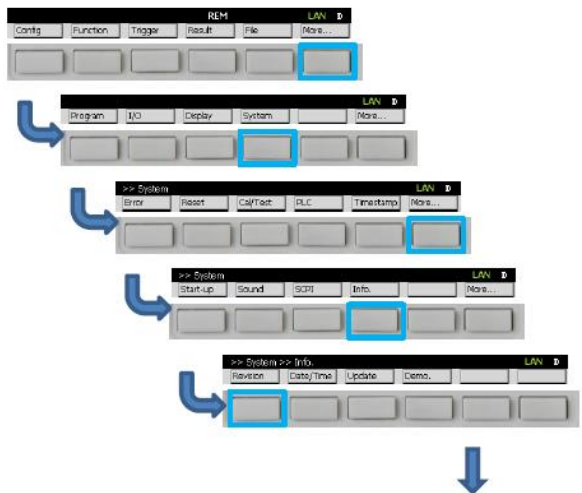
to open Revision dialogue.

(1) Press More...

(2) Press System

(3) Press More...

(4) Press Info.

(5) Press Revision

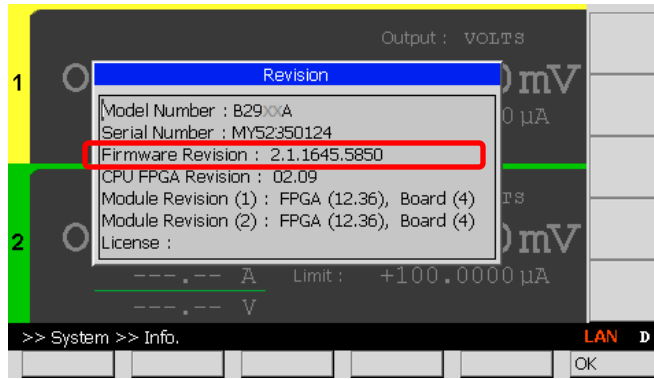
Step 2: If the firmware revision displayed is 3.1.1744.8690 or earlier, install the firmware 3.3.1829.4835 or later, following the procedure below.
