T1250A-01

S E R V I C E N O T E

T1250A Smart RF Switching Unit

T1250A amplifier issue, firmware fix

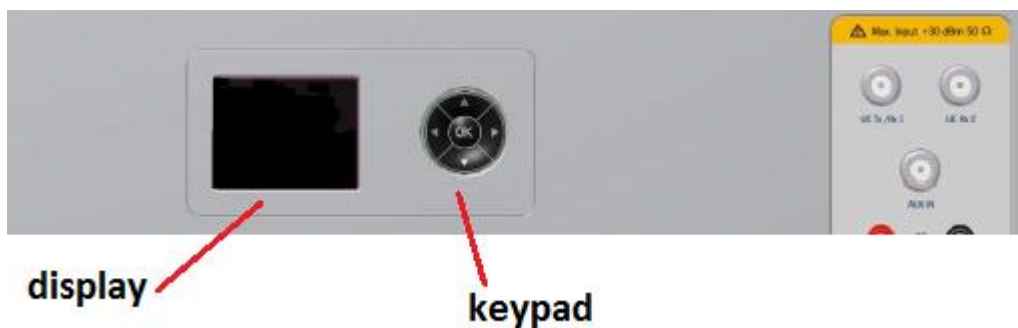
1. Firmware check. Firmware version can be easily checked with the front panel display and associated keys.

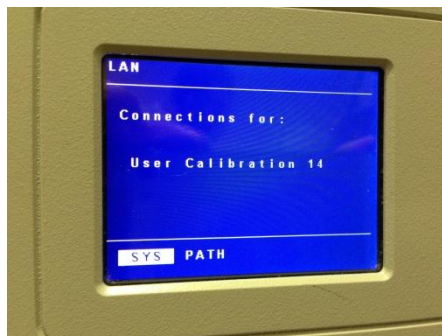
- Press OK at initial screen, to enter SYS menu:

Follow this steps to retrieve current firmware version:

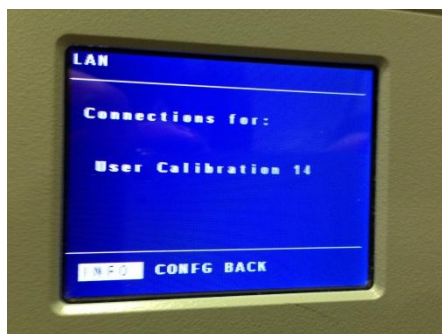
- Press OK again, to enter INFO menu:

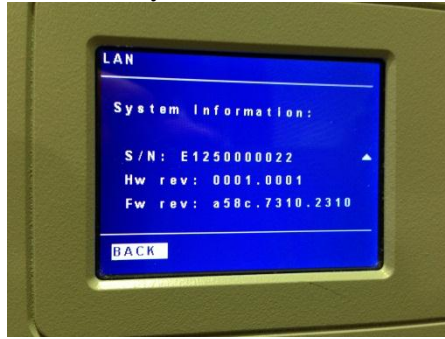
- Scroll down by clicking on down arrow key until firmware version is displayed:

- Check the first information field shown after “Fw rev” (in the picture, a58c)
2. If the firmware version is older than A58C, please contact LTE Technical Support e-mail node: mlg-techsupport-lte@agilent.com, to receive further assistance on upgrading the product.
