34401A-15B

S E R V I C E N O T E

34401A - Multimeter

10 megohm and 100 megohm ranges drift out of specification

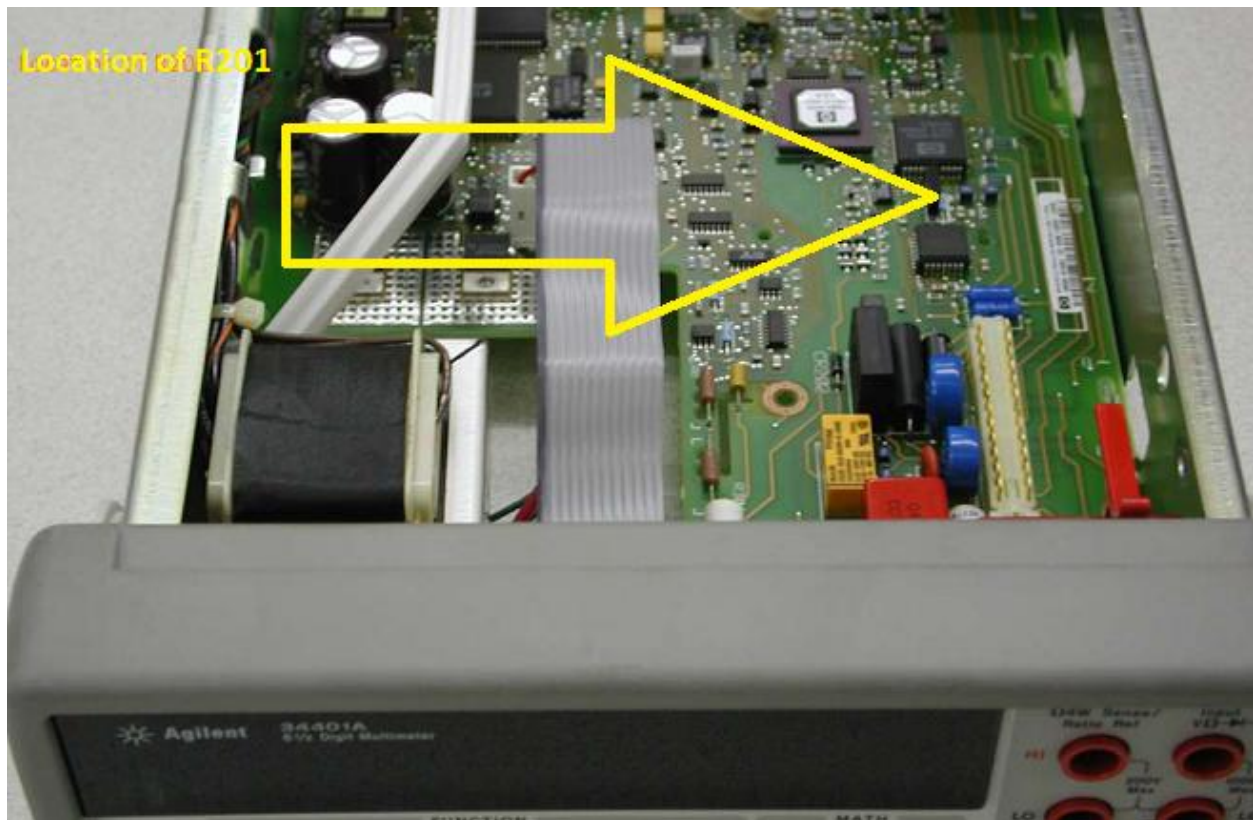
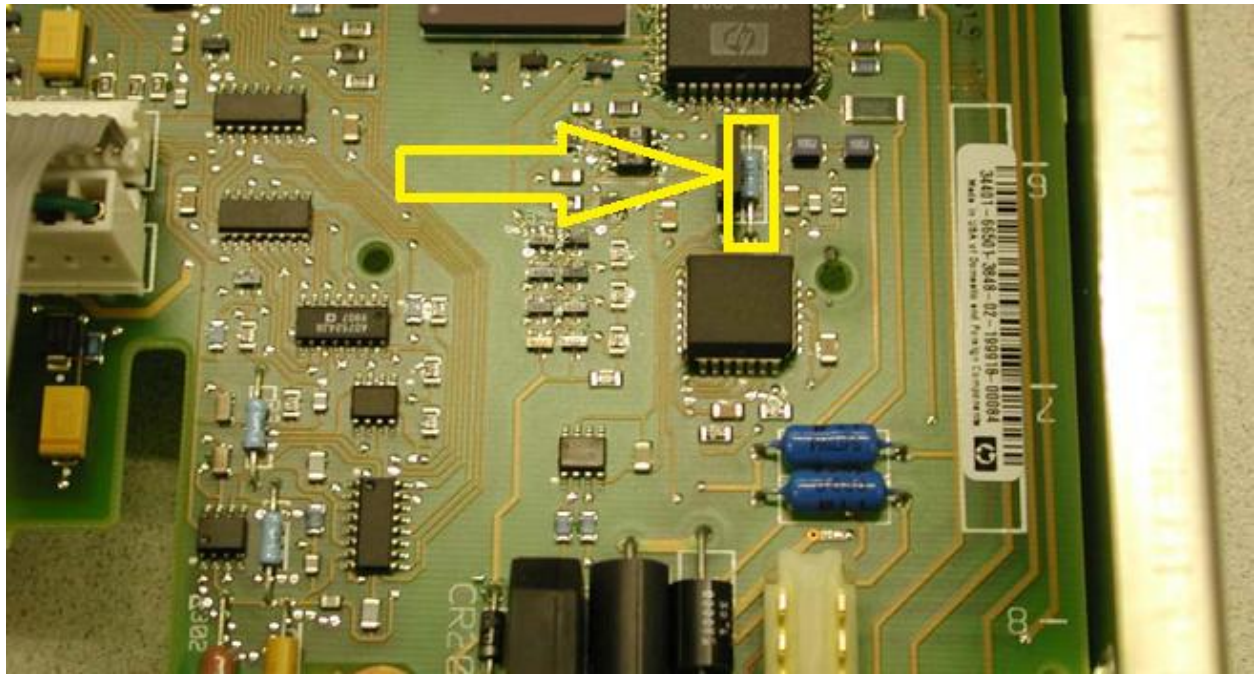
Customers World-Wide: Customers with technical ability to replace this resistor may replace the resistor themselves. (Note: A1R201 is a through-hole resistor located between A1U101 and A1U150 on the 34401A main PC assembly.) This approach will provide the minimum instrument downtime and inconvenience.

Remove the handle (MP5) from the unit by turning it to the top and pulling the sides out (away) from the product. Remove the rear bezel (MP1) and bumper (MP12) by unscrewing the two screws using a T-15 screwdriver. Remove the screw from the instrument cover (CVR1) and slide off the cover. Remove the screw holding the shields in place (SHD1 and SHD2) and remove the shields.

Locate and remove A1R201. Replace A1R201 and solder into position. Trim leads. Reassemble the 34401A and connect power. Power on the 34401A and allow it to warm up for 4 hours. Perform the Gain Adjustment Procedure found in Chapter 4 of the 34401A Service Manual for the 10 MOhm Range. Perform the Gain Verification Test for the 10 MOhm and 100 MOhm ranges.
