**44471A-01A**

**S E R V I C E N O T E**

**44471A** 10-channel General Purpose Relay for 3499A/B. Includes a screw terminal block

**Defective connectors shipped with 44470A, 44471A, 44473A, 44474A**

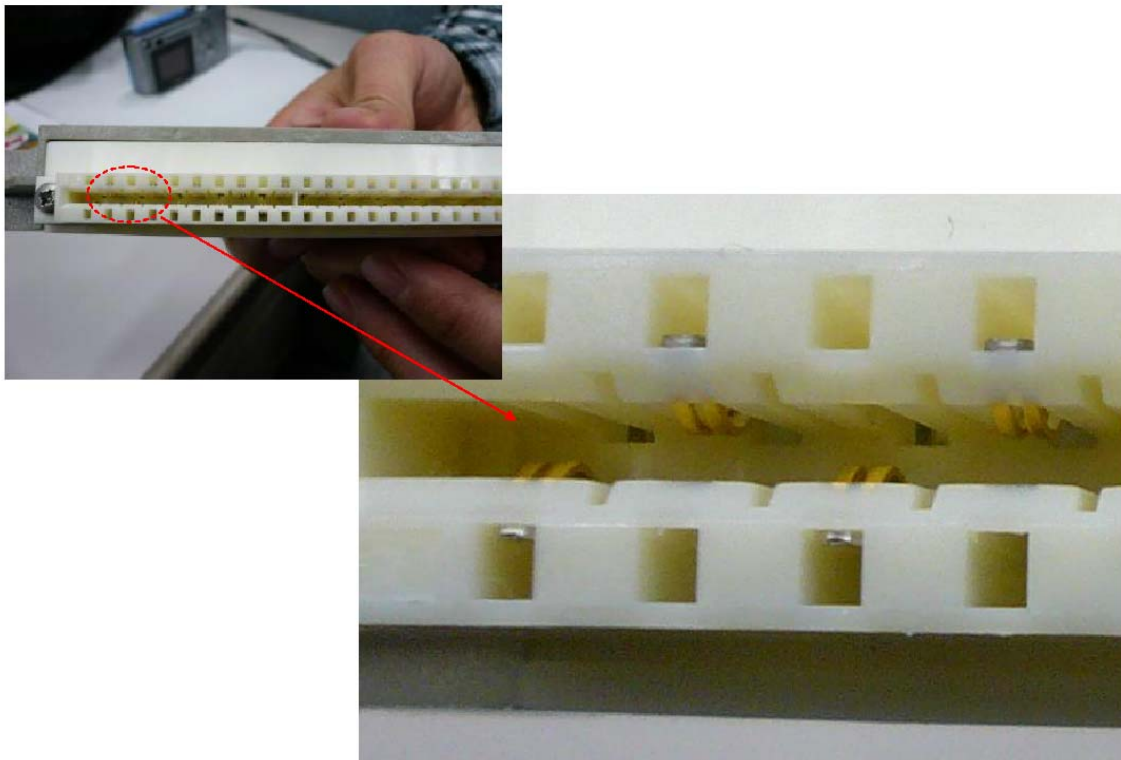
The 44470A, 44471A, 44473A, and 44474A products consist of a main relay plug in module and a removable terminal block (see Figure 1). These are plug in modules for the card cage mainframes 3488A, 3499A, 3499B, and 3499C. The main relay card contains the serial number. The removable terminal module does not contain a serial number. It is possible that over time a terminal block will no longer be used with the same serialized relay card that it was shipped with. A visual inspection of the connector in the removable terminal block is necessary to determine if a defective connector is present. The visual inspection should override the serial number range limits. All white colored connectors are good and have pins that alternate top to bottom (see Figure 2). A black colored connector is bad if it contains all pins on one side of the connector (see Figure 3). A black colored connector is good if it contain pins that alternate top to bottom (not pictured).

**Figure 2: Good Connector with alternating pins on top and bottom**

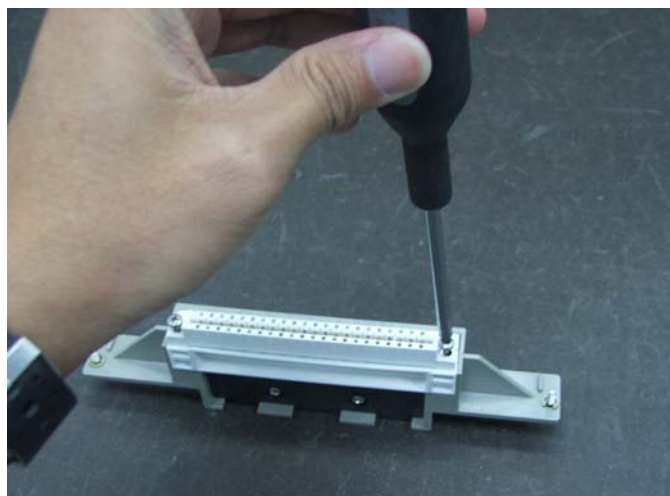
**Figure 5: Good Connector attached to terminal block**

Use the same torx driver to screw on the good connector, using the same orientation at the connector you just removed (see Figure 5).
