## S E R V I C E   N O T E

## HP MODEL 8565A SPECTRUM ANALYZER

## FUSED 30V POWER SUPPLY

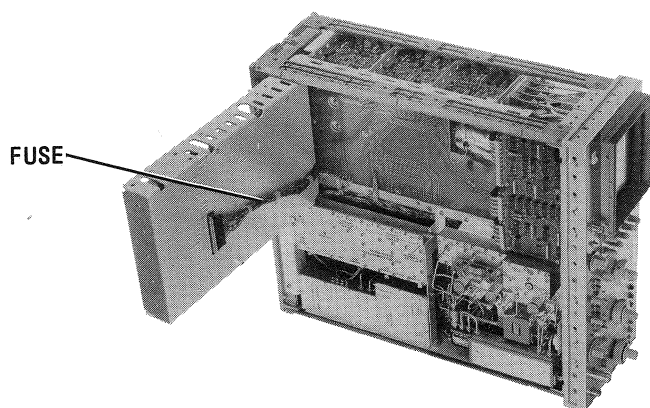
Figure 1

The input to the +30V regulator in the A40 Low Voltage Power Supply is fused. The 1.5 Amp fuse F2 is located under the Low Voltage Power Supply Module (see Figure 1). The A40 Low Voltage Power Supply Module can swing up for easy access to this fuse by the removal of 5 screws (see Figure 2). The fuse is located in this cable harness, soldered in series with the blue wire attached to A40A1J1 pin 6. The heat shrink tubing covering the fuse must be removed if the fuse is to be replaced. Replace heat shrink tubing after replacement.
