S E R V I C E N O T E

**8566B Spectrum Analyzer
85660B RF Section**

Recommended replacement for A10A6U2 OP AMP**Situation:**

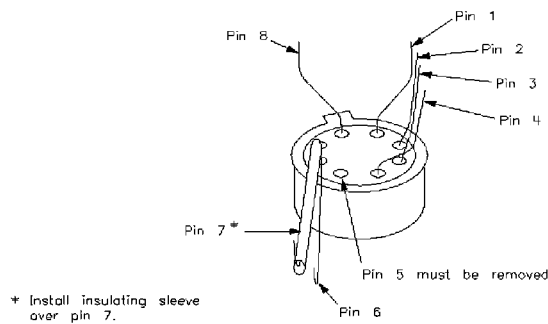
Figure 1 shows the bottom view of the op amp. The op amp leads are pointing towards you. Remove (cut off) lead 5 and form the remaining leads as shown.

Figure 1. How to form the part (bottom view).

Insert insulating tubing over lead 7 to prevent lead 7 from shorting to lead 6.

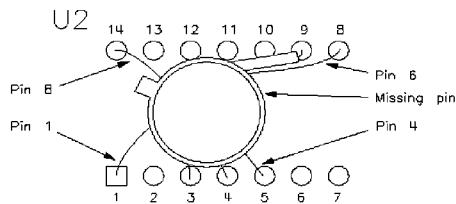
Figure 2 shows U2 inserted into the PC board.

Figure 2. Top view of U2 loaded into the PC board.

The following procedure outlines how to install the 8-pin op amp (U2) into the 14-pin “footprint” on the PC board.
