**86100B-02**

# S E R V I C E                      N O T E

## **86100B Infiniium DCA Wide Bandwidth Oscilloscope**

**When installing the A4 PC Motherboard, part number 0960-2568, into an 86100B, the BIOS must be flashed.**

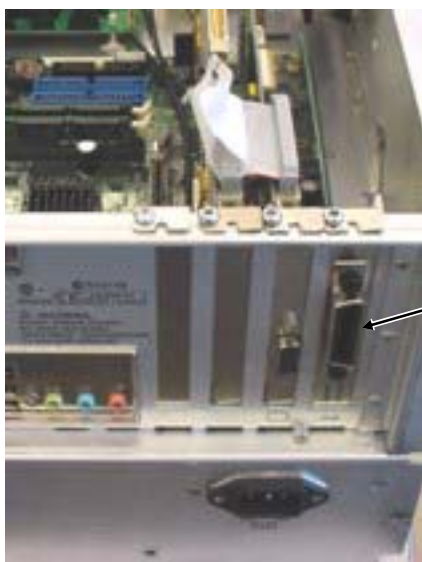
Figure 1, New GPIB Assembly Location

A11GPIB Board Assembly inserted in the A4PCI 3 Slot with newest A4 Motherboard

1. After installing the new motherboard (refer to 86100A/B/C Service Guide for instructions), ensure A11 GPIB card is installed into PCI 3 (right hand slot when looking from the rear) on Motherboard P/N 0960-2521. Refer to Figure 1.

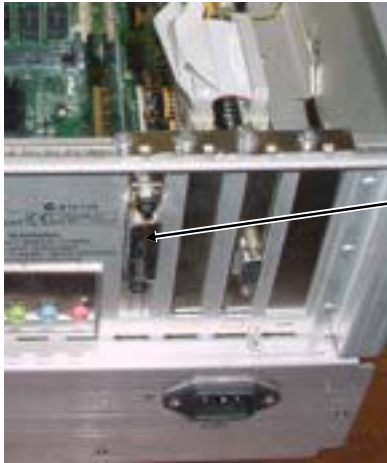
Figure 2, Original GPIB Assembly Location

A11GPIB Board Assembly inserted in the A4PCI 1 Slot with previous revision of the A4 Motherboard

Note – On Motherboard P/N 0960-2481 and earlier, A11 GPIB card was located in PCI1. There is no change to the A5/A6 assembly locations. Refer to Figure 2.
