**86100B-02B****S E R V I C E****N O T E**Supersedes:  
86100B-02A**86100B Infiniium DCA Wide Bandwidth Oscilloscope**

**When installing the A4 PC Motherboard, part number 0960-2568, into an 86100B, the BIOS must be flashed.****Depending on the existing CPU version, the A11 GPIB Board Assembly may have to be moved to a new PCI slot.****Parts Required:**

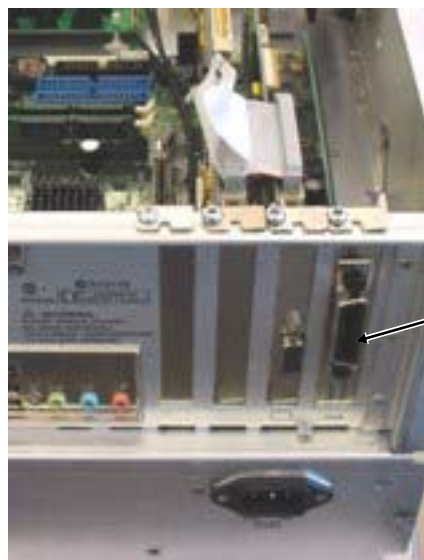
Figure 1, New GPIB Assembly Location

A11GPIB Board Assembly inserted in the A4PCI 3 Slot with newest A4 Motherboard

1. After installing the new motherboard (refer to 86100A/B/C Service Guide for instructions), ensure A11 GPIB card is installed into PCI 3 (right hand slot when looking from the rear) on Motherboard P/N 0960-2521. Refer to Figure 1.

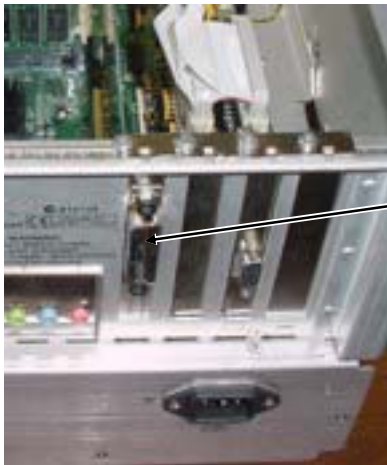
Figure 2, Original GPIB Assembly Location

A11GPIB Board Assembly inserted in the A4PCI 1 Slot with previous revision of the A4 Motherboard

Note – On Motherboard P/N 0960-2481 and earlier, A11 GPIB card was located in PCI1. There is no change to the A5/A6 assembly locations. Refer to Figure 2.
