**E3631A-13B****S E R V I C E****N O T E**Supersedes:  
E3631A-13A**E3631A DC Power Supply****Serial Numbers: MY51240260 to MY99999999****Metal Strap Kit for tightening loose bumper and for fitting rear lock link in side-by-side rack mounting****Parts Required:**

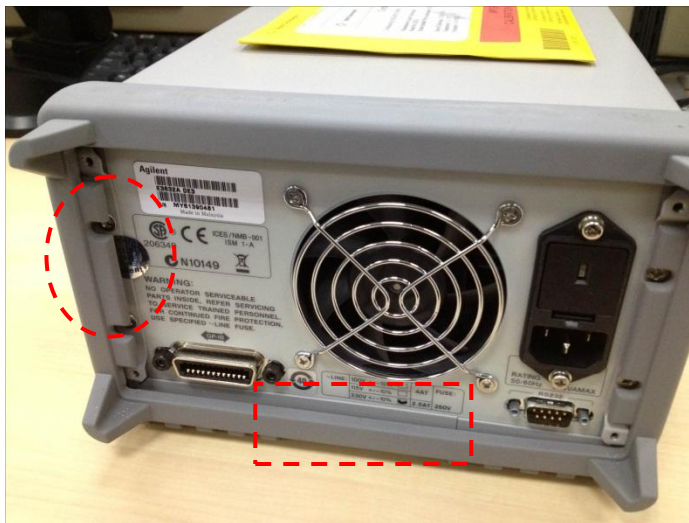
There is a new rear bumper design starting from serial number MY51240260. The rear bumper may become loose or it may slip out of the instrument chassis when force is applied to the rear bumper, as shown in Figure 1 below.

Figure 1: Loose rear bumper – gap observed between bumper and chassis

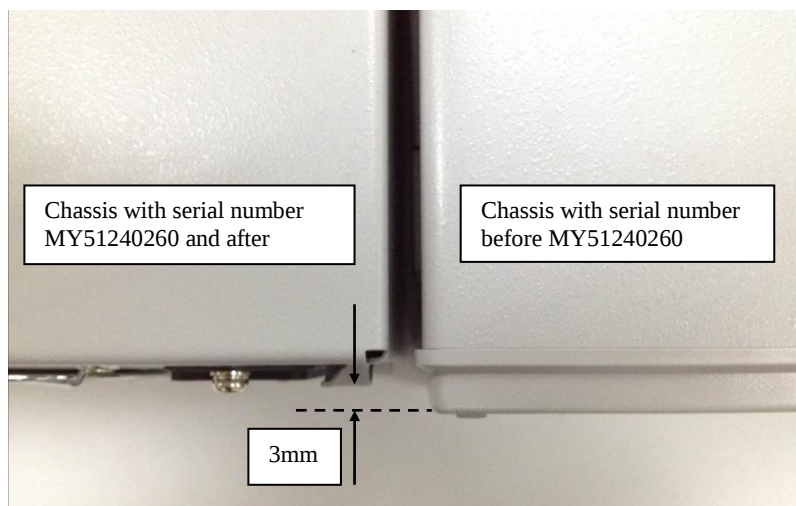
The chassis depth difference between the two designs is 3mm as shown in Table 1 and Figure 1 below.

Figure 1: Top view 3mm gap observed between two different chassis designs

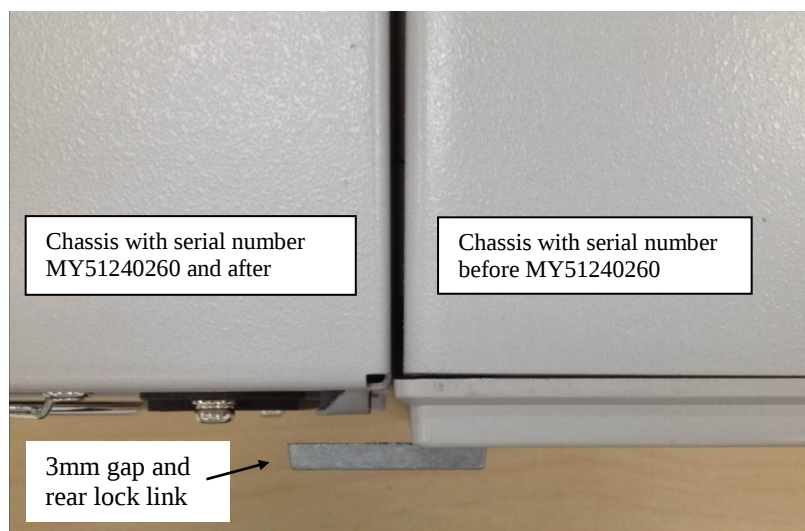
The 3 mm gap between the two different chassis may cause difficulties in securing them together using a rear lock link kit (part number 0050-2167) for side-by-side rack mounting as shown in Figure 2 below.

Figure 2: Top view 3mm gap observed on rear lock link for side-by-side rack mounting
