**E3632A-04C****S E R V I C E                      N O T E**Supersedes:  
E3632A-04B**E3632A DC Power Supply****Serial Numbers: MY51250037 to MY53220020****Metal Strap Kit for tightening loose bumper and for fitting rear lock link in side-by-side rack mounting****Parts Required:**

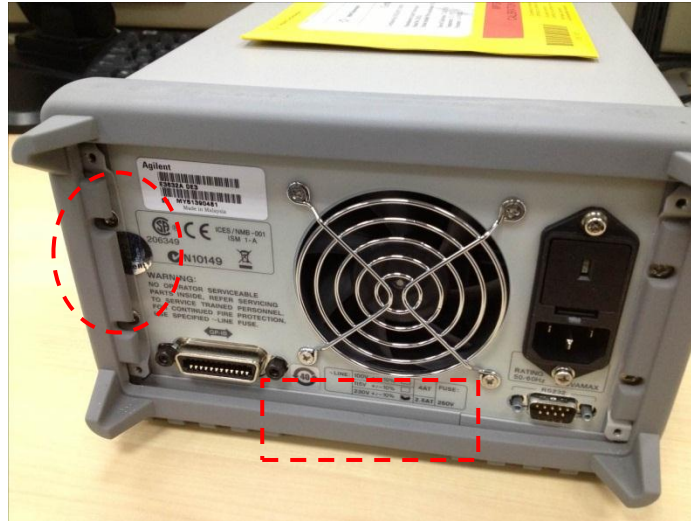
There is a new rear bumper design starting from serial number MY51250037. The rear bumper may become loose or it may slip out of the instrument chassis when force is applied to the rear bumper, as shown in Figure 1 below.

Figure 1: Loose rear bumper – gap observed between bumper and chassis

Use two metal straps (part number E3631-07901) to secure each side of the bumper as shown in Figure 3 below.

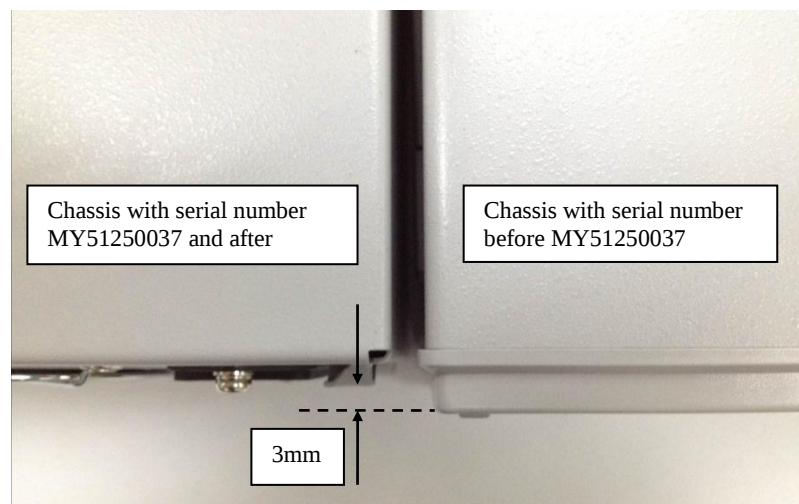
The chassis depth difference between the two designs is 3mm as shown in Table 1 and Figure 1 below.

Figure 1: Top view 3mm gap observed between two different chassis designs

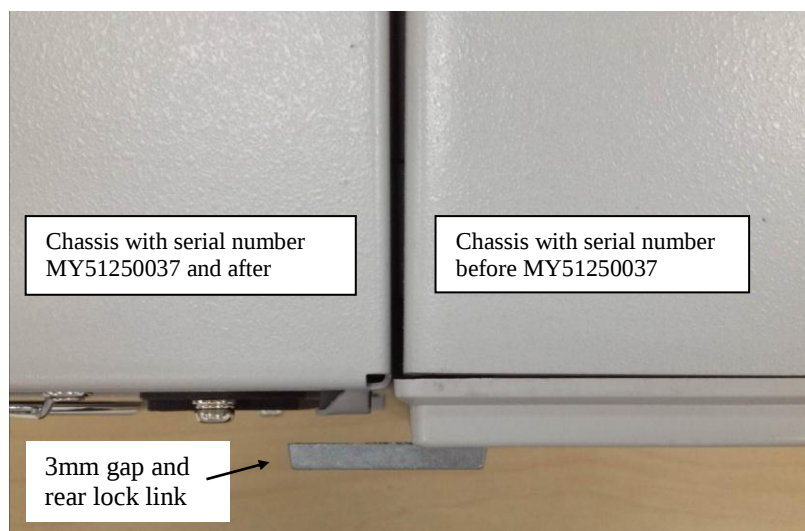
The 3 mm gap between the two different chassis may cause difficulties in securing them together using a rear lock link kit (part number 0050-2167) for side-by-side rack mounting as shown in Figure 2 below.

Figure 2: Top view 3mm gap observed on rear lock link for side-by-side rack mounting

Use metal strap (part number E3631-07901), and stack the provided two metal straps together to form 3mm thickness and secure it with the provided screws on the rear lock link as shown in Figure 4 below.

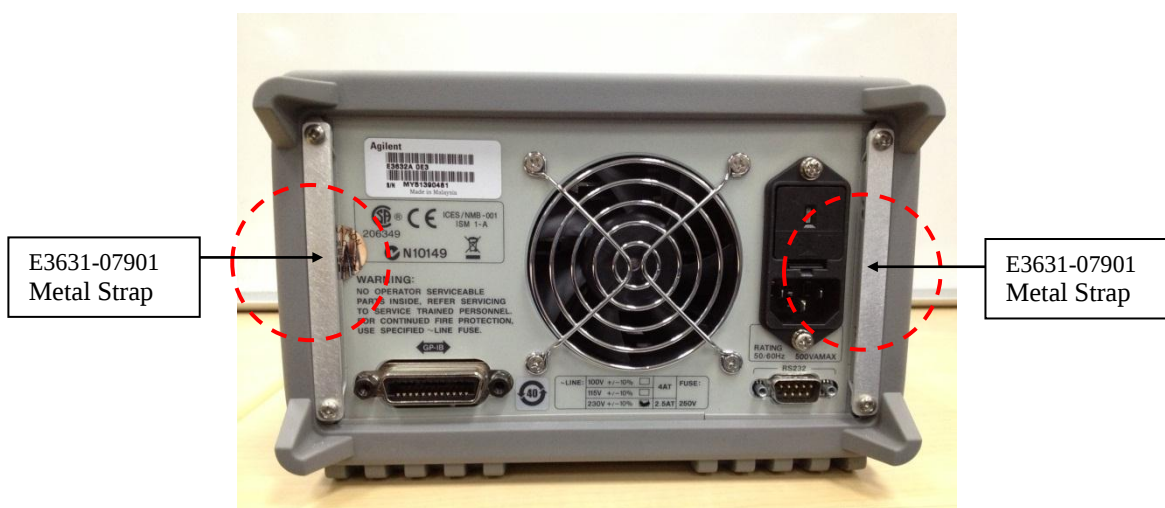
Figure 3: Secure with metal straps – no gap observed between the bumper and chassis

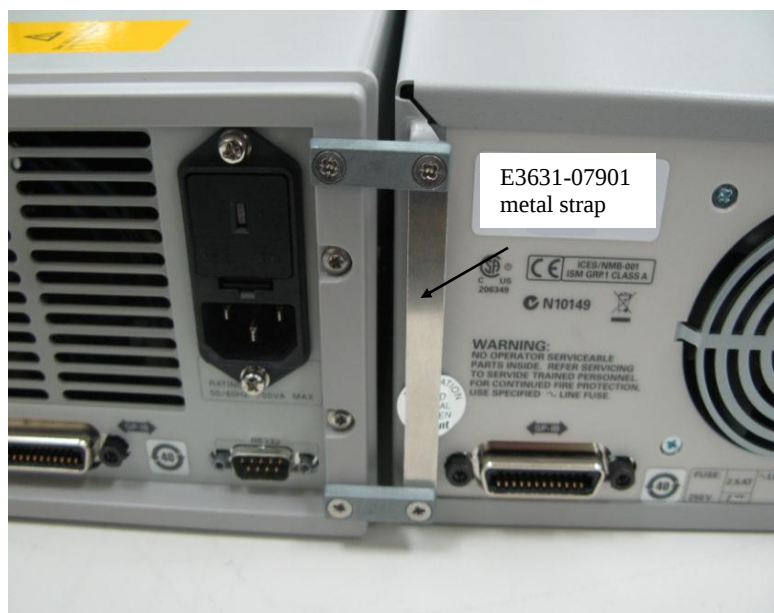
Figure 4: Rear view rear lock link secured with metal straps kit for side-by-side rack mounting
